30 Redington Road. Hampstead, London NW3 7RB

1262. Tree Survey and Arboricultural Method Statement. October 2014

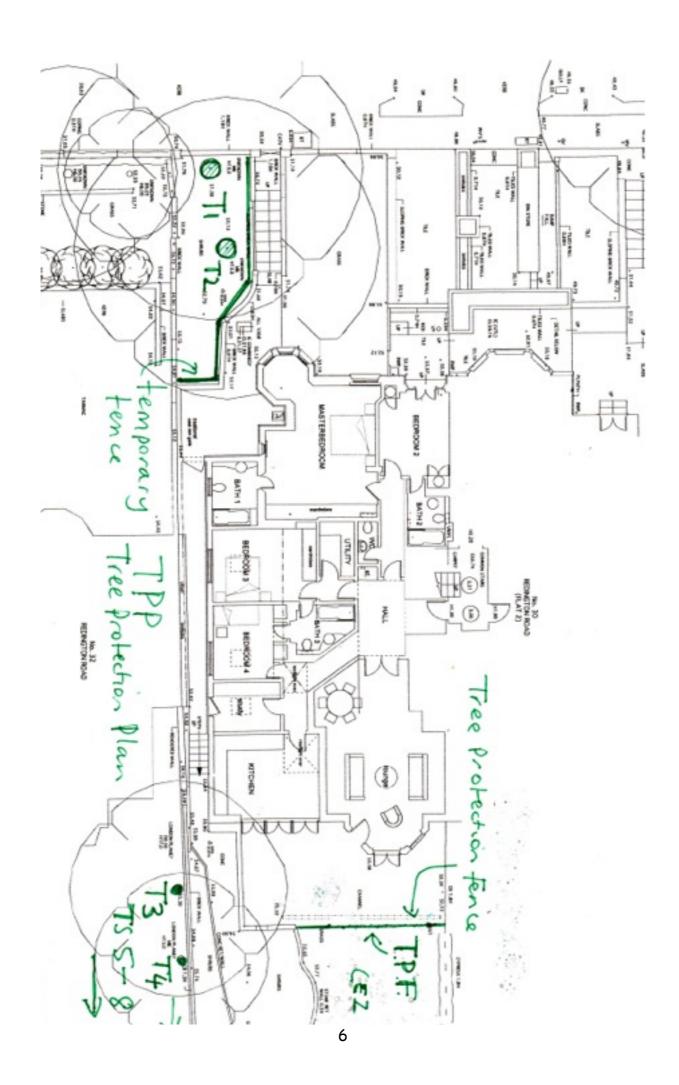
The position of both of these temporary fences are shown on the plan below. They follow existing features and this ensures they are assembled in the correct place. The areas enclosed by the fences are the self explanatory "construction exclusion zones" (CEZ).

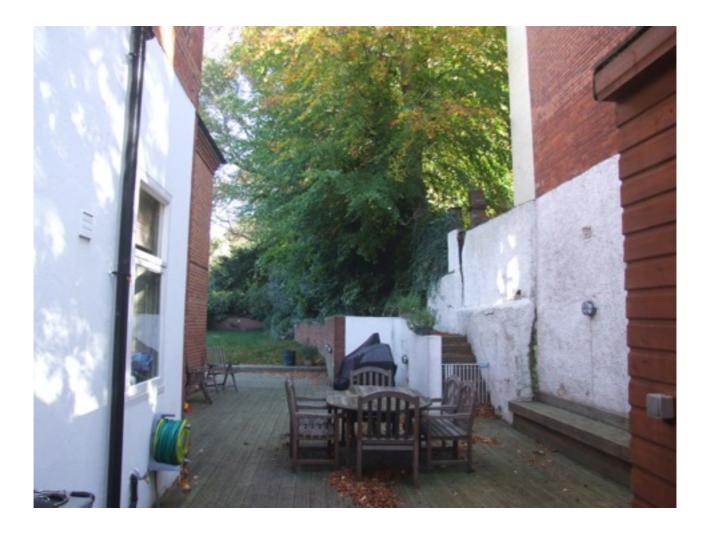
The above photograph shows.

- The level of the existing decking relative to the lawn.
- The extent of the decking and edge of the lawn where tree protection fencing will be placed.
- Existing retaining structures and relative levels.
- Repair is needed to the retaining structure adjacent to T3.

The photograph also shows that there are no tree related overhead obstructions to building.
