Greater London Industrial Archaeology Society

**Provender Store, Stables Market, Chalk Farm Road, London NW1 8AH,
Application Nos. 2014/6272/P and 2014/6589/L**

Stables Market Provender Store, MTT photos 24 Oct 2014 and some (in black and white) from 1975-81

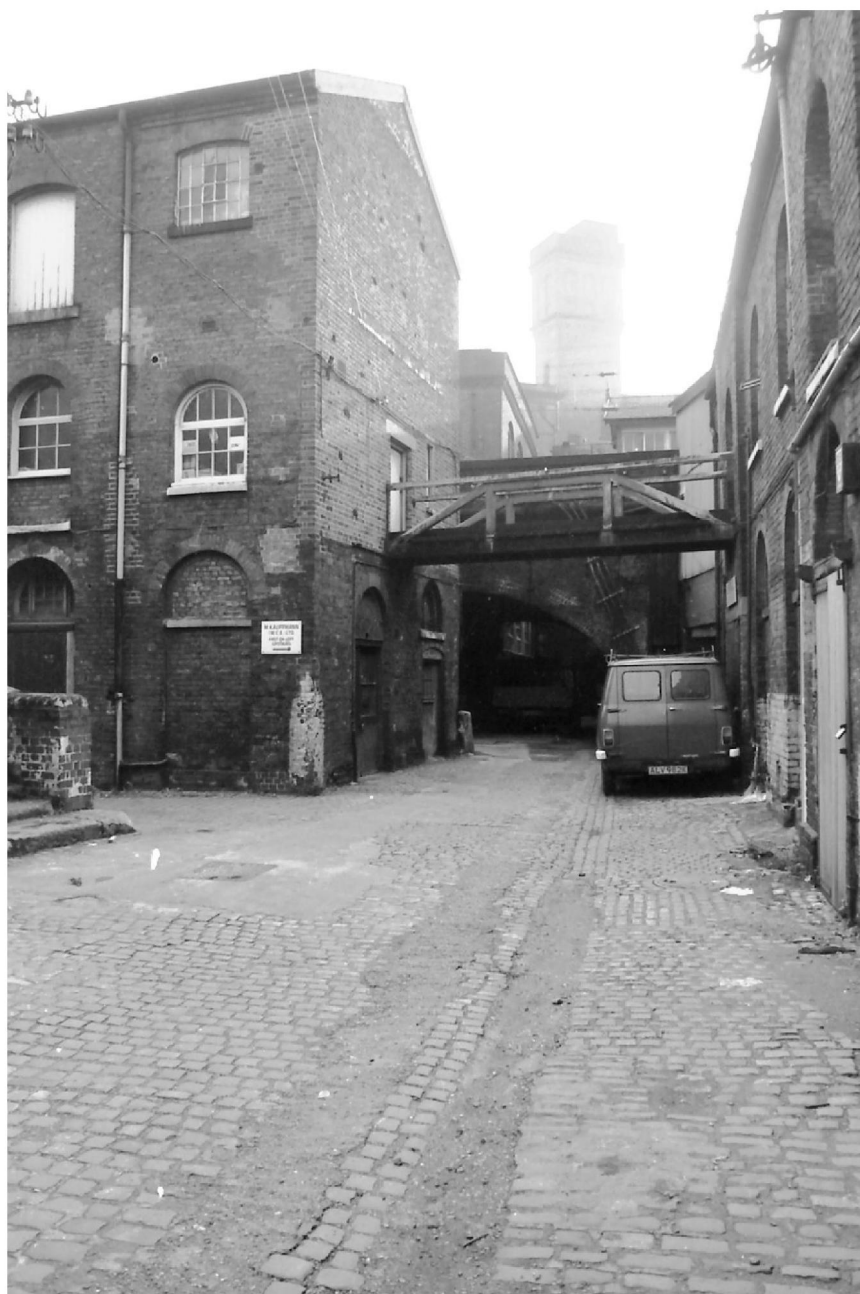
Section 1, north end, 29 Nov 1975 (MTT595_6A), showing former bridge to Tack Room

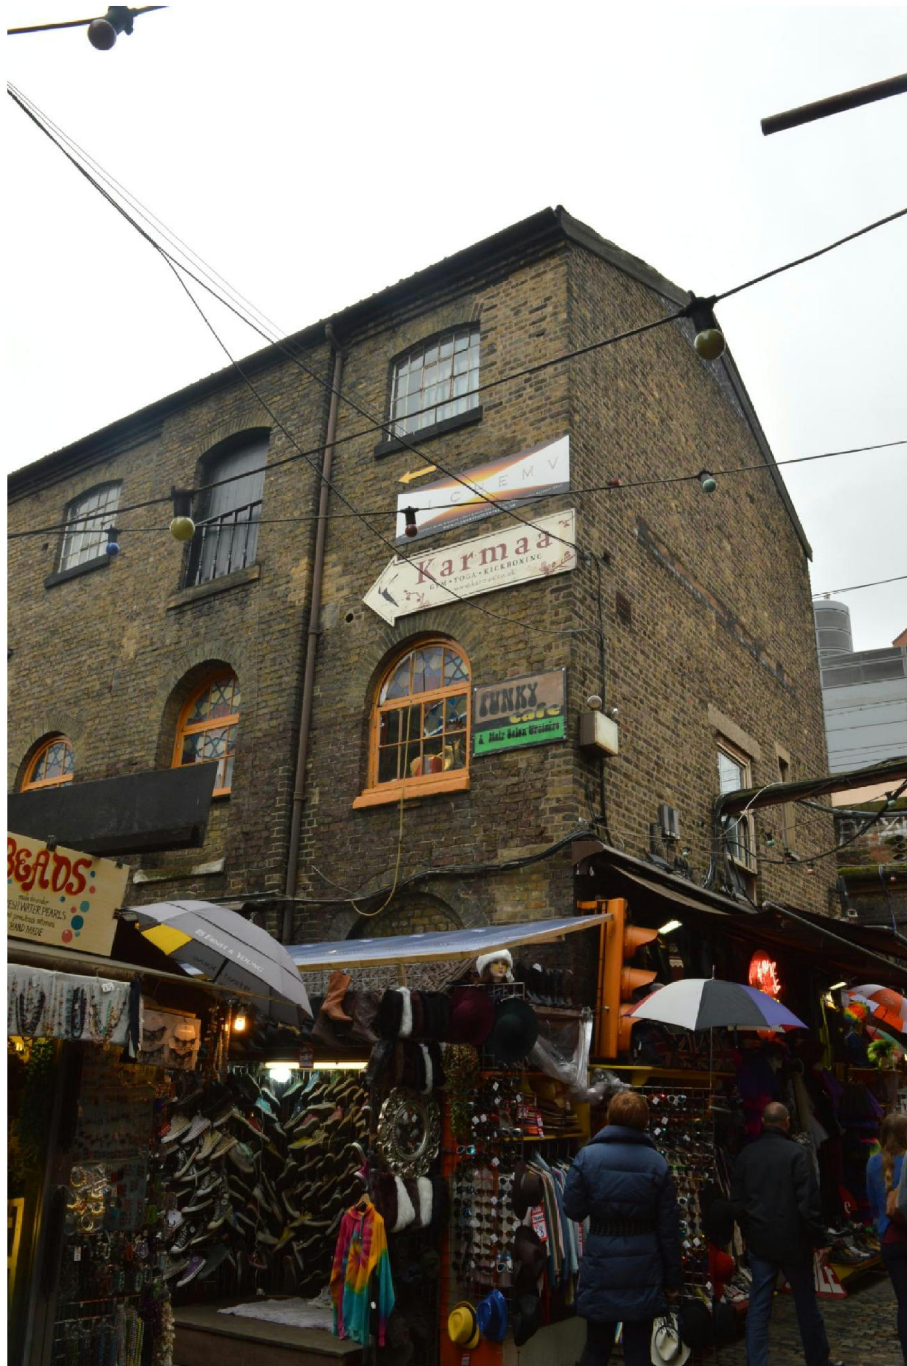
Section 1, north end today

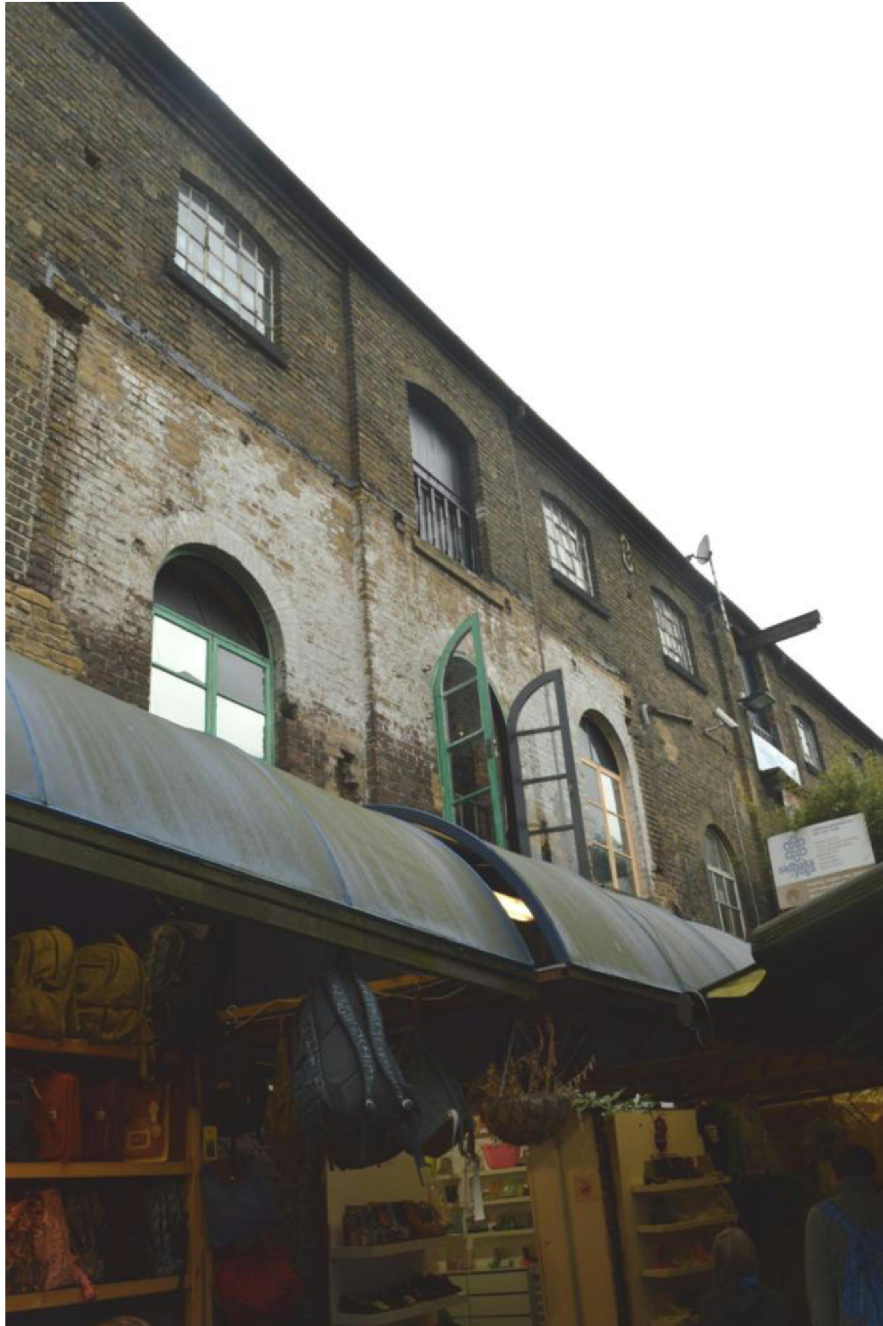
Sections 2 and 3 today. The whitewash on Section 3 marks the site of the 'New Provender Store', see following picture.

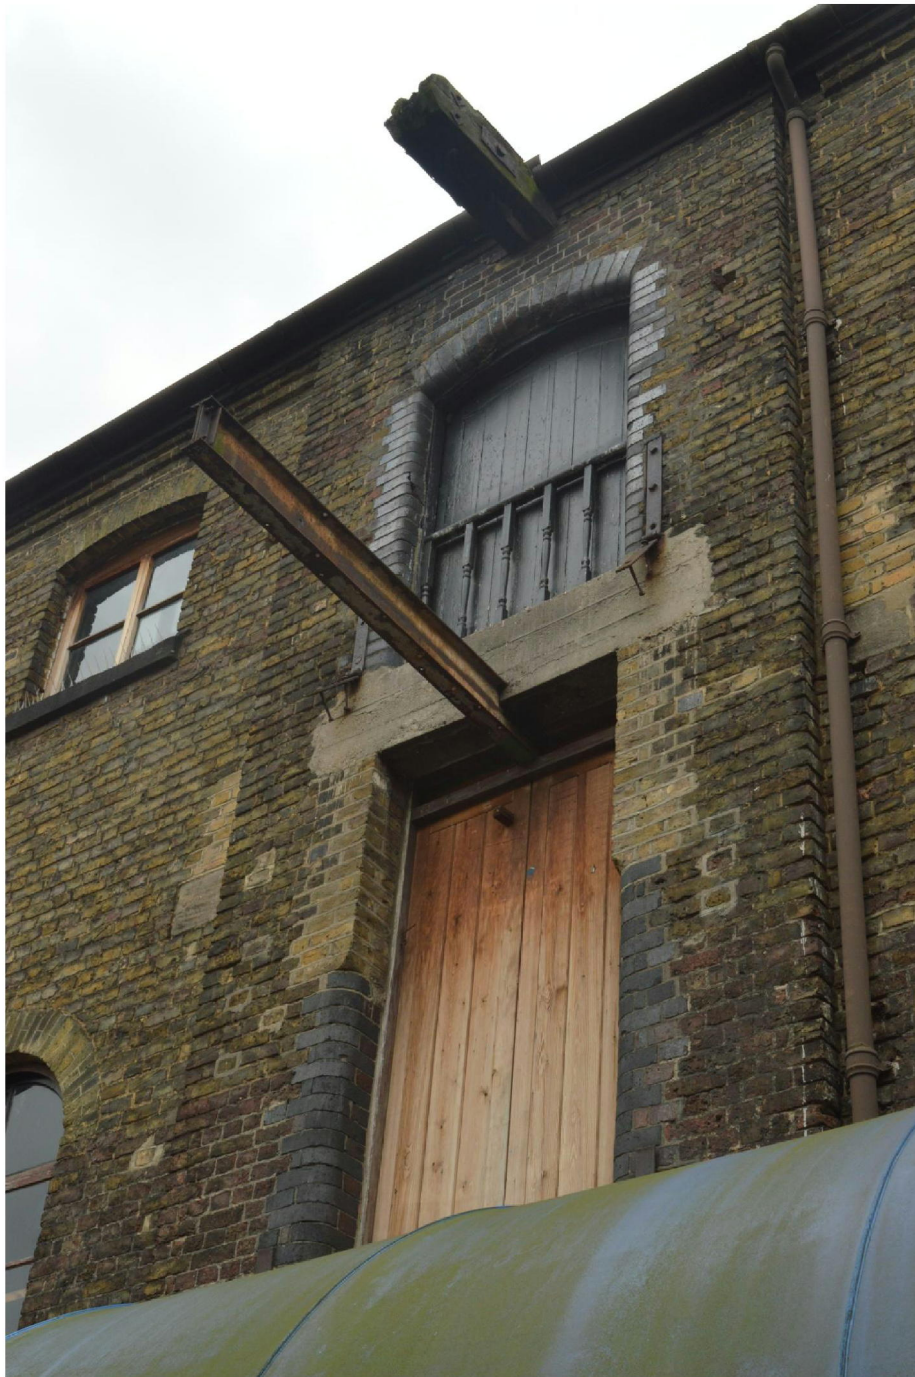
3.3) The proposals remove the characterful steel hoisting beams that have been added to the building in the 20th century, during the time when it was still used as a provender store, which is regrettable. The one original wooden hoisting beam, a valuable relic, is retained but left unprotected from the weather. Page 7 of the photo compilation shows that an attractive protective shelter was still in place in 1981, around the time the building was listed. This needs to be reinstated.

Section 4 today. Note original timber cathead beam and blue brick reveals to these loading doors

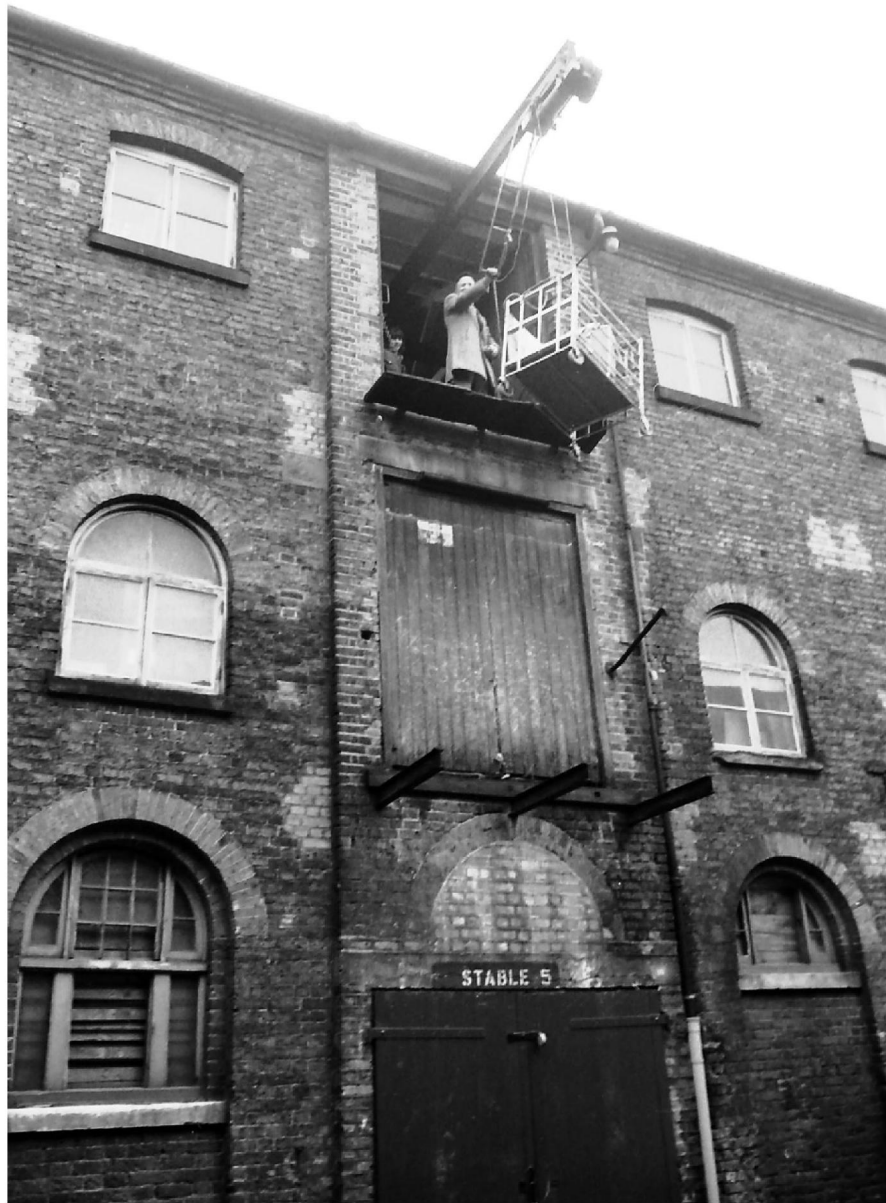
3.2) The half doors proposal may stem from a lack of understanding of the building's archaeology, and if approved they will certainly misinform future generations of lay people. Whereas stables often did have half doors, traditionally these opened inwards, not outwards. But these upper floors were built for storage and not stables at all, and their loading bays have full-height doors which open of necessity inwards rather than swinging into the wind. The idea of a flush door with external hinge straps and opening outwards might have been taken from one particular door, in the second doorway from the south on the middle floor, but that is a recent replacement – compare pages 11 and 12 of my photo compilation. The previous, nearly flush-mounted door at that point was itself the result of a mid-20th-century alteration, where the doorway can be seen to have been widened.

Section 5, 22 Feb 1975 (MTT510_5A). The loading doors here are seen to have been widened under concrete lintels during the 20th c. Note functional hinged flap at second floor. Doors fitted at first floor are less recessed than traditional doors.

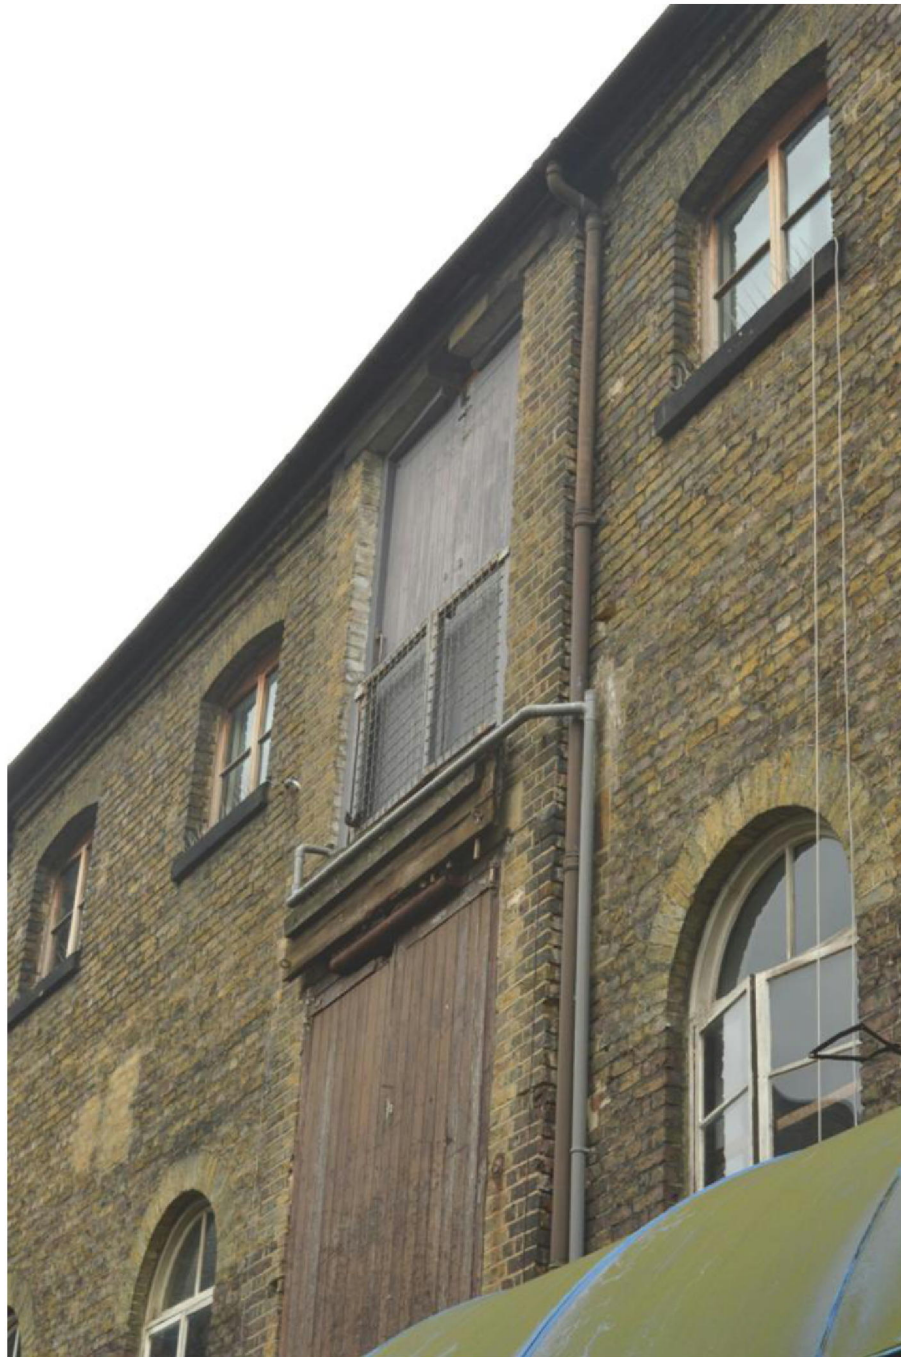
Section 5 today. Note the widened first floor doors have been replaced since 1975 and are now completely flush.

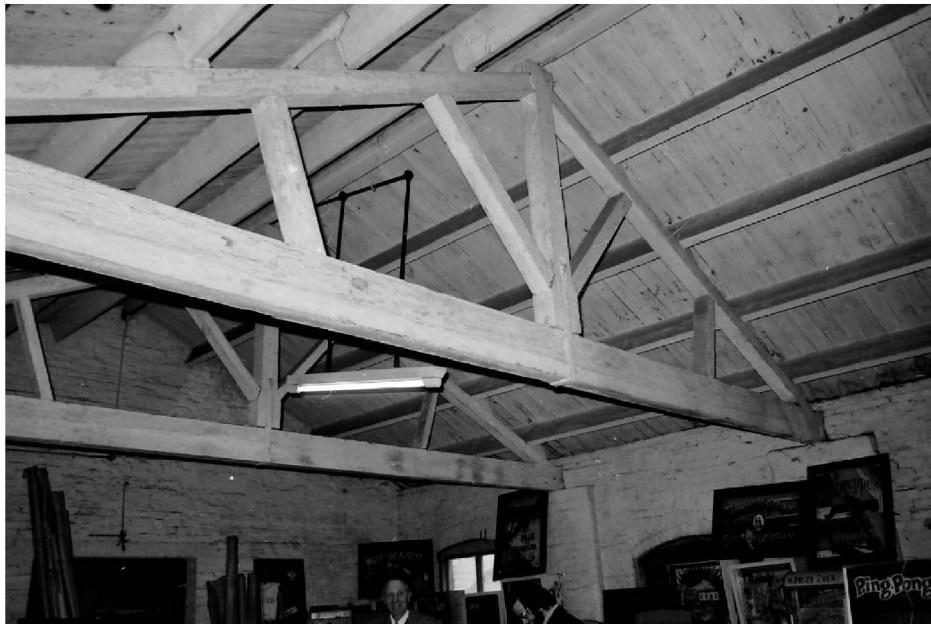
Roof truss, 25 Feb 1975 (MTT510_7A). Similar to the 1880 drawing in the National Archives.
