Trades Union Congress

Congress House Courtyard and Balcony Works

Design and Access Statement
incorporating
Heritage Impact Assessment
and Sustainability Statement

Hugh Broughton Architects

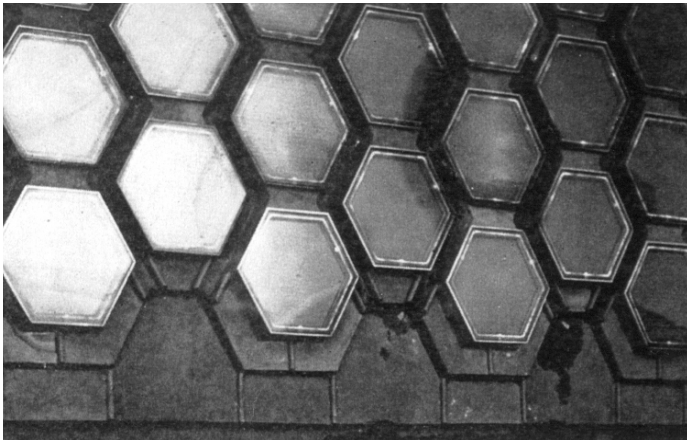
The original hexagonal coffered roof began to leak shortly after it was constructed. By 1994 it was regularly leaking in at least six places. Dye tests carried out on the roof showed that the ingress path for the water was very long making it impossible to determine exactly where the leak was occurring. At the time some double glazed panels were opened up and these were found to be dry inside. This meant that the leaks had to be occurring through the lead lined gutters. Standing water was often evident in the gutters reinforcing this assumption.

Whilst lead is a commonly used roofing material with a design life in excess of 80 years, it must be carefully laid on flat rooves with falls of at least 1 in 40, maximum sheet lengths of 2.4m and drops (or 'drips') of at least 50mm at laps between sheets. The combination of falls and drips combines to suggest an overall fall across the conference hall roof should be approximately 1 in 20. The actual fall across the roof is around 1 in 140. This explains why water was standing in gutters and why it was also penetrating the roof at junctions between sheets and leaking into the conference hall

View of the rooflights showing the lead lined gutters between the glazed hexagonal coffers (1958)

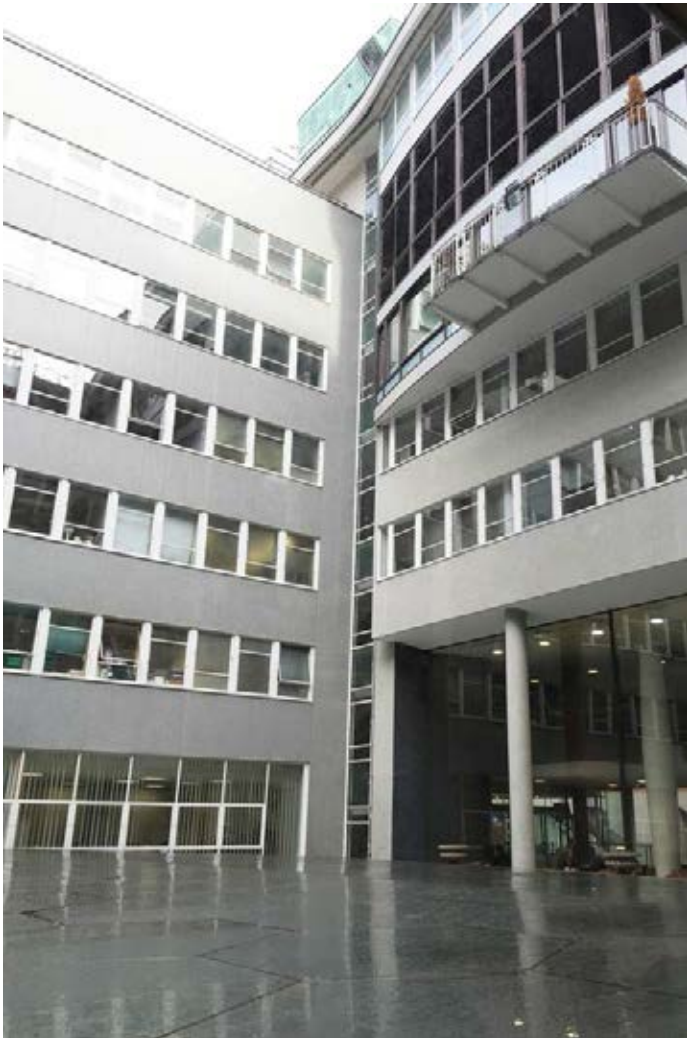
Following a review of options, in 1996 a low level single glazed roof was added above the failing hexagonal roof. Nearly 20 years after its installation this over cladding is now failing.

The over-glazing was designed with hexagonal panels supported with stainless steel stanchions under corners. In multiple locations vertical stanchions were omitted and in these areas the glass panels have tended to sag and the silicone filled joints between panels have broken and begun to leak. A few years ago, a repair of the damaged joints was attempted in one corner. As the gap between panels had become significant, the repair required large areas of mastic to cover the joints. This was extremely unsightly. On other occasions that the system has leaked, the TUC

As the problem has developed, some gaps have enlarged to such an extent that repairs would be very unsightly, requiring excessive amounts of mastic to fill gaps. Looking across the roof now it is clear to see that many of the panels have dropped out of level. As the over-glazing is directly on level with people in the Marble Hall, the problem is compounded by the dust, which accumulates on the roof making it difficult to see the original roof.

Glass over-cladding to the original conference hall roof. Black metal mesh to Council Chamber also visible

As not all the additional vertical supports can be installed, the problem of movement of the glass panels cannot be solved and an alternative means to protect the original roof is needed.

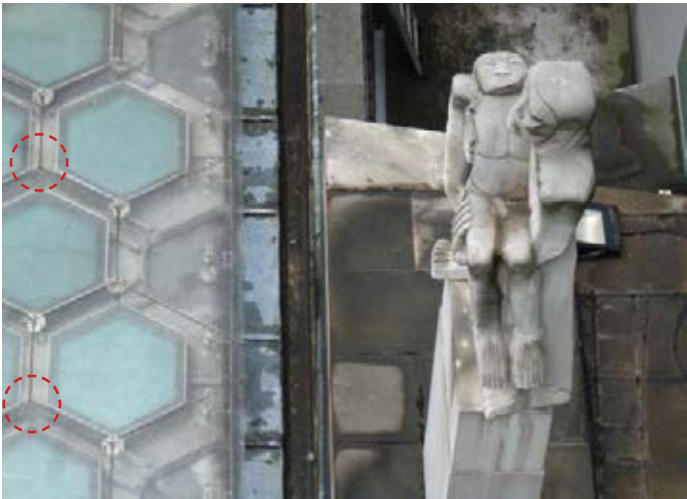
Detail view. Note missing stanchions to some corners of overcladding

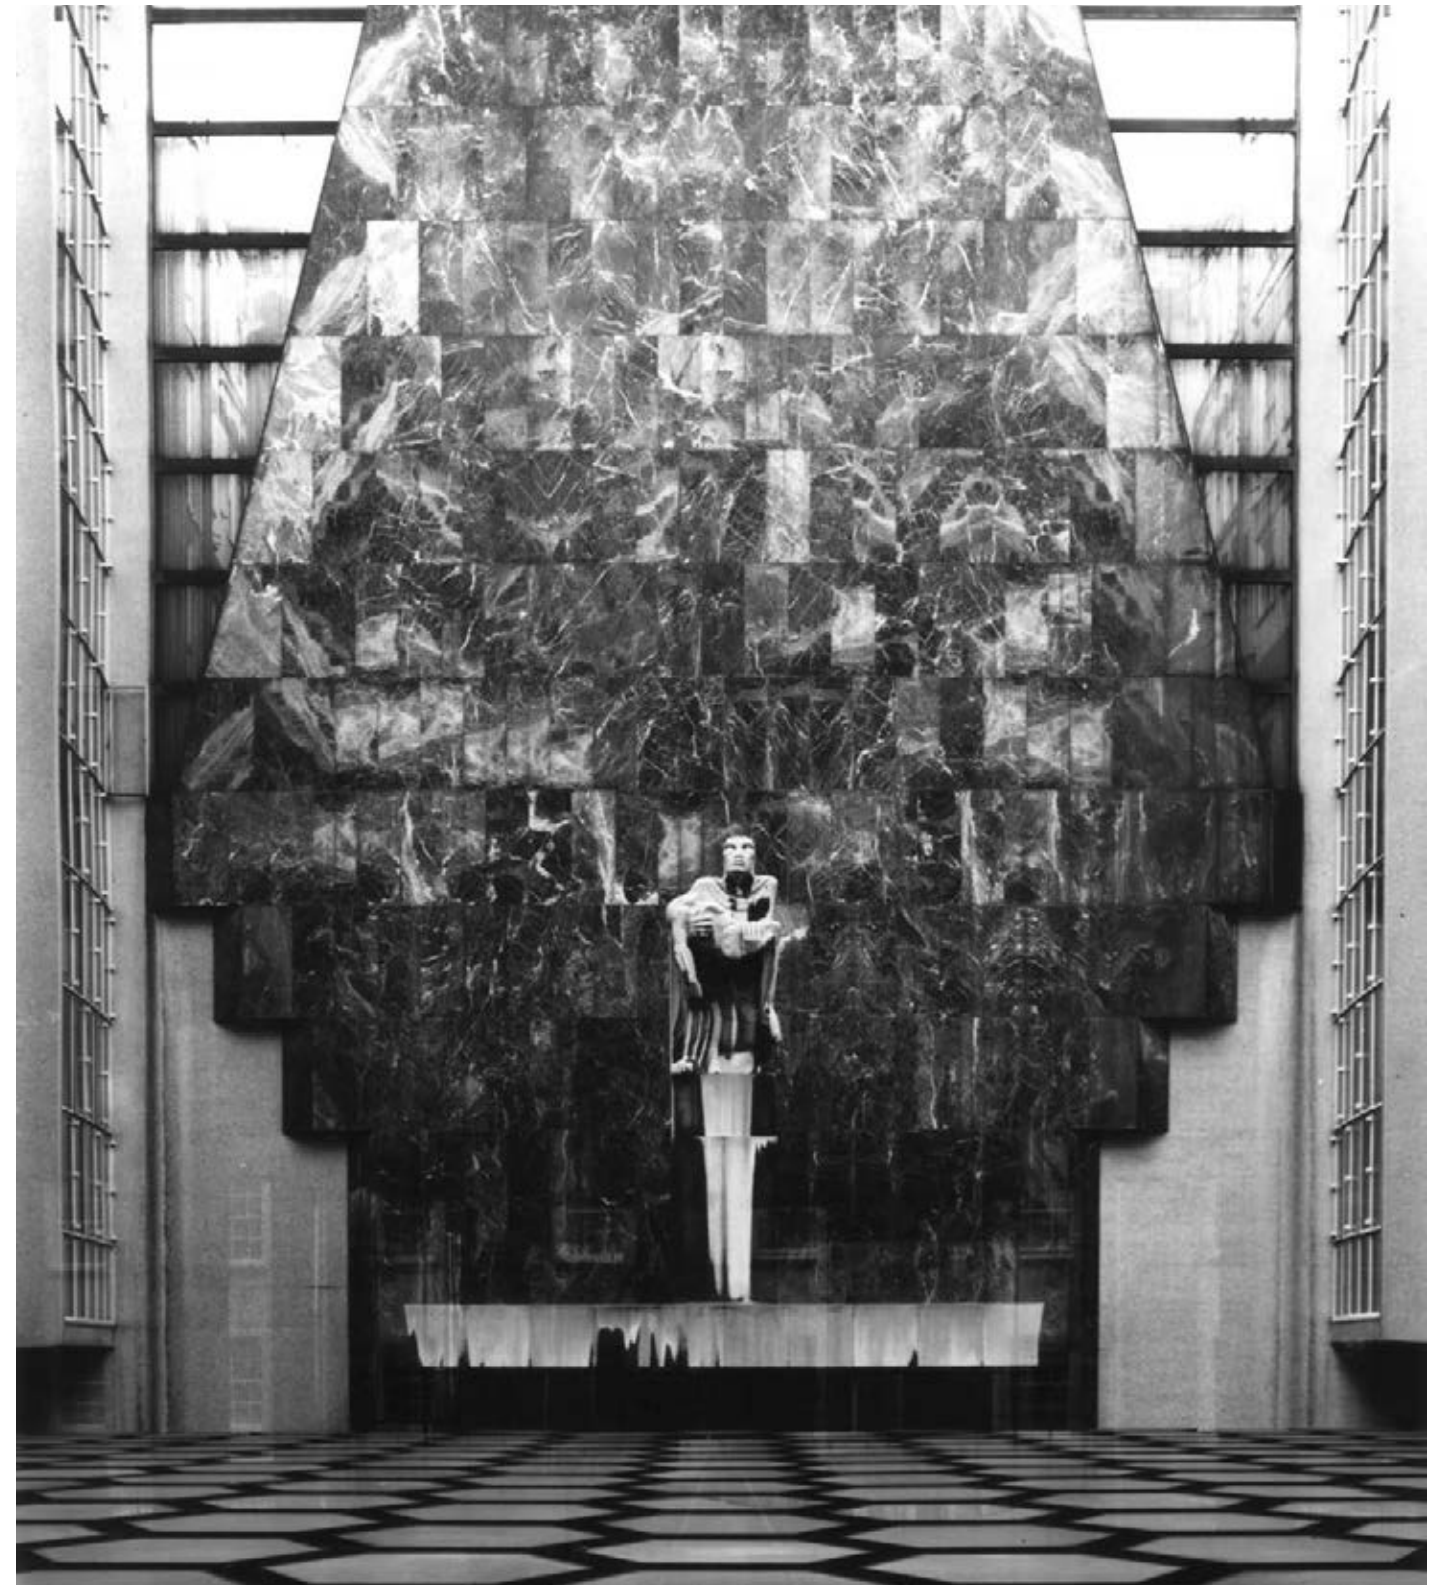
In the 1960's, the fixings of the marble panels began to fail. The marble panels were therefore replaced with lighter grey green mosaic tiles to match the other courtyard elevations, using a more robust fixing system.

View from the Marble Hall across the Conference Hall roof (1958). The marble cladding to the Memorial Wall was replaced with mosaic after fixings for the marble failed.

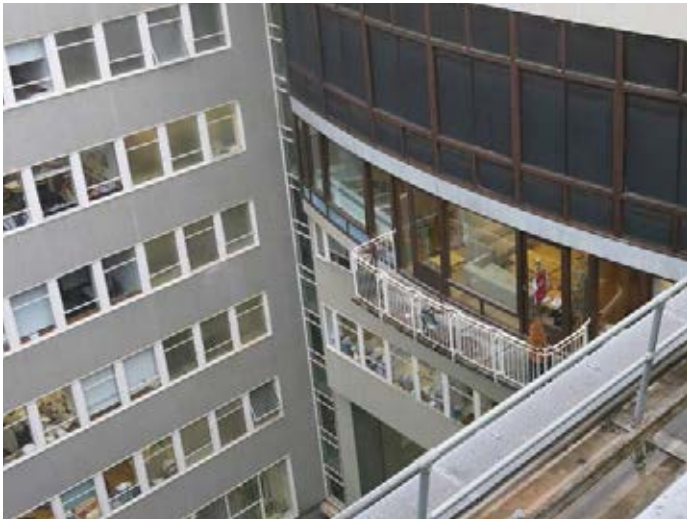
Black mesh to Council chamber glazing (2014)

- It will provide an opportunity to remove the black mesh to the west elevation of the Council Chamber.
- The courtyard elevations will be cleaned and any redundant items (eg cables, planters etc) will be removed helping to return the space to its original form.
- The north and south balconies at sixth floor level will be refurbished with enhanced paving, lighting and new glass balustrades to provide a pleasant outdoor covered space for amenity use by sixth floor offices.

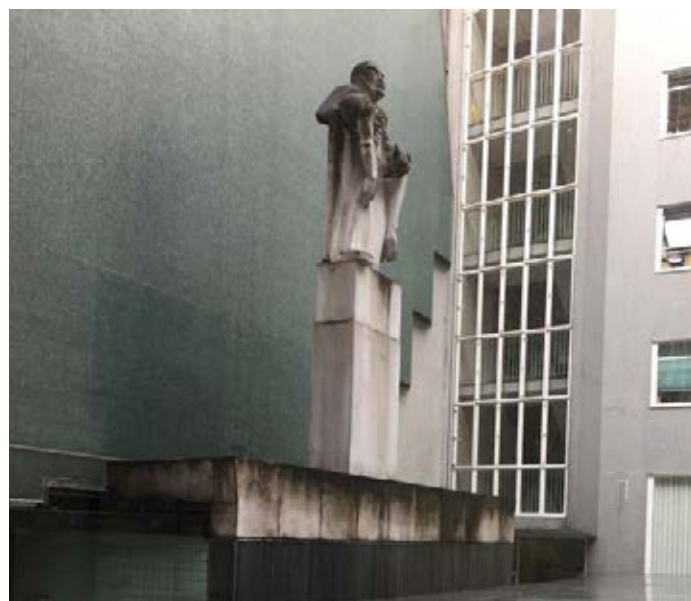
The new canopy will protect the Memorial Wall and Epstein sculpture from further exposure from the elements

The Group, the sculpture by Sir Jacob Epstein, and the plinth on which it sits currently suffer from exposure to the elements and require regular cleaning. The more it is cleaned, the more it needs to be cleaned. The proposed canopy will offer protection to the sculpture and to the glass rods and mosaic tiles of the Memorial Wall.

As part of the works, the sculpture and plinth will be cleaned and re-lit. The impact of the proposed canopy will therefore be very positive and protection will be a significant improvement to the ongoing conservation of the stonework.

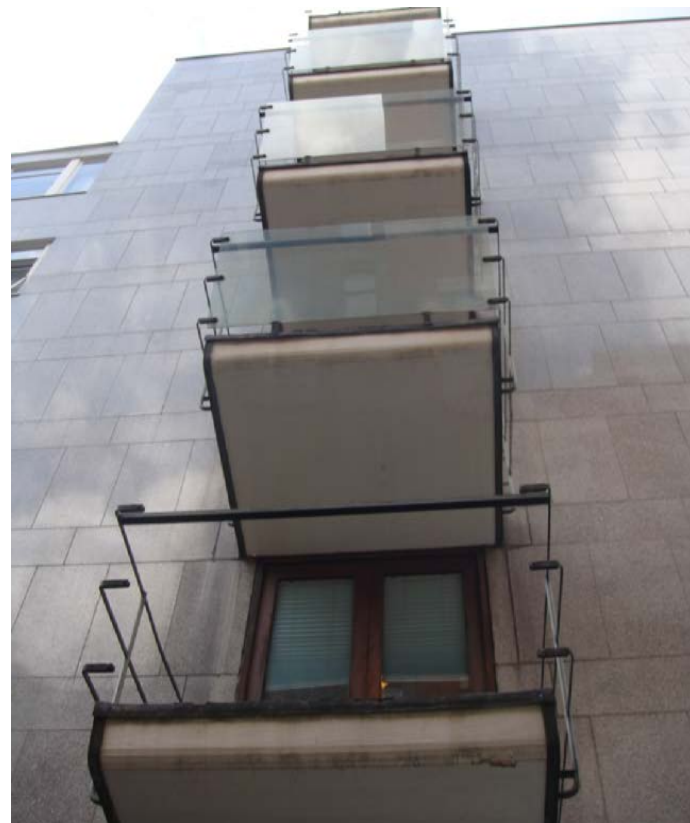
On investigation it was seen that the fixings for the panel were still intact and fragments of glass were on the balcony and it was therefore likely that the glass had broken in situ. There was nothing on the balcony or street level to indicate that an object had broken the glass and the reason for the breakage is inconclusive.

Recent view showing 1st floor balcony with missing glass panel. Subsequently the remaining glass was removed for safety

All the glass in the balconies has been removed for fear that other panels may similarly fail. The doors leading from the meeting rooms to the balconies are being fitted with restrictors to allow continued natural ventilation whilst preventing access.

In order to prevent any risk of the glass falling onto the street in the future, the replacement panels will be toughened and laminated so that they hold together in the event of breakage. The glass panels will therefore be framed with very slender bronze frames to minimise the visual impact of this change. The existing bronze balustrades will be replaced and adapted to incorporate the framed glass panels.
