Landmark Trees

ARBORICULTURAL IMPACT ASSESSMENT REPORT:

23 Downside Crescent
Belsize Park
London
NW3 2AN

Ref: BDA/23DWN/AIA/01

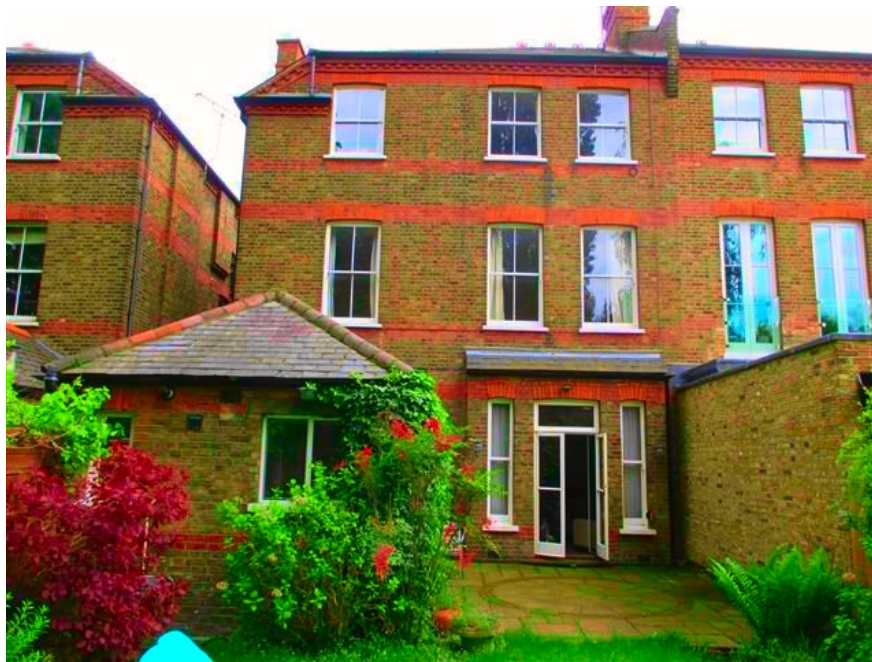
Photograph 1: Rear view of 23 Downside Crescent, Belsize Park, London NW3 2AN

| 3.1.1 | The site currently comprises an existing residential dwelling, situated on the north western side of Downside Crescent. The property has a courtyard garden to the front, and a rear garden with an outbuilding and existing hard landscaping (see photograph 1 above). |

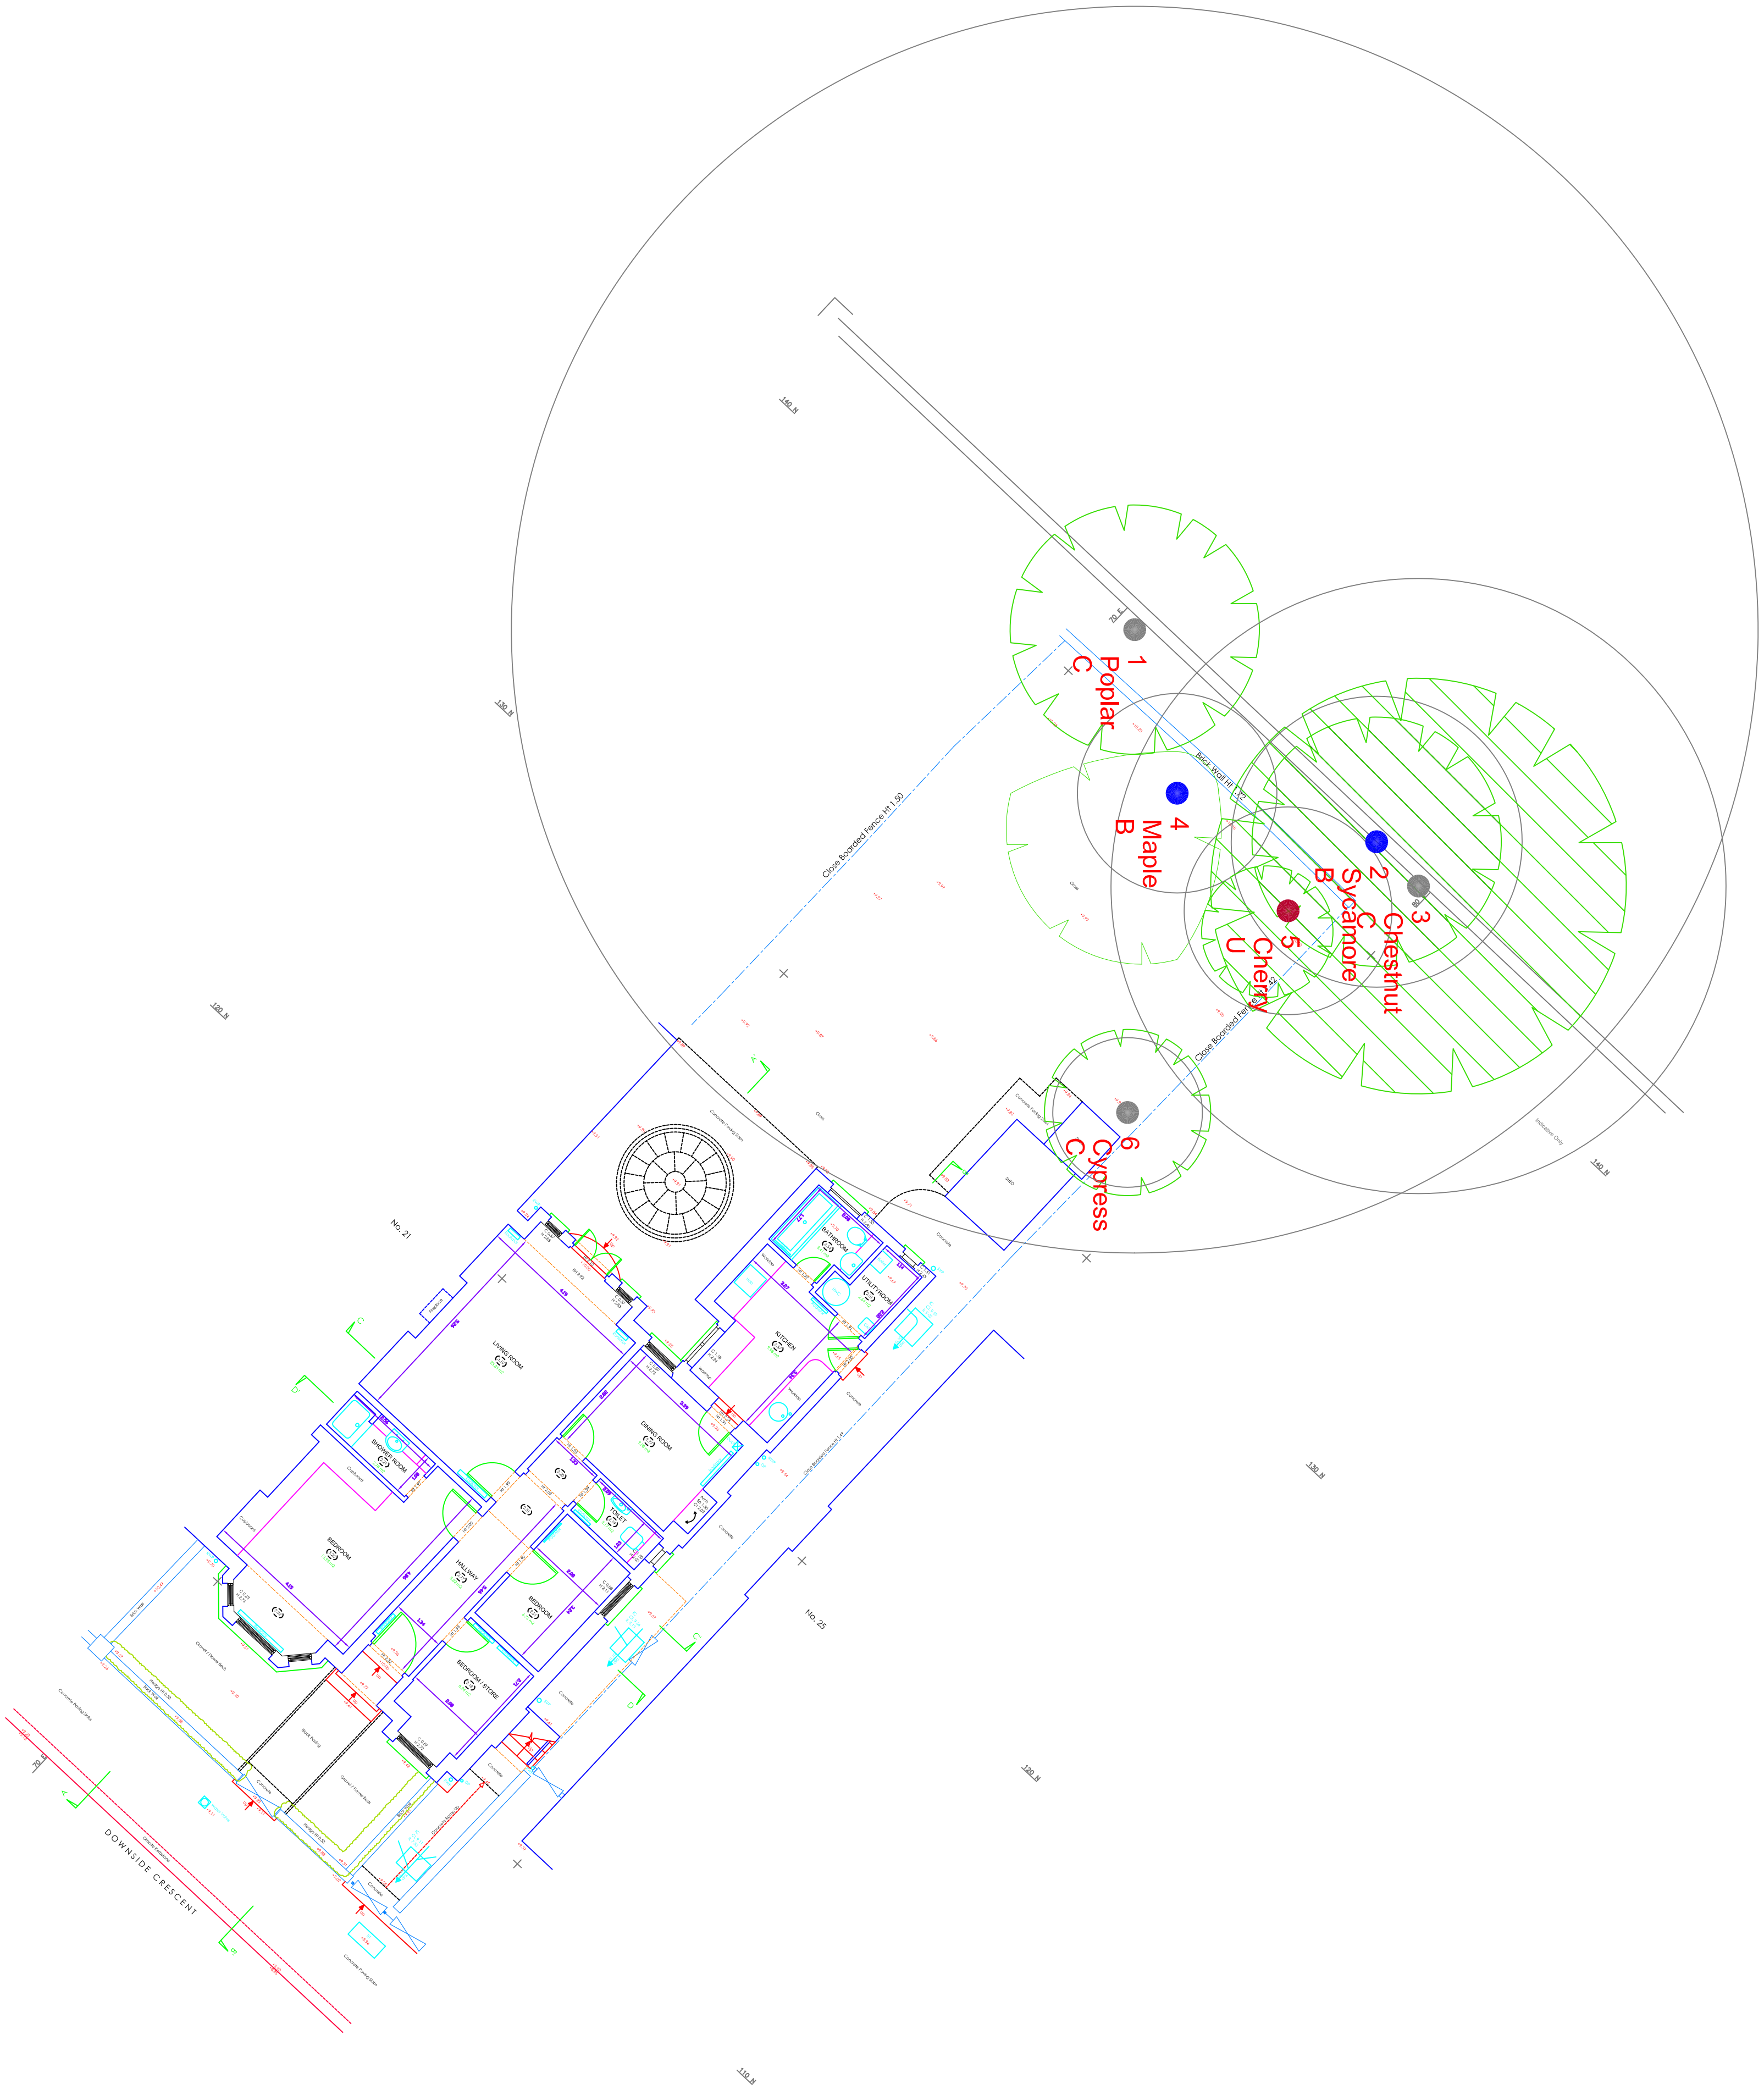
TREE CONSTRAINTS PLAN

- 1.3 The principal primary impacts in the current proposals are very low, comprising the minor encroachment to the theoretical RPA of the off-site poplar, T1, from the basement piling line; the boundary wall and existing hard standing may well have limited rooting within the small area of theoretical RPA affected by the proposed development. If not, poplar is a very robust species. Manual excavation of the piling line to 750mm depth within the RPA has been proposed as a precautionary measure only. If there is rooting within the site from T1, there will be some benefit to the RPA if the existing shed and associated hard standing removed with care by hand. Any further hard landscaping within the theoretical RPA of T1 should be constructed using no dig techniques with porous surfacing. It is also important to note that this tree has a broken canopy profile and is therefore vulnerable to wind snap; further investigation of current condition by the third-party owners has been recommended. There is little point specifying tree protection measures, if the tree has to be felled. Conversely, the engineer is advised to consider the very real possibility of this tree being felled and any heave potential arising in the surrounding soil.

| 2.4.3 | This plan also serves as the Tree Constraints Plan with the theoretical Recommended Protection Areas (RPA's), tree canopies and shade constraints, (from BS5837: 2012) overlain onto it. These constraints are then overlain in turn onto the client's proposals to create an Arboricultural Impact Assessment Plan in Appendix 4. General observations and discussion follow, below. |

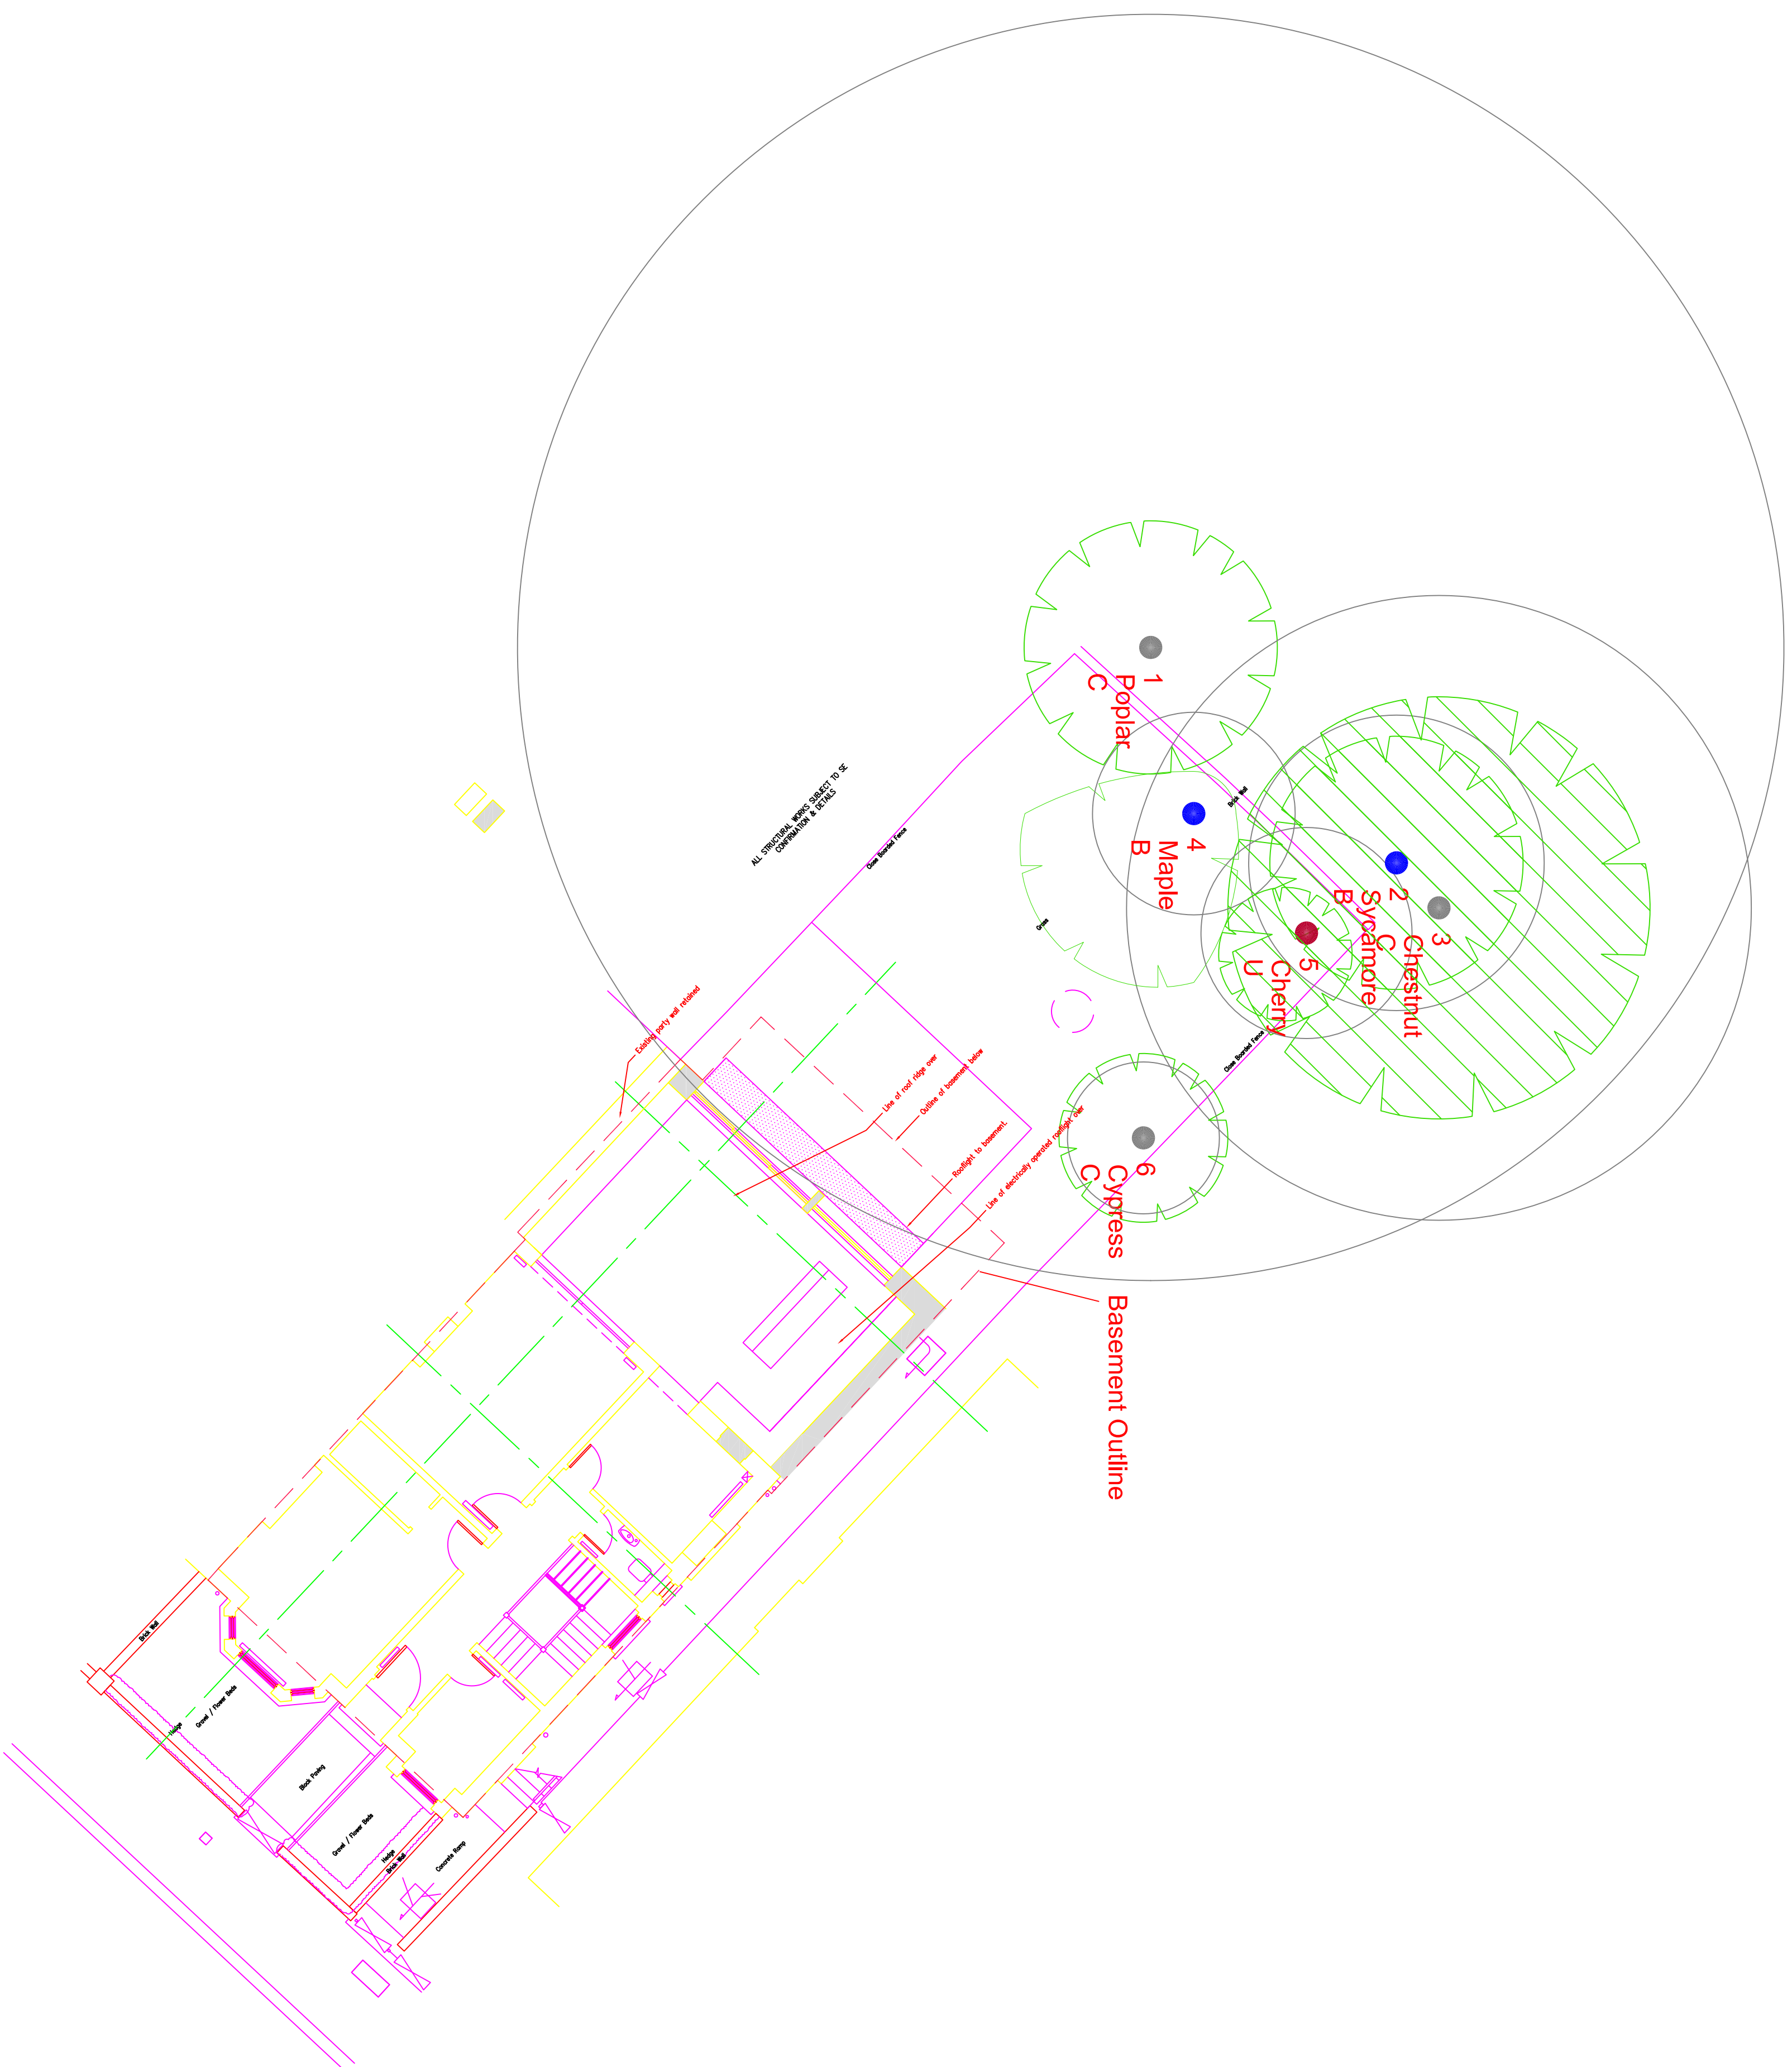
ARBORICULTURAL IMPACT ASSESSMENT PLAN

6.1.1 The principal primary impacts in the current proposals are very low, comprising the minor encroachment to the theoretical RPA of the off-site poplar, T1, from the basement piling line; the boundary wall and existing hard standing may well have limited rooting within the small area of theoretical RPA affected by the proposed development. If not, poplar is a very robust species. Manual excavation of the piling line to 750mm depth within the RPA has been proposed as a precautionary measure only. If there is rooting within the site from T1, there will be some benefit to the RPA if the existing shed and associated hard standing removed with care by hand. Any further hard landscaping within the theoretical RPA of T1 should be constructed using no dig techniques with porous surfacing. It is also important to note that this tree has a broken canopy profile and is therefore vulnerable to wind snap; further investigation of current condition by the third-party owners has been recommended. There is little point specifying tree protection measures, if the tree has to be felled. Conversely, the engineer is advised to consider the very real possibility of this tree being felled and any heave potential arising in the surrounding soil.

6.1.2 The careful removal of the shed/hard standing will also have a potentially positive impact for T6, providing the tree is protected and the soil beneath the structures left undisturbed.

6.3.1 All plant and vehicles engaged in demolition works should either operate outside the RPA, or should run on a temporary surface designed to protect the underlying soil structure. The demolition of the outbuilding building should proceed inwards in a “pull down” fashion. Hard surfacing can be lifted with caution by hand, ensuring that roots that may be just below the surface are not damaged.

6.3.2 The path of foundations through the theoretical RPA of T1 will be manually excavated to 750mm depth under arboricultural supervision; any roots encountered within the trenches / pits will be cleanly pruned back to an appropriate junction with a sharp pruning saw or secateurs back to a junction. Roots larger than 25mm diameter may only be cut in consultation with an arboriculturalist.

6.3.3 The replacement paving/hard landscaping will require a no-dig construction technique, either using a cellular confinement system with no fines aggregate for the sub-base or simply building upon the existing sub-base without disturbing the ground below. Choice of construction method will initially depend upon root penetration within the existing sub-grade. The key principle is not to excavate in the presence of roots and to provide a porous surface to promote healthy soil water relations for future root growth.
