# Arboricultural Impact Assessment

Parliament Hill School, Highgate Road, London,  
NW5 1RL

Gardiner & Theobald LLP

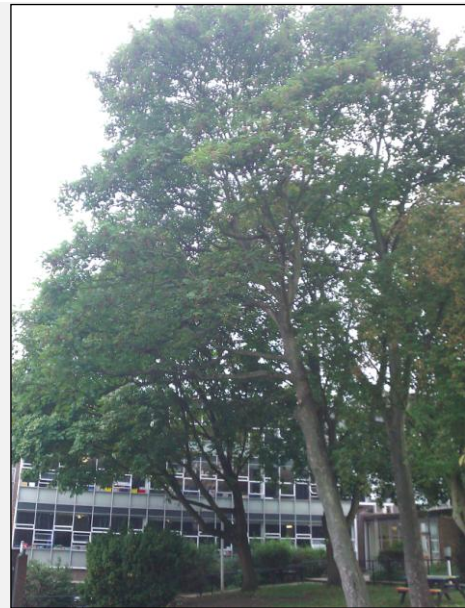
Sycamore and Norway Maple, T37-T38 and T40-T41

T38	Sycamore	0.547	1	20	5.5	7	6	6.5	B2	Mature	20_39	6	Average form, shape and condition. Asymmetric canopy. Subject to past management - Lifted & Thinned. Dense upper crown, low crown deadwood. Soil heavily compacted within rooting zone.	No Works	135
T39	Holm Oak	0.19	1	8	4.5	4	3	3.5	U	Semi-Mature	<10	2	Poor form, shape and condition. Dense asymmetric crown, low crown deadwood. Suppressed specimen. Co-dominant tree with included unions.	Remove & Replace with suitable species of tree within final landscape scheme	16
T40	Norway Maple	0.611	1	20	9	5	4	8	B2	Mature	20_39	3.5	Average form, shape and condition. Dense upper crown, low crown deadwood. Subject to recent crown management - Lifted /Thinned and reduced. Soil heavily compacted within rooting zone.	De-compact rootzone	169
T41	Norway Maple	0.516	1	16	7	9	10	5	B2	Mature	20_39	5	Average form, shape and condition. Dense crown, low crown deadwood. Asymmetric canopy. Soil heavily compacted within rooting zone.	Crown reduce and reshape asymmetric crown by 20-30% to suitable side growth points retaining a flowing canopy shape.	120

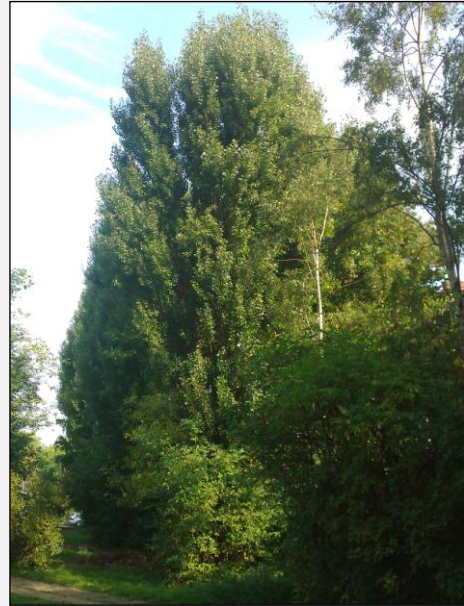
**T56-T61, Lombardy Poplar**

7.3.5 The Lombardy Poplars, T56-T63 along the southern site boundary are within the current influencing distance of the Heath building and potentially of the building to replace it. Given that in 90 of recorded cases Poplar trees, that caused tree related subsidence to buildings, were closer than 20m, it is advised that this distance should be maintained and / or detailed foundation design by a structural engineer given the potential for shrinkable London clay on the site. Also given the height of these trees, also around 20m, and that they tend to shed major leading stems as they senesce, a 20m separation distance from a health and safety point of view is also advisable.

7.7.1 Where retained trees are located south of new buildings the shade they cast have the potential to constrain them and cause a 'pressure to prune' such trees. This undesirable consequence applies particularly to the linear group of Lombardy Poplar along the southern site boundary, T56-T63, as their shading arcs could extend up to 30m into the development area.

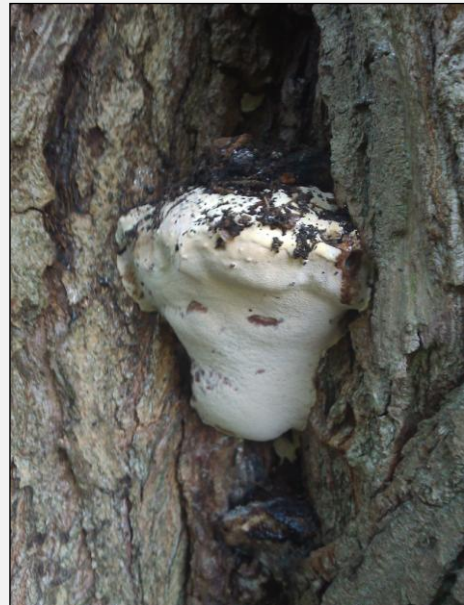
**Rigidiporus on L.Poplar**
