# Arboricultural Impact Assessment

William Ellis School, Highgate Road, London, NW5  
1RN

Gardiner & Theobald LLP

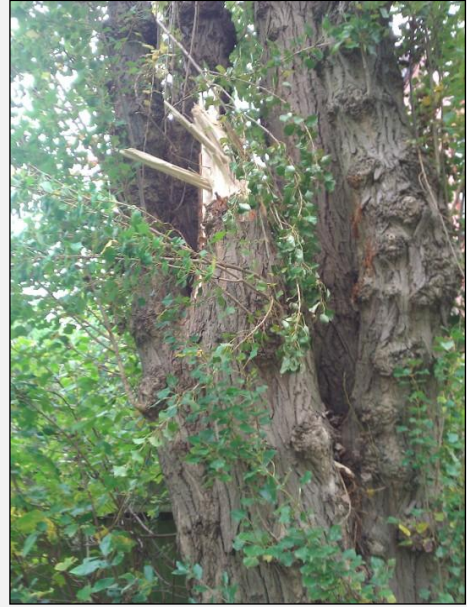
Failed leading stem on T62, L.Poplar

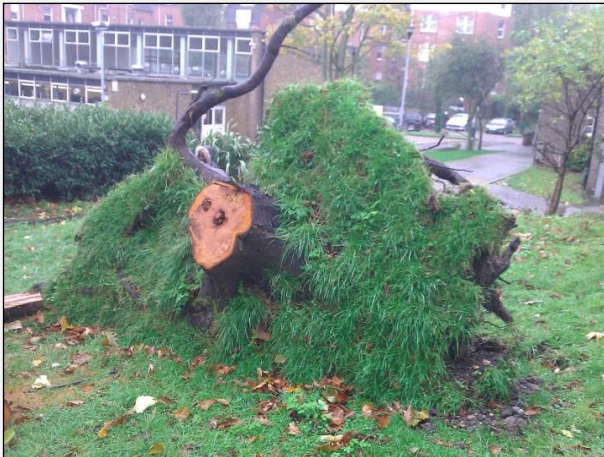
T116, Windblown Cherry

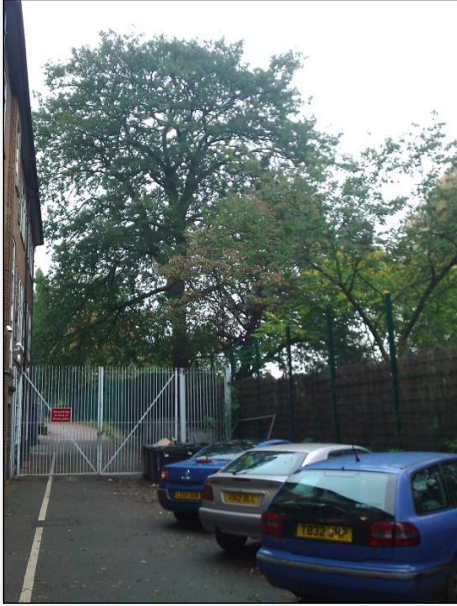
**T126, Turkey Oak**

7.3.1 The Large offsite Turkey Oaks, T126 & T128 as well as the Lombardy Poplars within TG8, the pollarded Willow T129, the Holm Oak, T130 and Sycamore T73, are all within the current influencing distance of the existing buildings and / or likely development area. These trees have the potential to cause tree related subsidence, if they are not already, given their proximity to existing buildings and their location upon a shrinkable clay soil. Detailed geotechnical investigations and advice from the project structural engineer has been obtained to advise upon foundation design by a structural engineer

- 7.7.1 Where retained trees are located south of new buildings the shade they cast have the potential to constrain them and cause a 'pressure to prune' such trees. This may apply to the largest trees adjacent to / south of the development area and could likely be the large Turkey Oaks T126 & T128.

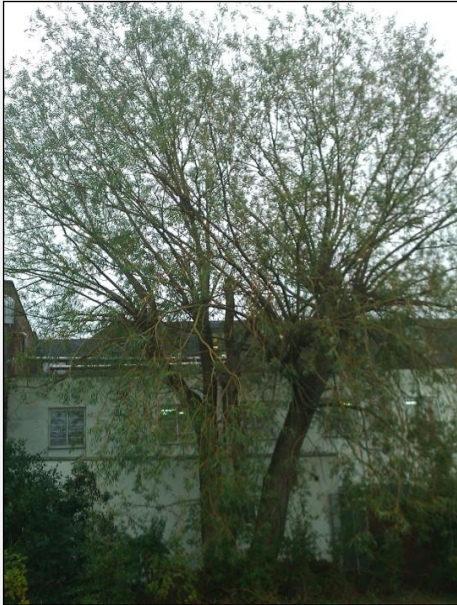
**T129, Pollarded Willow**

Tree No.	Species	DBH	No of Stems	Ht (m)	N	E	S	W	BS Cat	Age Class	Life Expect	Cr Ht (m)	Observation	Recommendations	RPA (m2)
T129	Crack Willow	1.527	M/s	14	10	12	8	9	C2	Mature	10_19	1	Poor form, shape and condition. Multiple stemmed tree - with basal included unions. Subject to past management - Pollarded at 8m. Asymmetric canopy. 3rd party offsite boundary tree with overhanging branches. Dense crown, moderate crown deadwood. Large basal cavity with aparent 'mammal' use.	Re-pollard to previous pollard points	707
T130	Holm Oak	0.732	1	14	3.5	6	7.5	6.5	B2	Mature	20_39	3	Average form, shape and condition. Asymmetric canopy. Subject to past management - Reduced/Cut back from adjacent building. Dense crown, moderate crown deadwood. Ivy clad crown and stem.	Crown reduce and reshape by 20-30% to suitable side growth points retaining a flowing canopy shape to re-balance asymmetric crown.	242
