ARBORICULTURAL REPORT

33c Mill Lane NW6 1NZ (Formerly land at rear of 34 Hillfield Road NW6 1PZ)

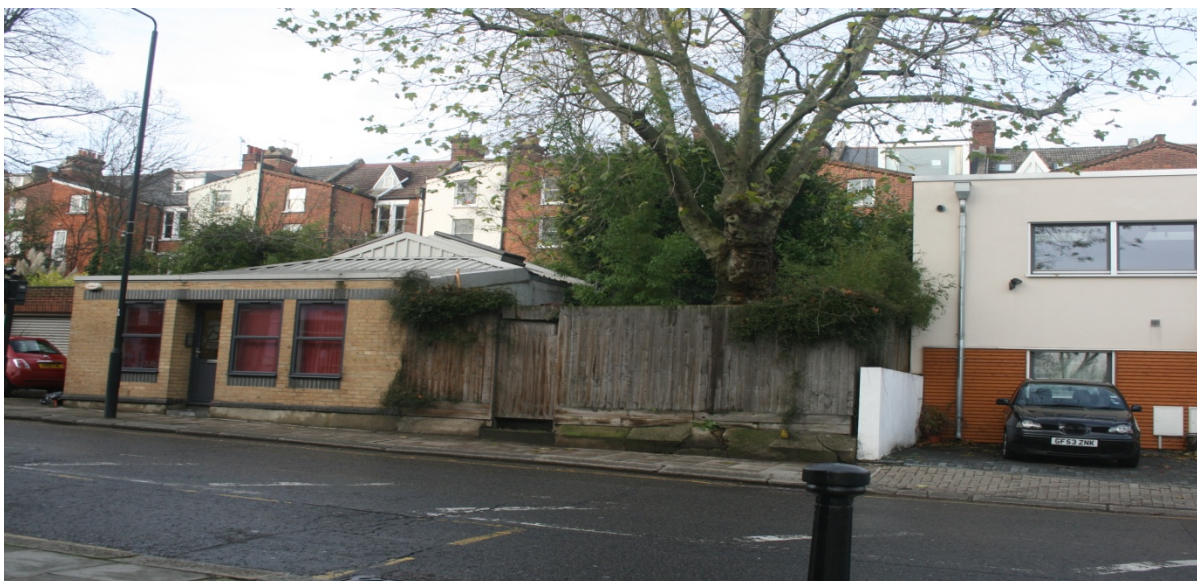
It is also not clear whether the recommendations of John Harraway DipArb (RFS), FArborA were ever carried out but a visual inspection of the tree as it stands today would appear to indicate that it remains in a similar condition as indicated in the photograph below and no further action is considered necessary at this time or to enable the proposed works to be carried out
