Site: 79 Fitzjohns Avenue, Hampstead, London, NW3

TM/NO/11099/45943

# APPENDIX 1. TREE SURVEY SCHEDULES

# APPENDIX 2. TREE SURVEY AND CONSTRAINTS PLAN 11099/45943

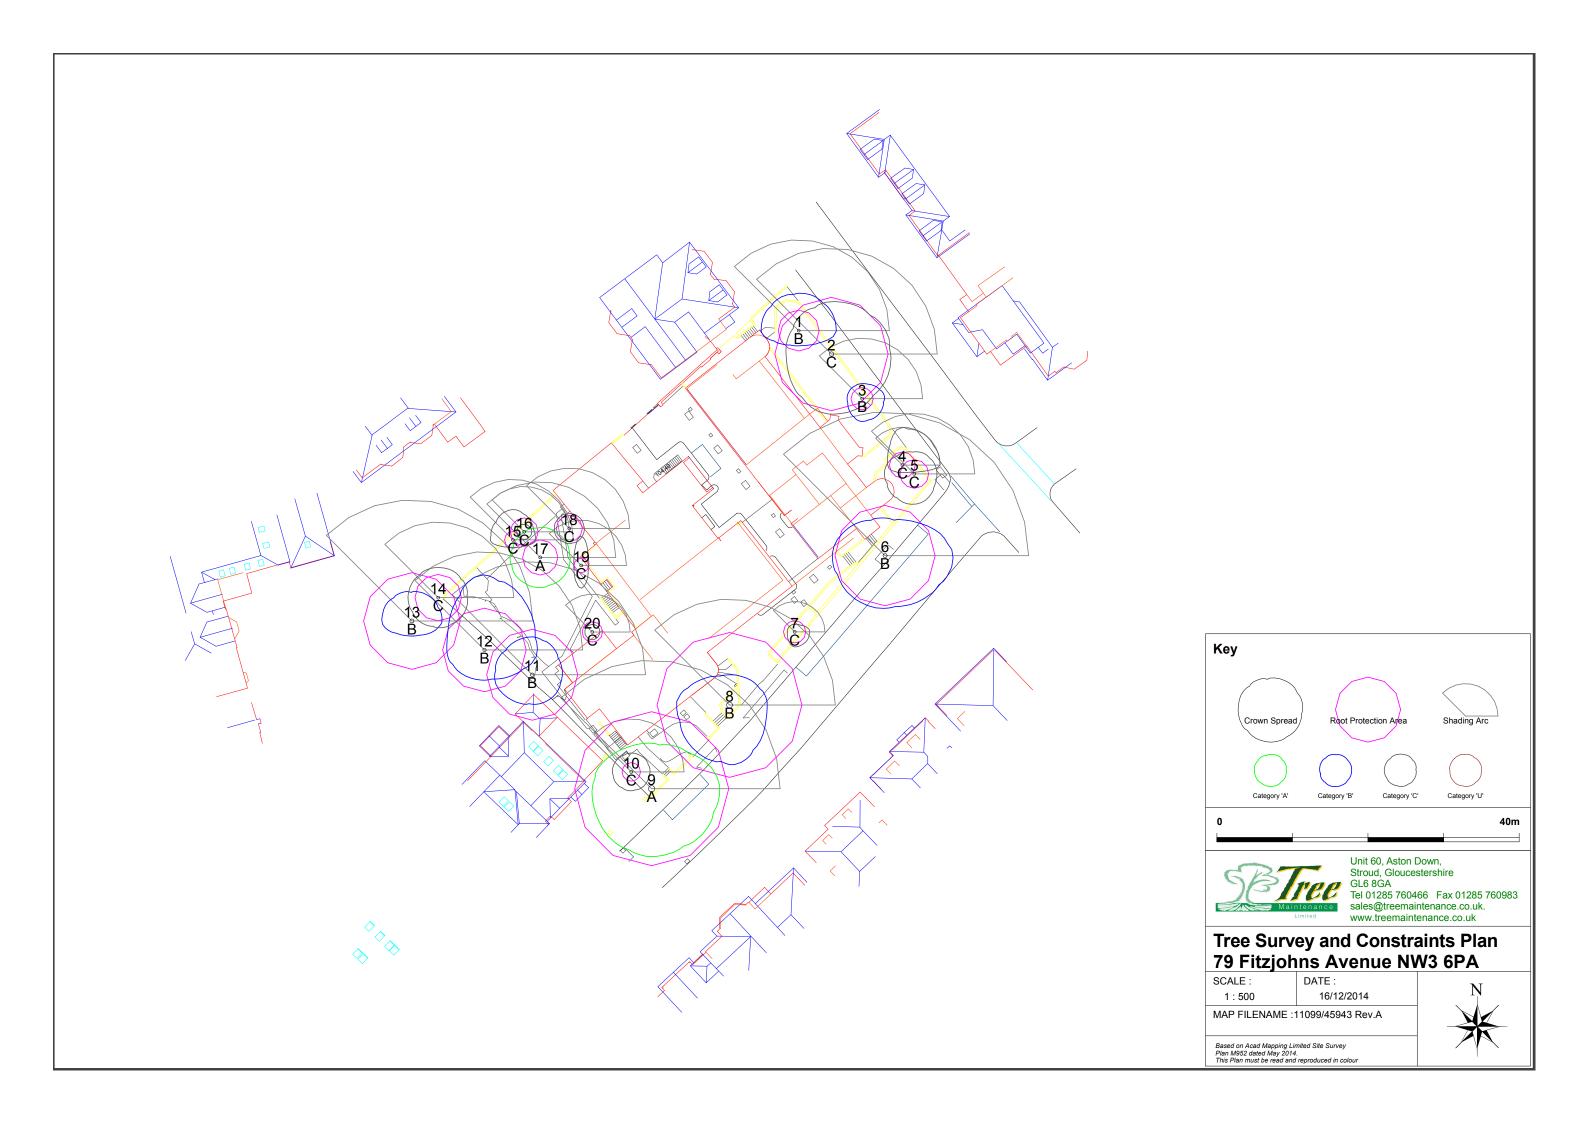
- 5.1.1 Below ground constraints (Root Protection Areas (RPAs)) are shown on the tree Survey and Constraints Plan 11099/45943 (appendix 2). This is the minimum area which should remain undisturbed and protected from construction activity. At this stage it is represented as a circle centred on the trunk of each tree. Groups of small trees are shown with root protection areas 1 metre outside the plotted canopy, groups of large trees are based on the largest stem diameter within the group to ensure sufficient space has been provide. As a default position, construction, services and working space should not be required within the RPAs of retained trees.

- 5.1.5 Where trees are to be retained, as part of the new layout, all efforts should be made retain existing levels and avoid the installation of services within their RPAs. This would remove the added cost of specialist installation methods and supervision during installation. Favoured locations for service entry onto site are shown on the Tree Survey and Constraints Plan.

- 5.2.3 Obstruction of sun and daylight. Sunlight obstruction has been crudely estimated on the tree constraints plan. It is represented by a grey segment the height of the tree from east through north to south west, centred on the trunk of the tree. This depicts the approximate area of shade from May to September between 10.00am to 6.00pm daily. Detailed sunlight and daylight obstructions were not requested at the time of the instruction but can be provided subject to agreement of costs. Shading from trees 6 20 will need to be carefully considered as part of the initial layout. However this constraint is relatively minor, moderate, significant given the overall developable area.
