Landmark Trees

**ARBORICULTURAL IMPACT ASSESSMENT REPORT:**

53 Fitzroy Park  
London  
N6 6JA

**Ref:** WFA/53FZP/AIA/01D

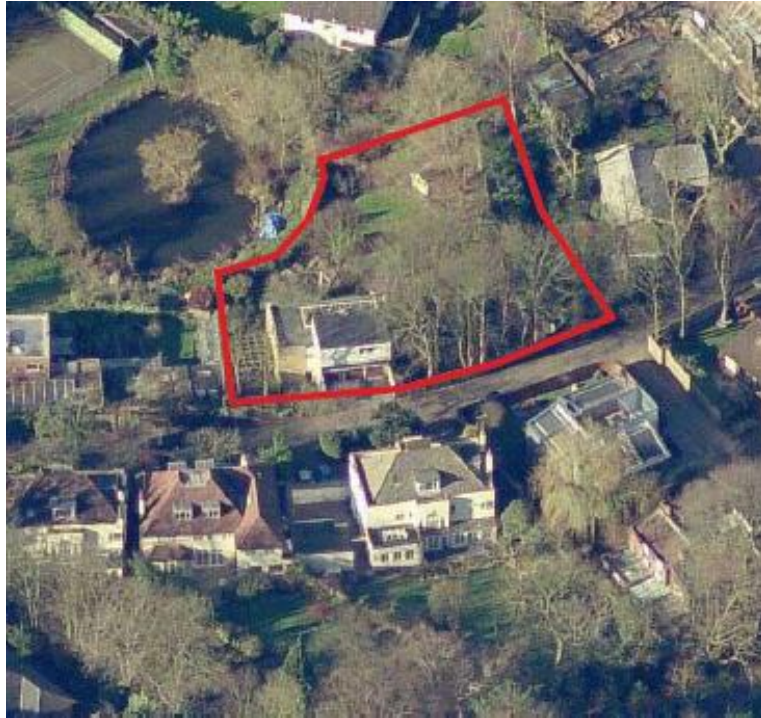
Photograph 1: Aerial view from the east of 53 Fitzroy Park, London N6 6JA

- 3.1.1 The existing property is situated off Fitzroy Park, which is a private road located in the north-eastern boundary of Hampstead Heath. The current residential dwelling is developed over 3 storeys, two of these above street level and a lower ground floor at the back garden level. The current dwelling is dilapidated.

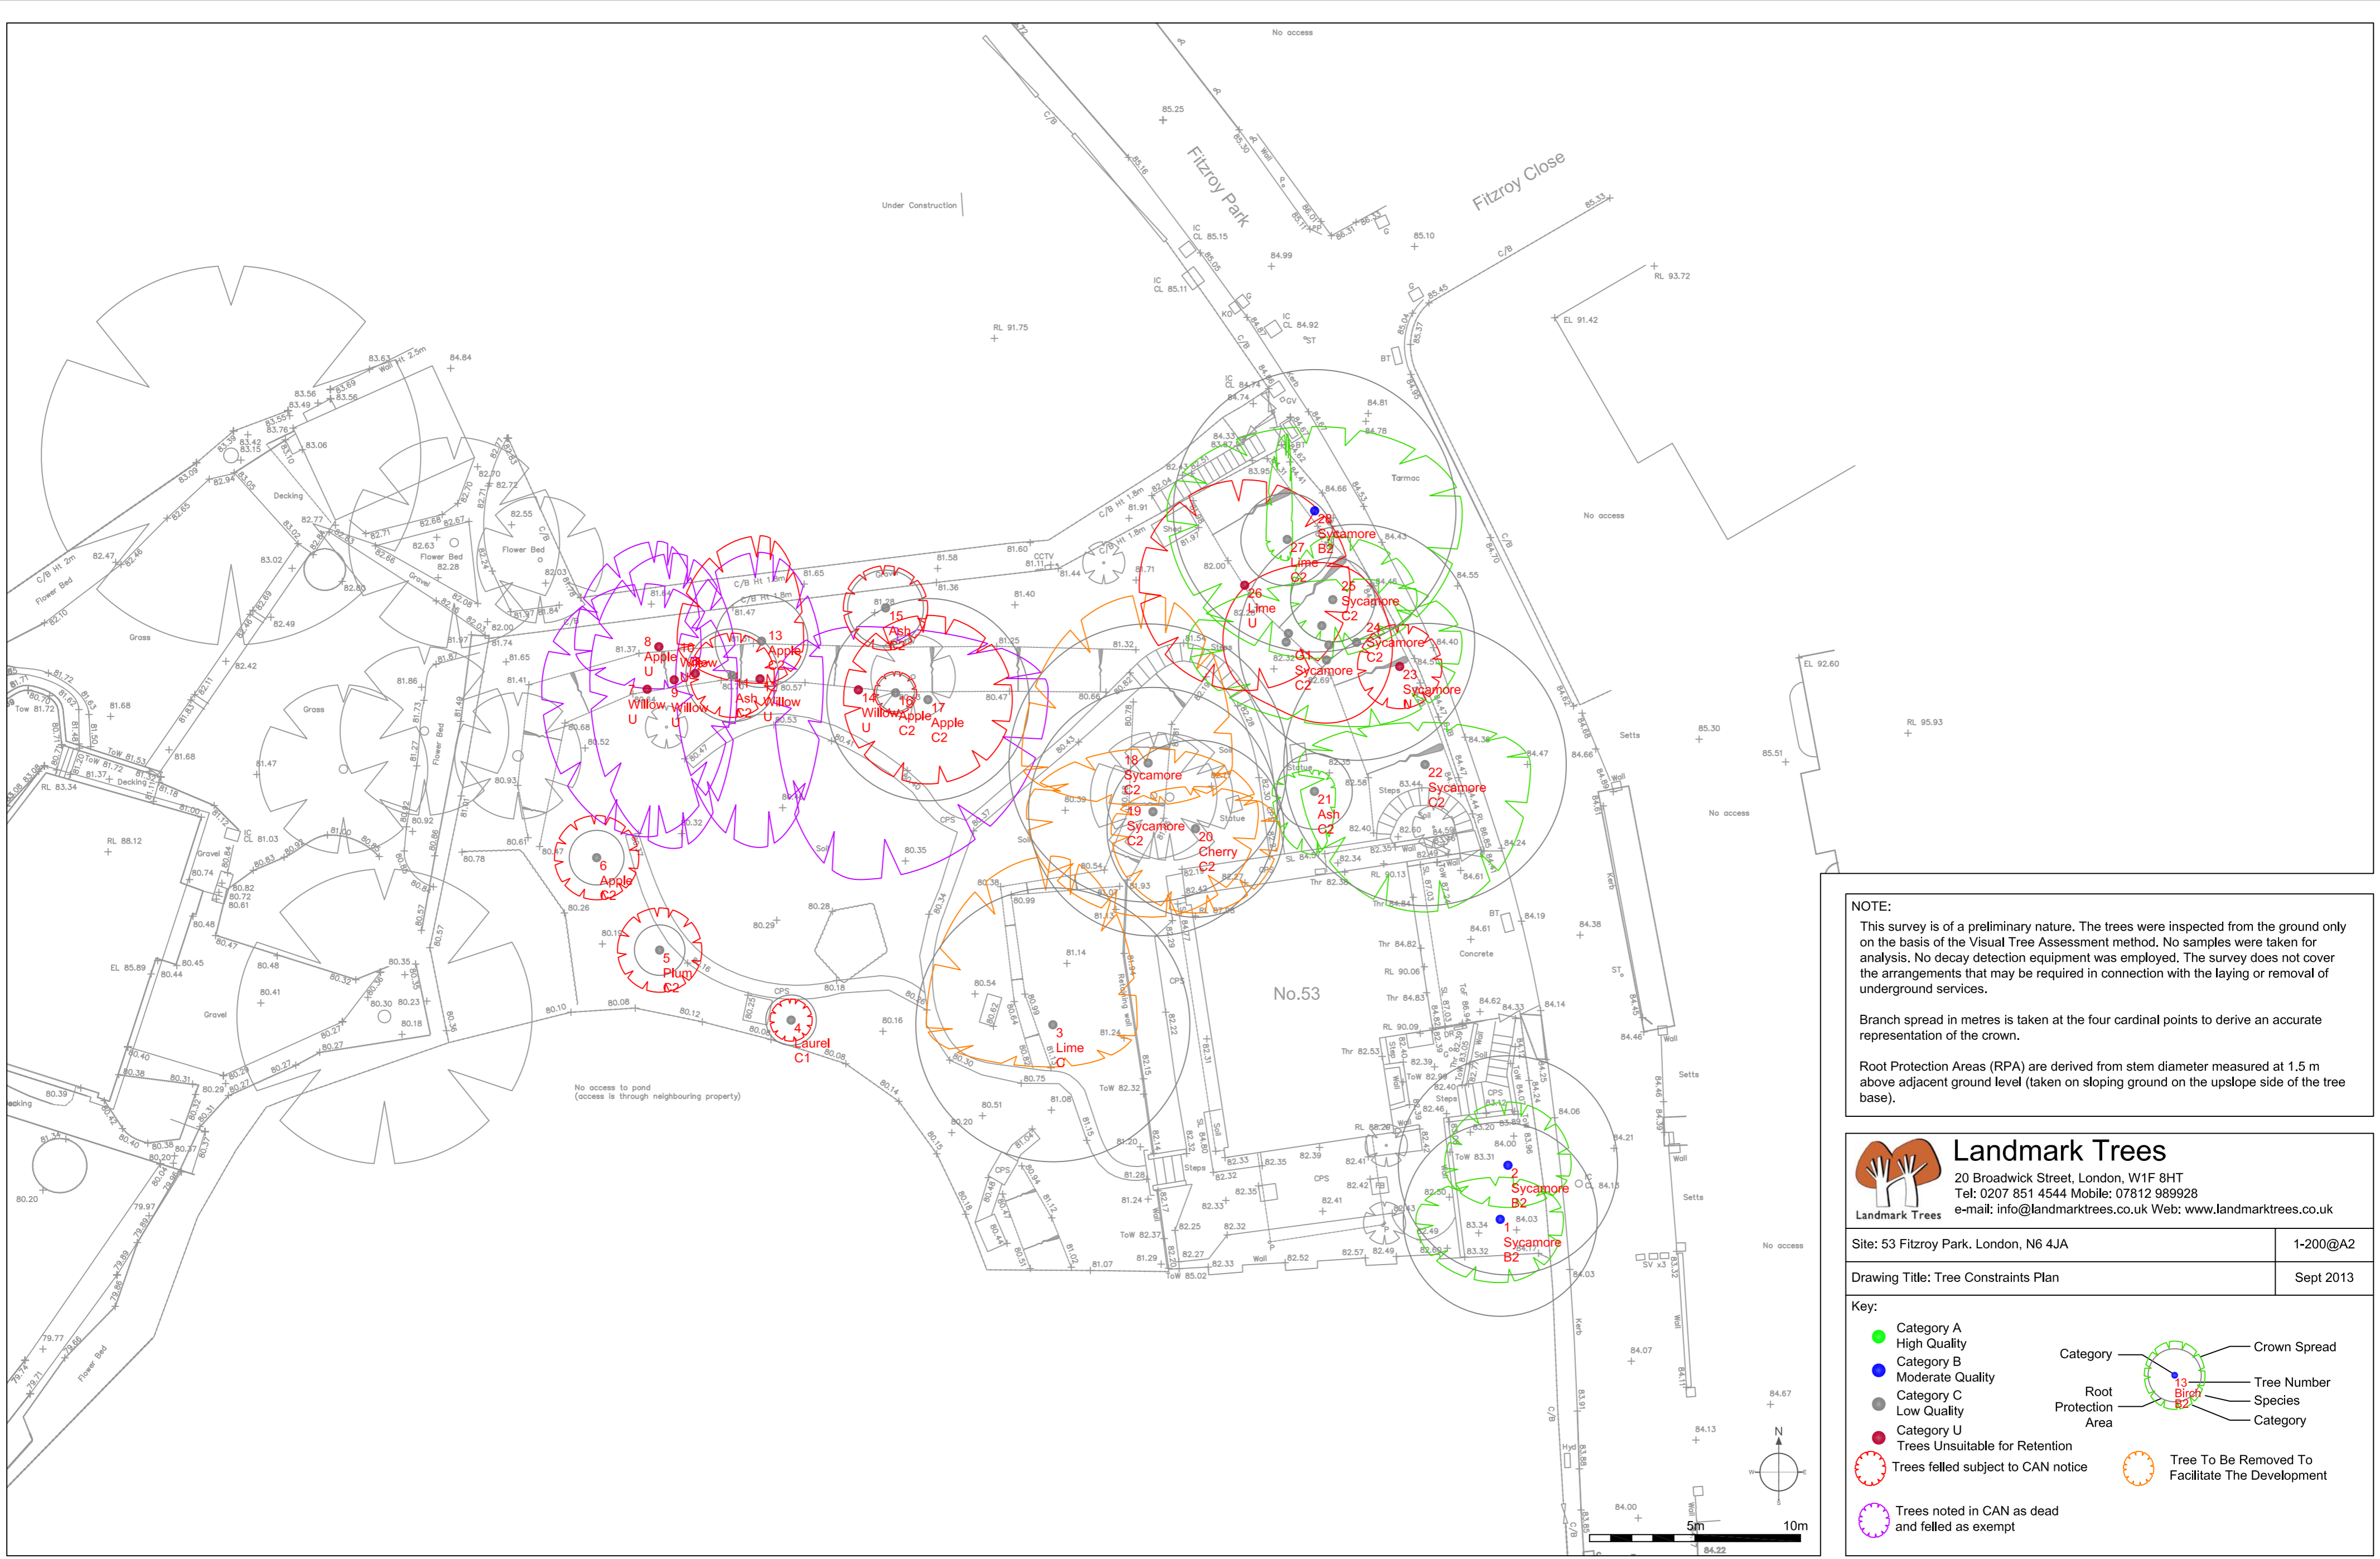
**TREE CONSTRAINTS PLAN**

3.2.1 Of the 12 retained trees 3 are 'B' category (Moderate Quality) and 9 are 'C' category (Low Quality) trees. The tree numbering remains the same from the original survey (see Tree Constraints Plan in Appendix 1).

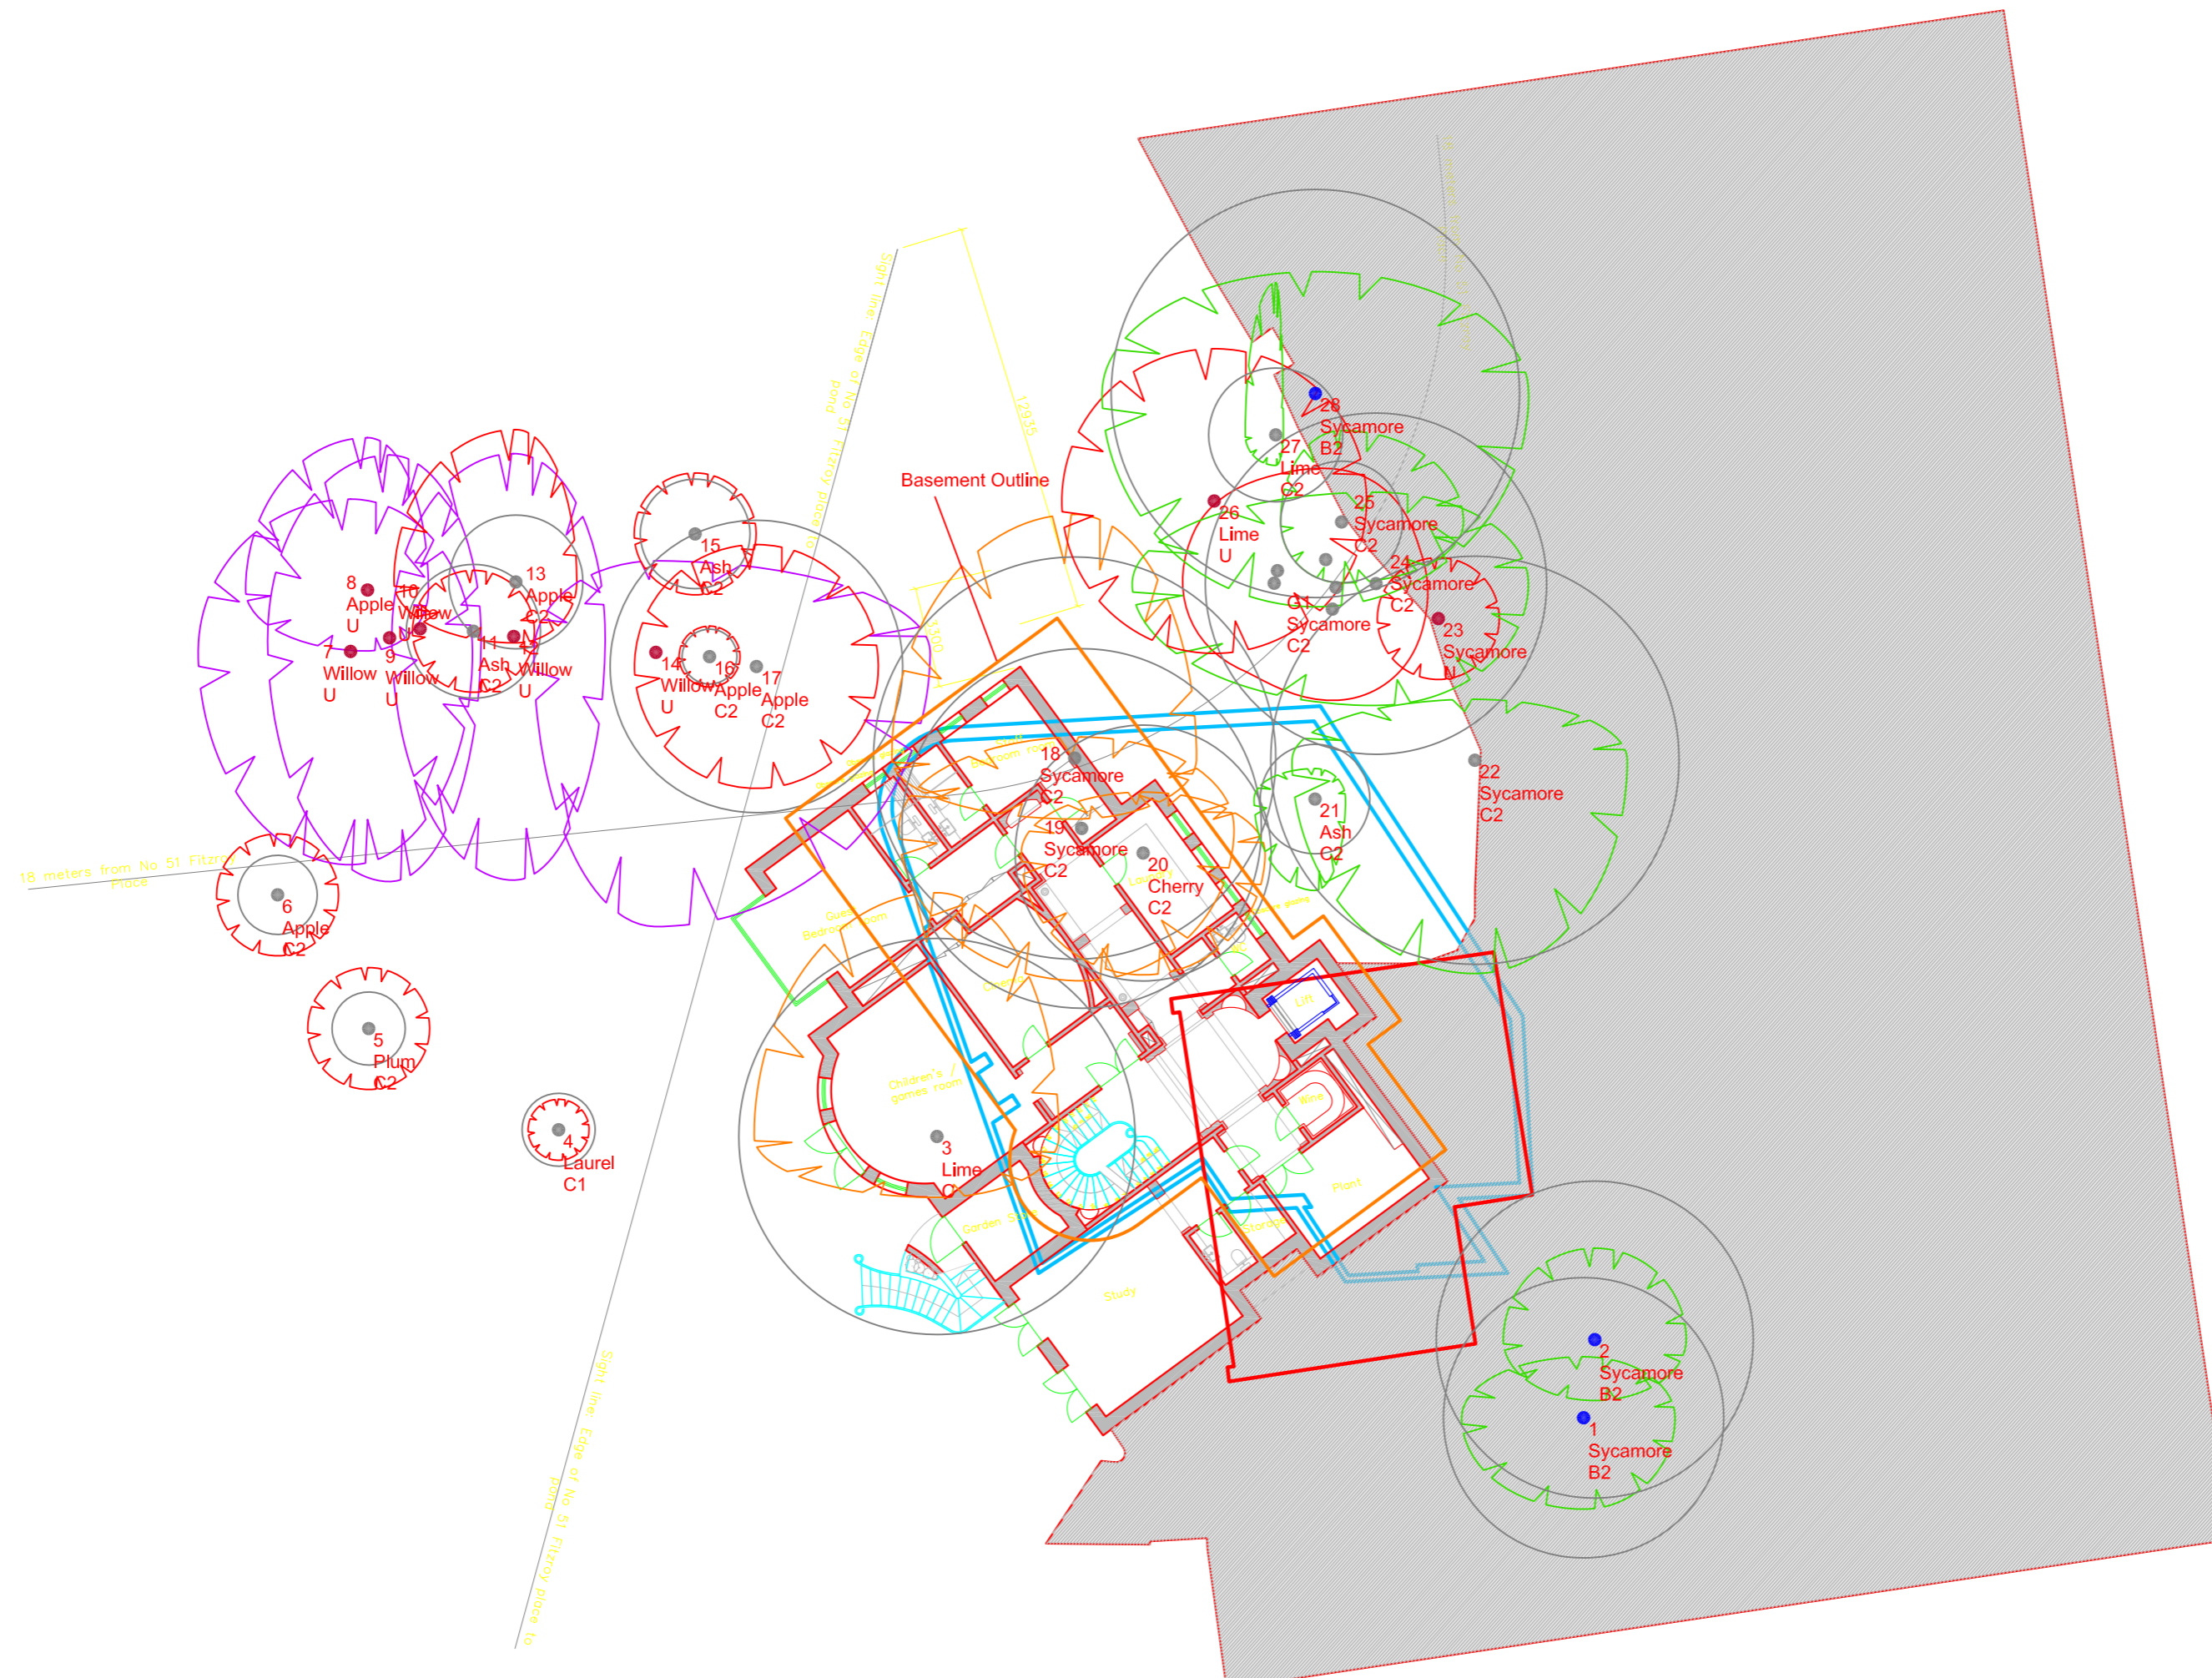
**ARBORICULTURAL IMPACT ASSESSMENT PLAN**

- 1.3 The principal primary impacts in the current proposals are the felling of T3, T18, T19 and T20. The overall loss of these 4 trees is rated as a low impact, with no significant effect on the visual character of the local conservation area. The removal of these trees was consented under a previous scheme (2011/1682/P). The proposed replanting scheme is shown in Appendix 4 of this report, which will include 22 new trees. This replanting will also include the two small leaved limes (*Tilia Cordata*) specified in condition 3 of 2013/6828/T.

- 1.4 Other primary impacts comprise the demolition of the existing building within a small area of T22's theoretical RPA, therefore mitigation has been proposed to reduce the potentially low impacts. Further low impacts include alterations to the existing hard landscaping and the replacement path/pedestrian access. The revisions have ensured that there are no RPA encroachments from the new dwelling. Low impacts are theoretically possible from the removal and replacement of existing hard standing for driveway access within the RPA's of T1 & T2; however, the rooting area of these trees will have been restricted by the retaining walls and will likely be confined to the raised area. The likely impacts are therefore very low/negligible and will be mitigated in accordance with the Method Statement.

- 8.1.2 Excavation and construction impacts within the RPA's of trees identified in Table 1 above, will be controlled by the method statement WFA/53FZP/AMS/01B, which specifies mitigation methods suggested in para 6.3 above and by consultant supervision as necessary. This method statement can be used for the discharge of arboricultural conditions.
