41-42 CHESTER TERRACE
LONDON, NW1 4ND

PROPOSED ALTERATIONS TO EXISTING WINDOWS DESIGN & ACCESS STATEMENT and HERITAGE STATEMENT

PREPARED FOR
SHALIMAR INVESTORS LTD
February 2015

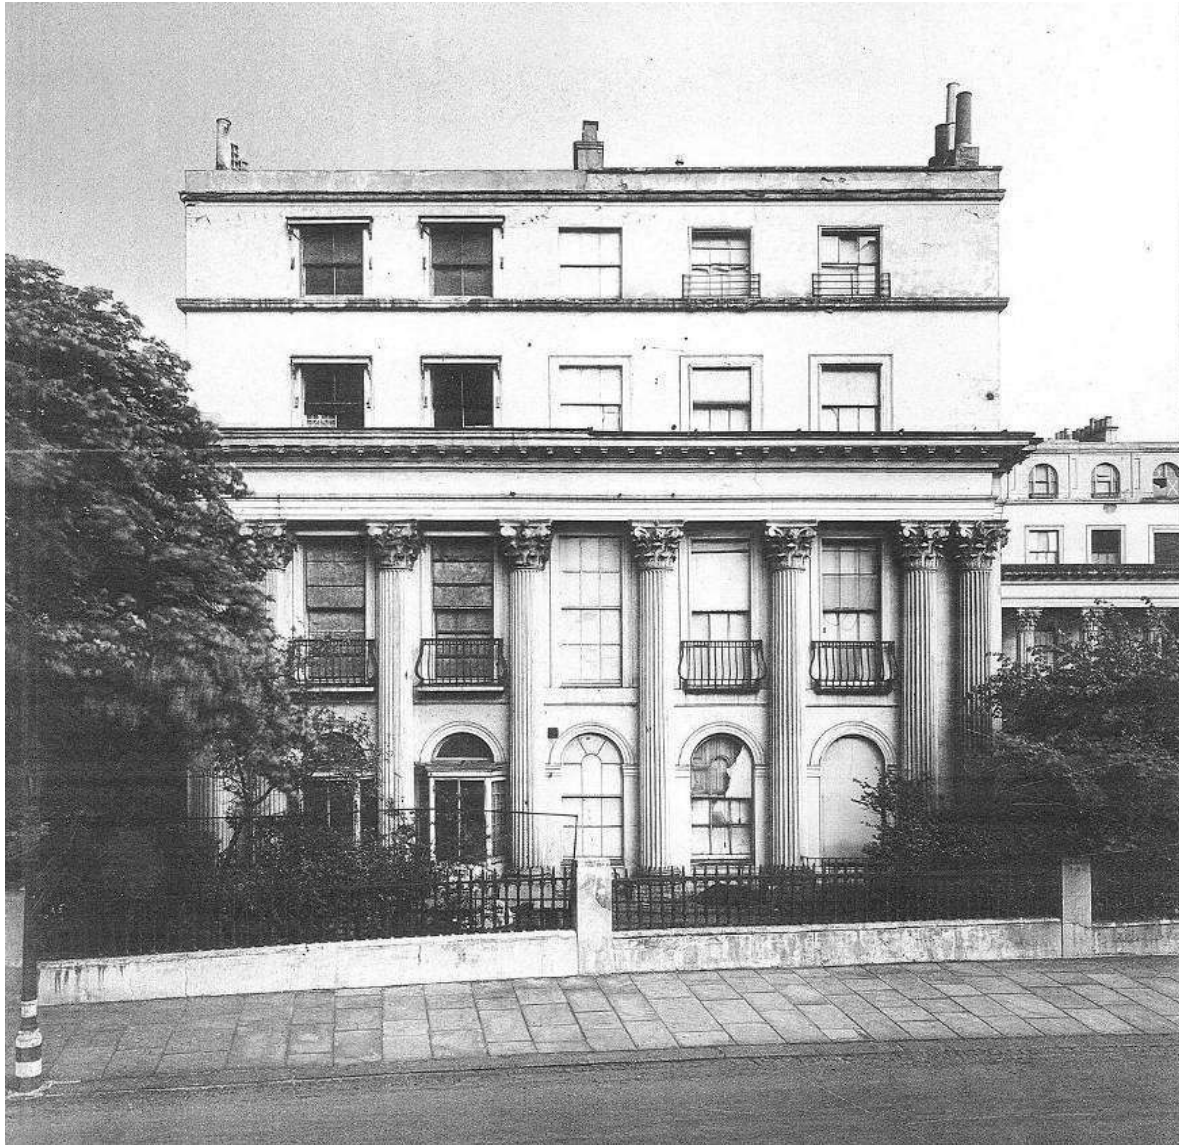
Records show (see Appendix 5 for details) that No. 41 suffered from bomb damage to the roof, windows, ceilings and stair landings. It was declared uninhabitable and was later requisitioned by the War Office for use as the offices, similar to the rest of the terrace.

Figure 13: Photograph taken in 1943, shows 41 and 42, Regents Park elevation damage to the windows
