BS5837 Arboricultural Impact Assessment

7 Boscastle Road, London, NW5 1EE

Job Reference: 02260R

February 2015

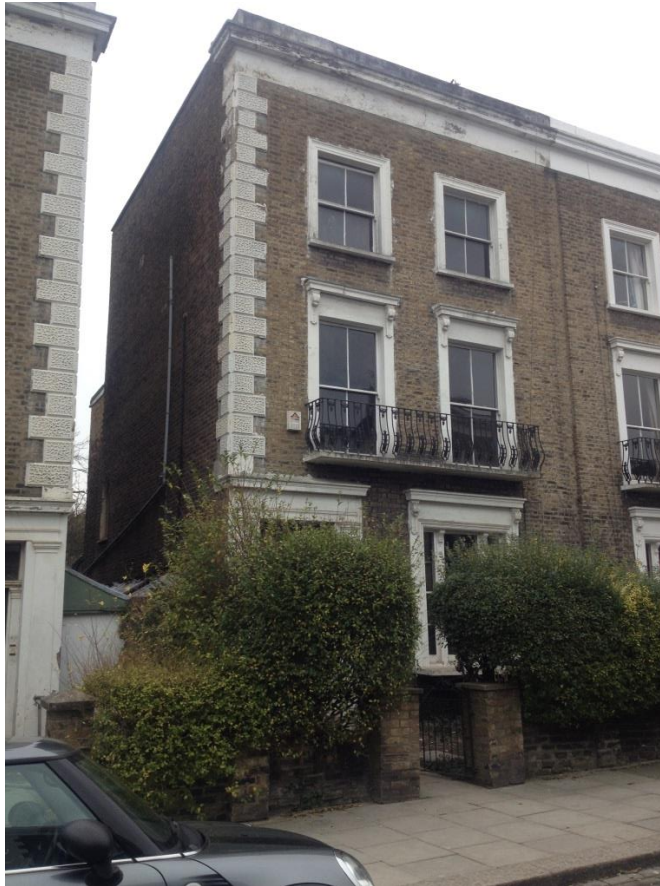
Image 1 – H1 and property front

5.5.2 A temporary material storage area to the front of the property is advised (see Appendix 5) to limit any inadvertent impact on H1. This will included temporary ground protection and ply sheet hoarding to physically protect the hedge.

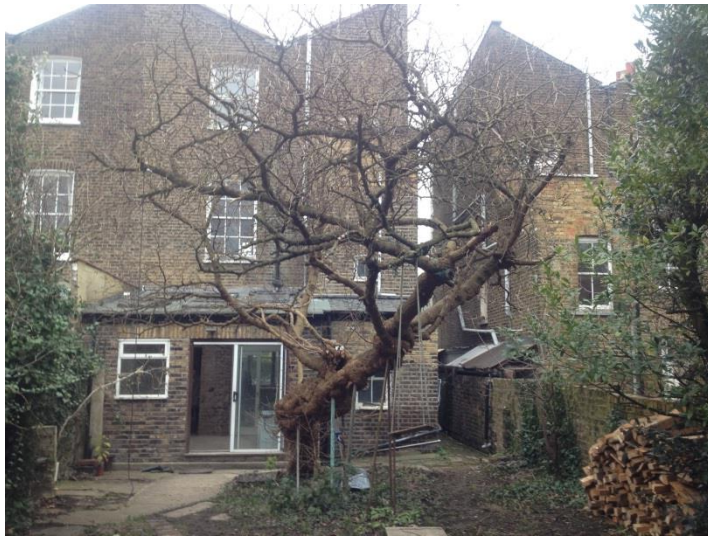
- 5.3.2 T1 is visually insignificant to the wider amenity as it is a low level tree in terms of overall size and is located within the rear garden. As often occurs with this species there has been partial root plate failure and the tree is now heavily propped for support.

Image 2 – T1 (Mulberry)

- 5.3.1 The proposal seeks to remove T1 (Mulberry). It is this tree which led to the council requesting a report in relation to the existing planning application.

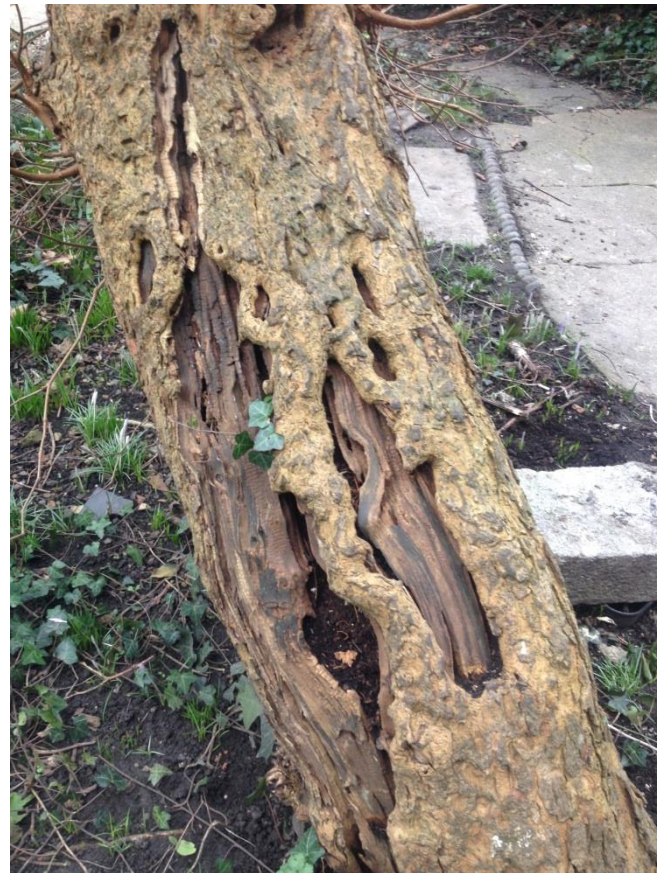
- 5.3.3 In addition the tree has multiple areas of well-established stem decay (see photos). The history of root plate failure combined with the extensive stem decay have led us to consider the tree has a safe useful life expectancy of <10 years. As a result it has been classified as a U Cat tree in accordance with BS5837.

Image 3 – T1 (Mulberry) showing stem decay

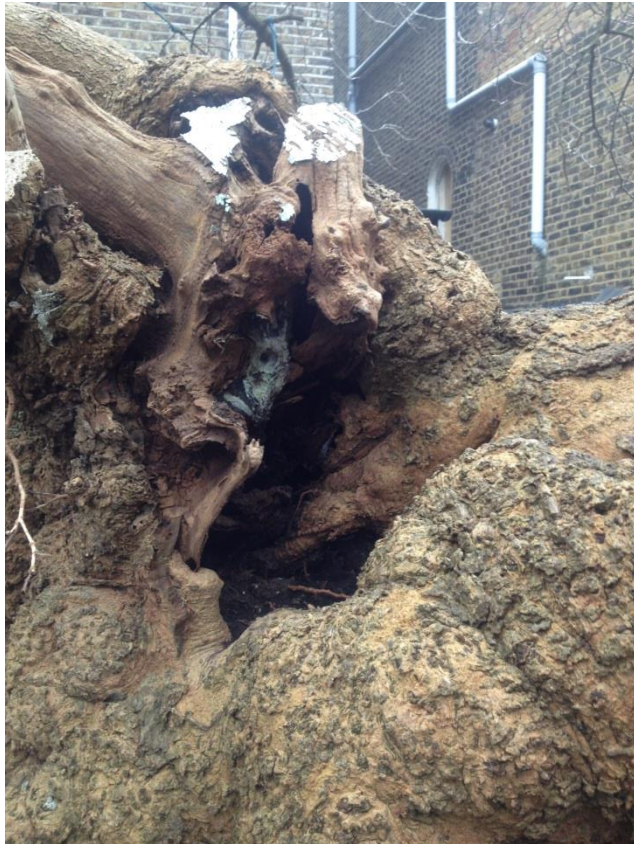
Image 4 – T1 (Mulberry) further stem decay

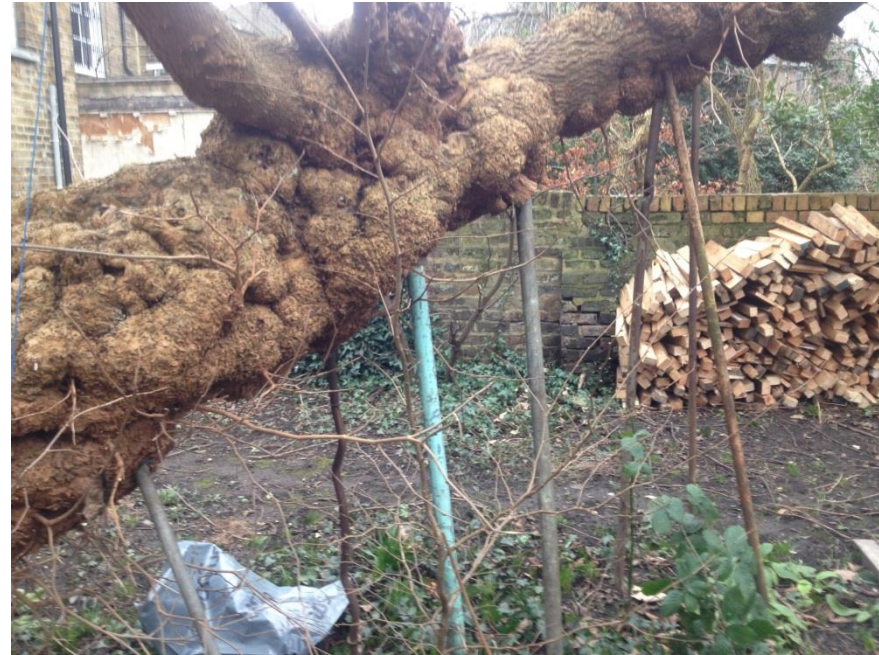
Image 5 – T1 (Mulberry) showing propping

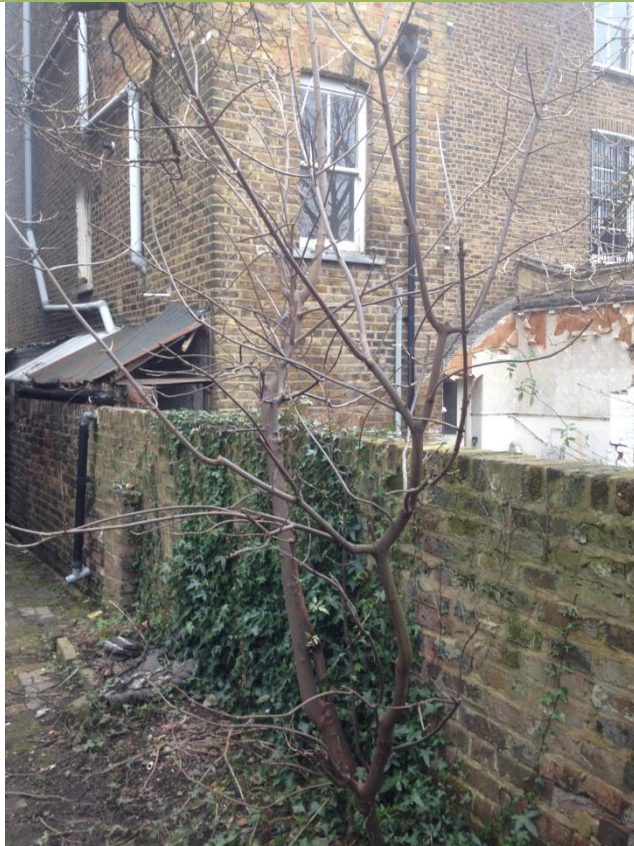
- 5.3.5 T3 (Sycamore) is also identified for removal. This is a small low quality self-set Sycamore tree and its stem diameter is such that it is below the official BS size threshold but has been included for completeness.

Image 6 – T3 (Sycamore)

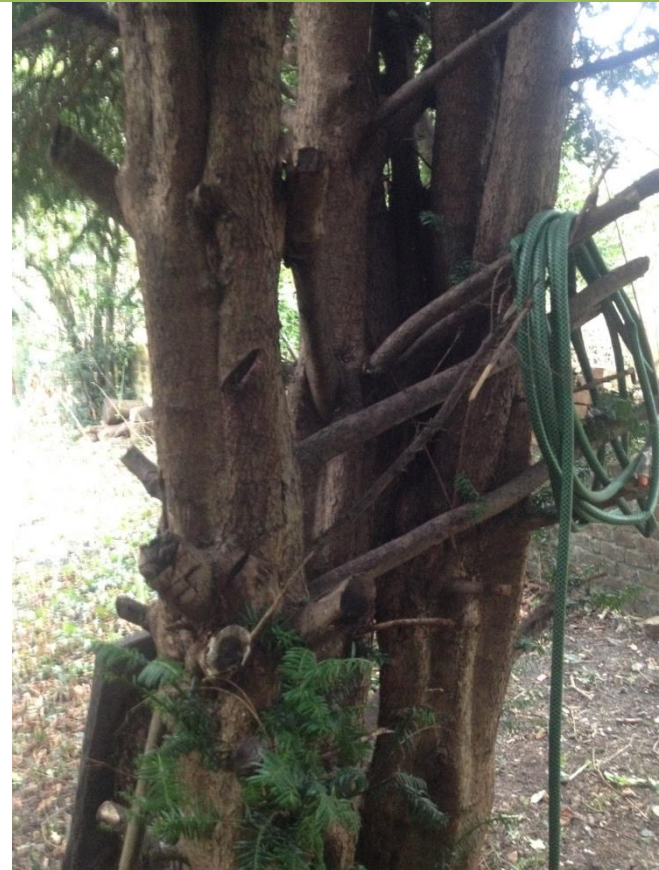
Image 7– T6 (Yew) showing dead wood stubs

Tree No.	Species	Proposed Tree Works	BS Cat
T5	Hazel	Re-coppice (discretionary)	C1
T6	Yew	Remove deadwood stubs on low stem	B1
H1	Privet	Prune to shape	B2

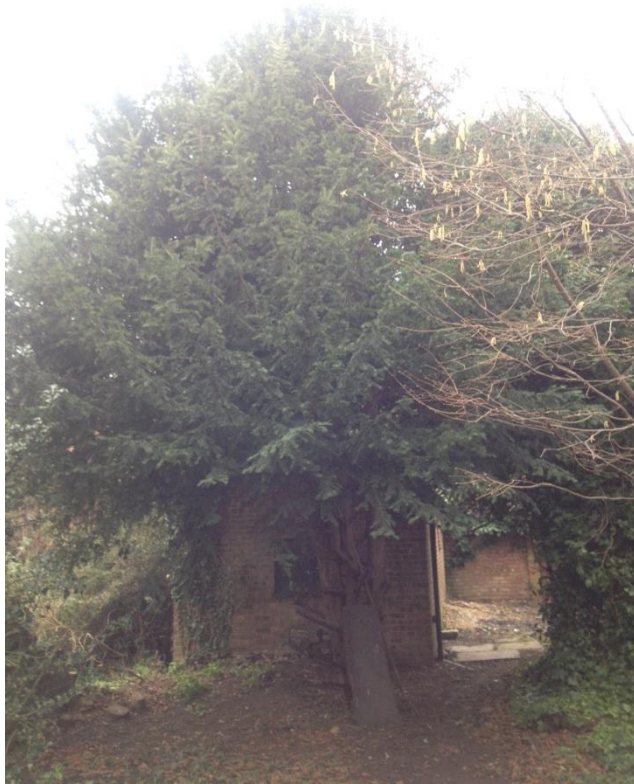
Image 8 – T6 (Yew)

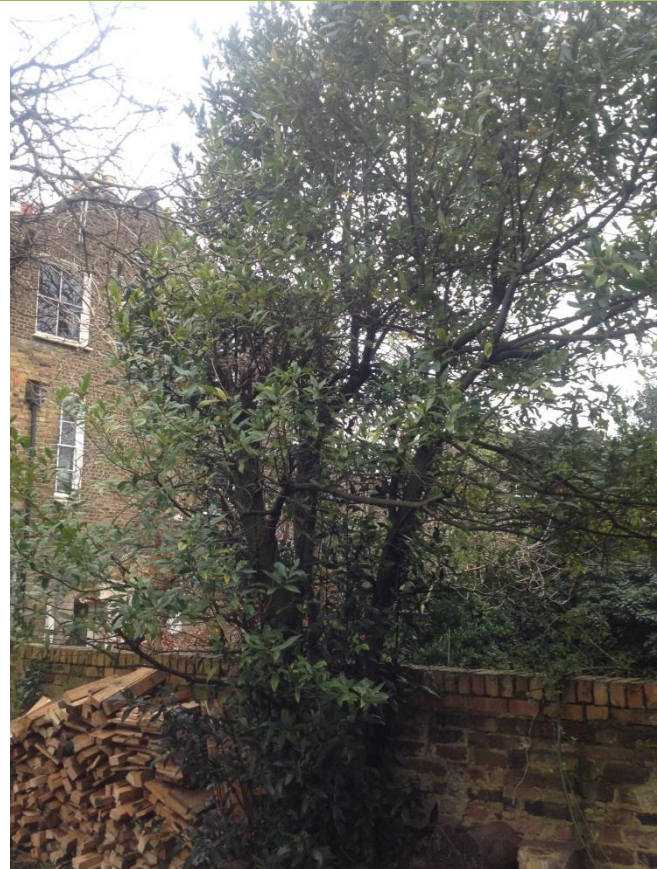
Image 9 – T4 (Bay Laurel)
