Croft Structural Engineers
Clock Shop Mews
Rear of 60 Saxon Road
London SE25 5EH

Basement Structural Method Statement

6 Sumatra Road, London NW6 1PU

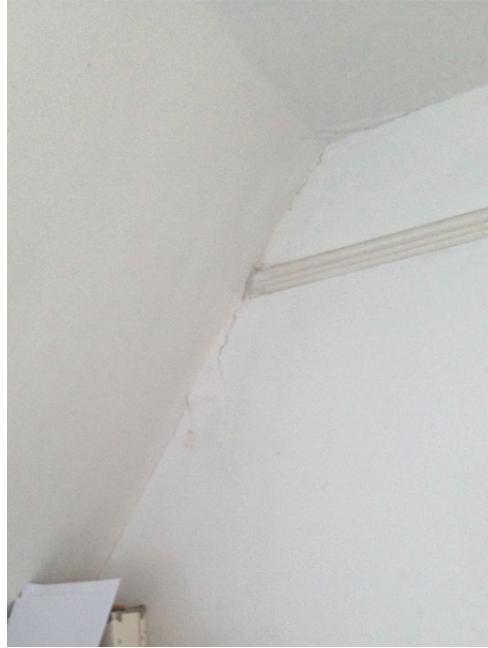
Few cracks were noted on the plasterboard during the Chartered Engineers first visit. They were no construction cracks at the time of inspection. The cracking can be repaired through normal decoration.

Figure 4 Crack 1 - 2nd floor

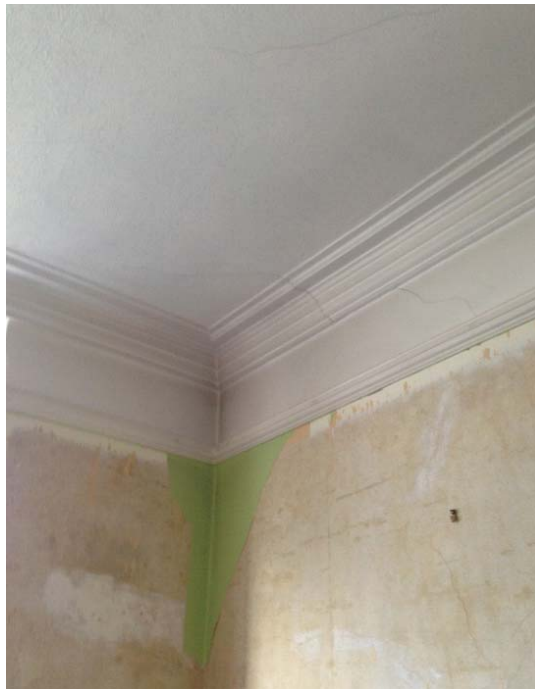
Figure 5 Crack 2 first floor

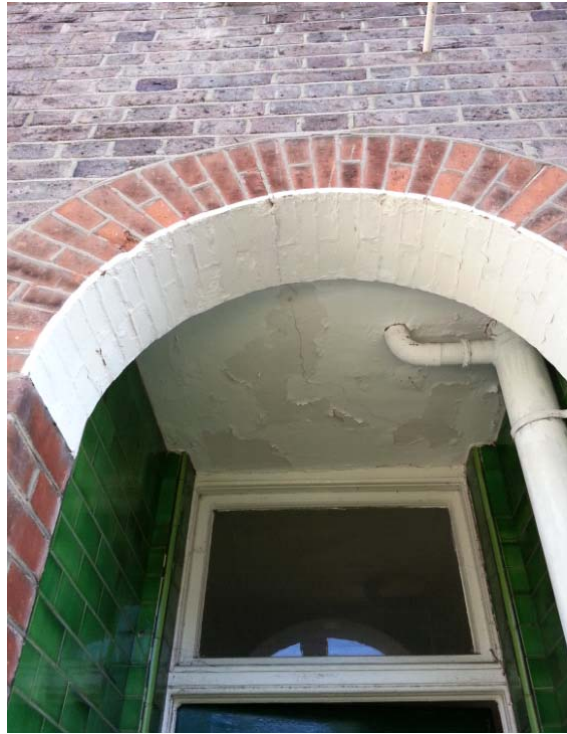
Figure 6 Crack 3 front elevation

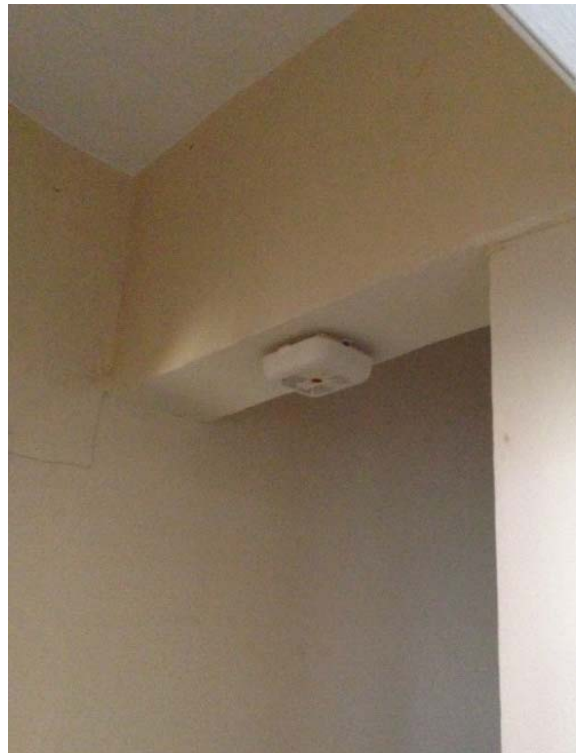
Figure 7 Crack 4 - below the beam

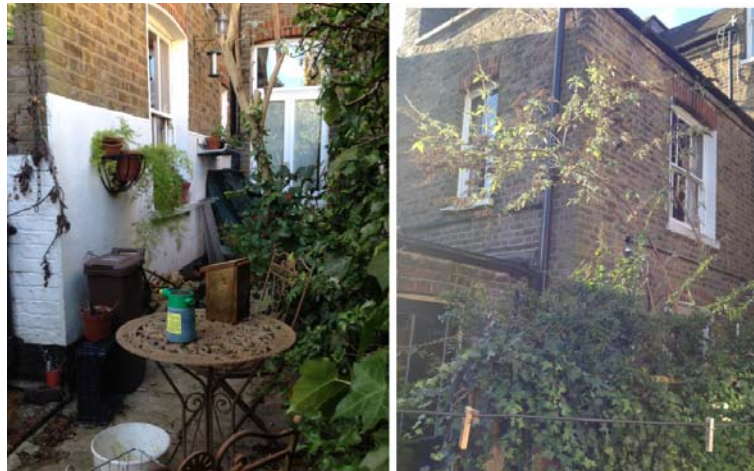
Figure 8 Sumatra Road - tree at the rear next to timber fence

No existing trees are going to be cut down. The current roots have been founded 2.0m bgl to the front (borehole 1). Neighbour's self-seeded tree is located next to the timber fence (boundary line) at the rear, approx. at the point where a new lightwell of the basement will be placed.

The current roots will be within the existing foundations (TBC during excavation) and therefore the new foundations will cut through the roots.

The base of the foundation excavations must be extended at least 300mm into non-root penetrated soil.

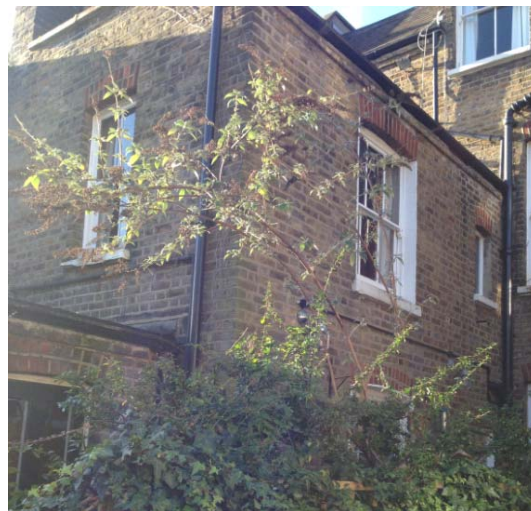
Some shrubbery and general vegetation to be removed.

Figure 34 8 Sumatra Road - garden area

Root barrier protection can be required to protect new basement walls. The base of foundation excavations must extend at least 300mm into non-root penetrated soils.

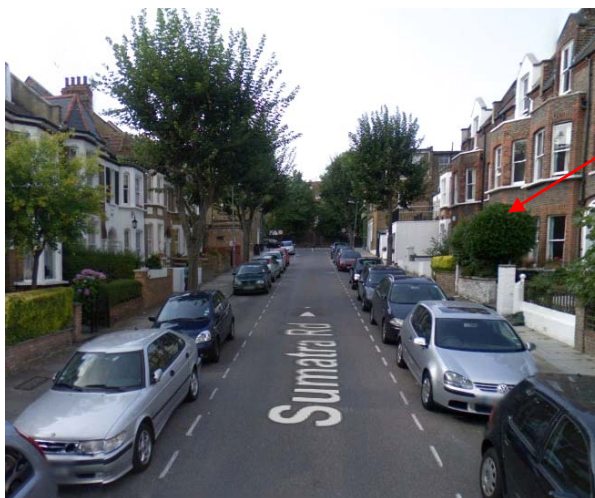
- Excess flow from Sumatra may accumulate in the area of road in front of the site,
- This flow would travel in the direction away from the front elevation of the property owing to the site being on a slightly higher level than the opposite side of the street, and the raised level of the pavement above the road (see photo below).

Figure 50 Street level view

- Construct an upstand around the front lightwells to form a barrier against excess flow,
- Install a dual pumping system to maintain operation in the event of a failure. This should include a battery backup and a suitable alarm system for warning purposes,
- in terms of flood vulnerability, significant „betterment“ can be achieved through the implementation of warning procedures and formalisation of a safe egress route to the upper floors of the building,
- During basement construction, it is recommended that rainwater entering the excavation from above be pumped out to the existing site surface water drainage system, with a settlement tank as necessary to remove excessive suspended fines,
- All electrical and communications services to be routed from ceiling down rather than floor up,
- Tiles are recommended rather than carpets for flooring in the basement rooms.
