BS5837 Arboricultural Impact Assessment

Flat 1-2 24 Belsize Park, London, NW3 4DU

Client: Ecospace Studios

Job Reference: 02271R

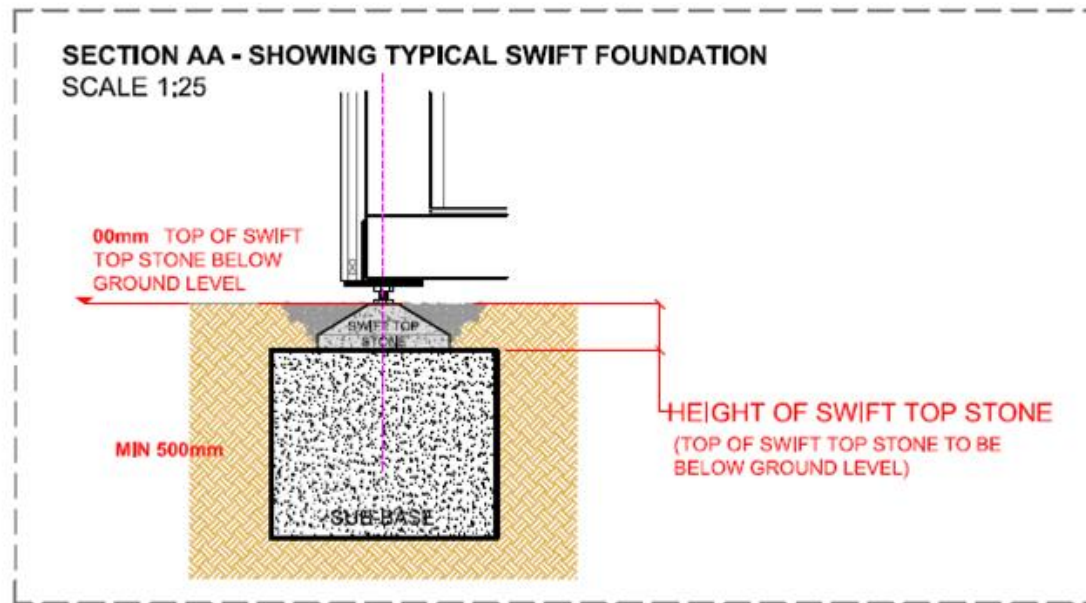
5.4.1 Only a very minimal level of the Garden Rooms foundations encroach in to the RPA of T1 (Ash). At the distances involved (see plans) we would expect only minimal feeder roots. Such roots are seasonal and short lived and the presence of existing tree roots in this area from T3 are likely to have limited further the presence of tree roots from T1.

5.4.2 The level of incursion in to the RPA of T1 constitutes less than 5% of the trees overall RPA and is therefore considered insignificant.

- Cross section of pad foundation
- All excavation works undertaken by hand
- Any roots >25mm originating from the direction of T1 will result in localised repositioning of the individual pad.
- Pits lined with non-permeable membrane to remove the risk of concrete to root contact

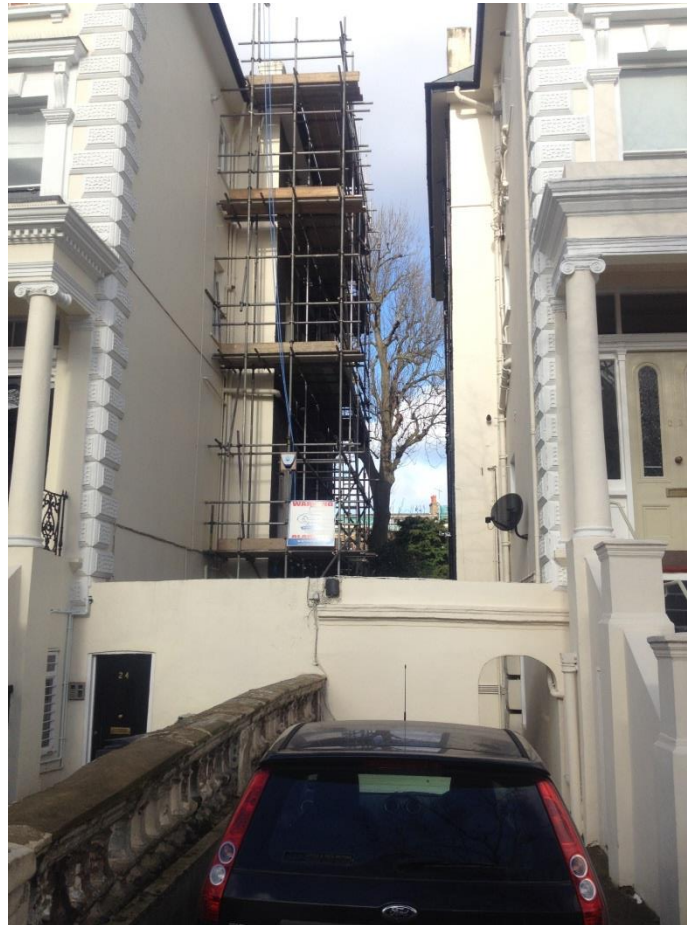
Image 1 – T1 (Ash) is of only limited public amenity

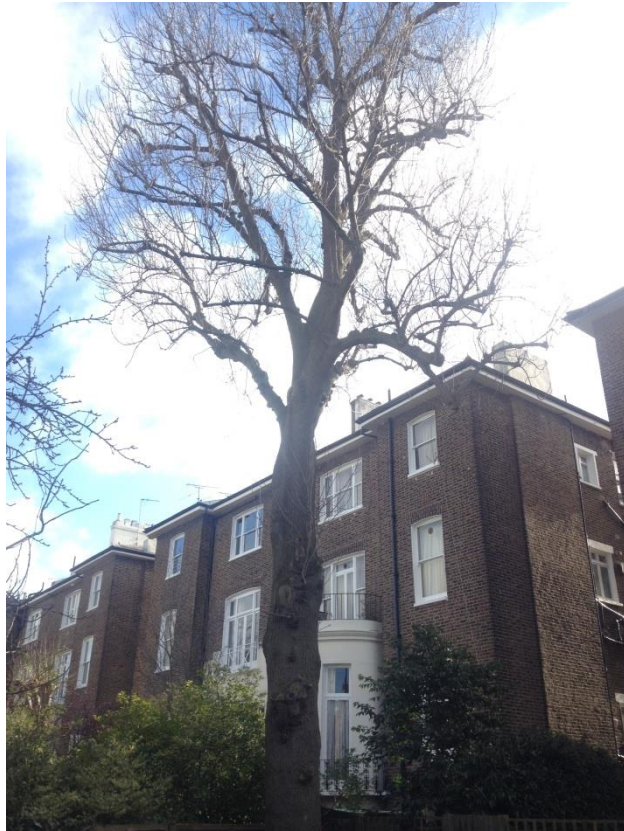
Tree No.	Species	DBH (m)	No of Stems	Ht (m)	Crown Spread				BS Cat	Age Class	Life Expect	Cr Ht (m)	Observation	Recommendations	RPR (m)
					N	E	S	W							
T1	Ash	0.78	1	20	4.8	4.8	4.8	4.8	B1	Mature	20 to 40	8	High crown lifting and previously crown reduced. Decay pockets evident on main stem and vigilance for Inonotus hispidus at these pruning wound points advised.	No works	9.4
T2	Cotoneaster	0.08	M/S	4.3	1.8	3.7	3.3	2	C1	Mature	20 to 40	1.8	Multi stemmed shrub/ tree of very low wider amenity. Limited screening from upper canopy to 3rd party.	Remove to allow for proposed development	1
T3	Prunus spp	0.13	1	4.2	2	37	2.3	1.6	C1	Early-mature	20 to 40	1.3	Poor form with stem lean and asymmetrical canopy.	Remove to allow for proposed development	1.6
T4	Unknown	0.122	1		0	2	3	2	U	Early-mature	<10	0.6	Dead	Remove to allow for proposed development	1.5

Image 2 – T1 (Ash) has been reduced and crown lifted previously. Vigilance for any fungal fruiting bodies on main stem (summer) around previous pruning wounds is advised

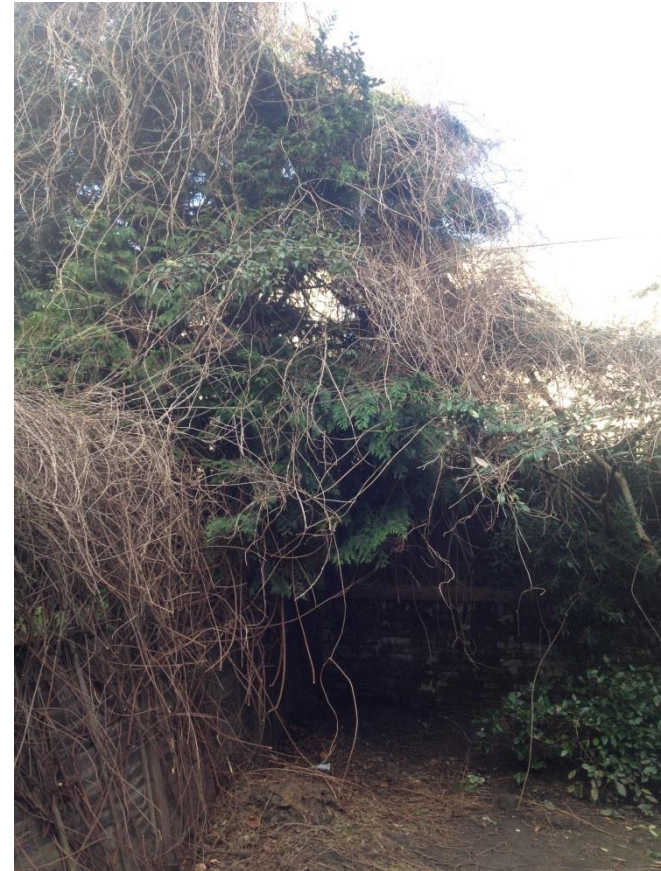
Image 3 – TG1

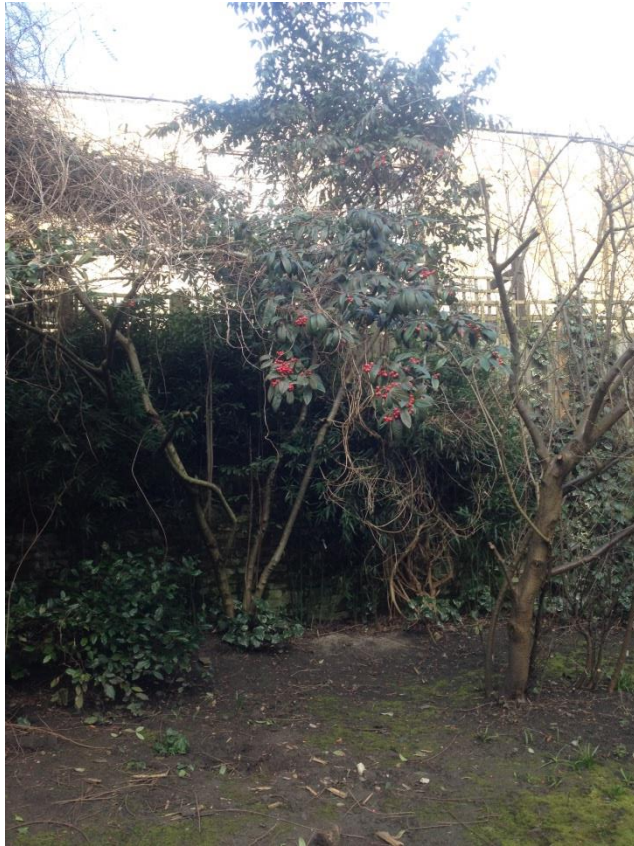
Tree No.	Species	Proposed Works	Observations	BS Cat
T2	Cotoneaster	Remove to allow for proposed development	Multi stemmed shrub/ tree of very low wider amenity. Limited screening from upper canopy to 3rd party.	C1
T3	Prunus spp	Remove to allow for proposed development	Poor form with stem lean and asymmetrical canopy.	C1
T4	Unknown	Remove to allow for proposed development	Dead	U

Image 4 – T2 & T3 to be removed

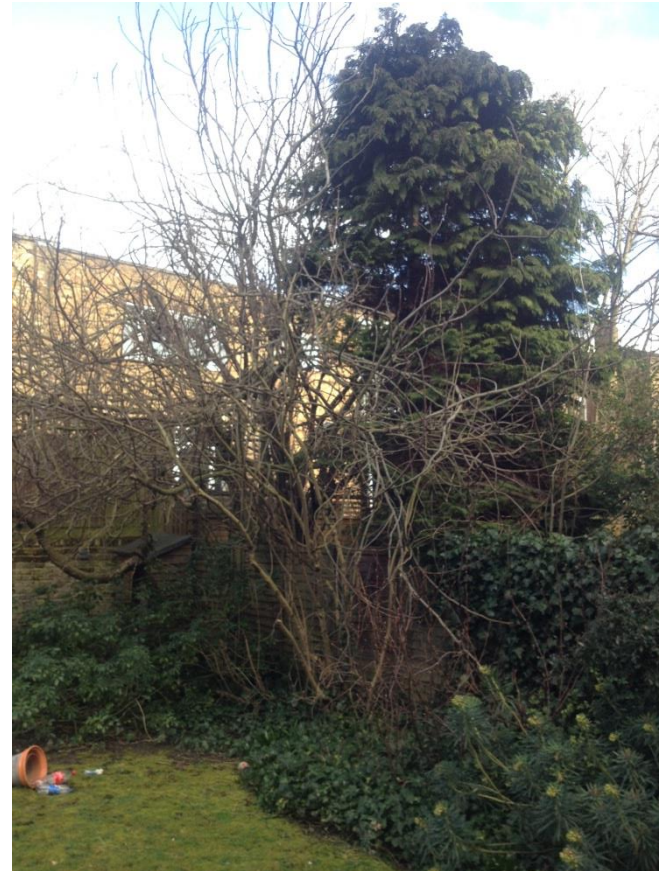
Image 5 – T4, T5 & T6

Tree No.	Species	Proposed Tree Works	BS Cat
T5	Rhus	Crown lift to 3m/ cut back to provide construction clearance Note: The sap of this tree can cause burns and as such any tree works must be done by a qualified tree surgeon	C1

Note: minimal tipping back of T4 (Cotoneaster) may also be required. See photos. **Proposed Removal**

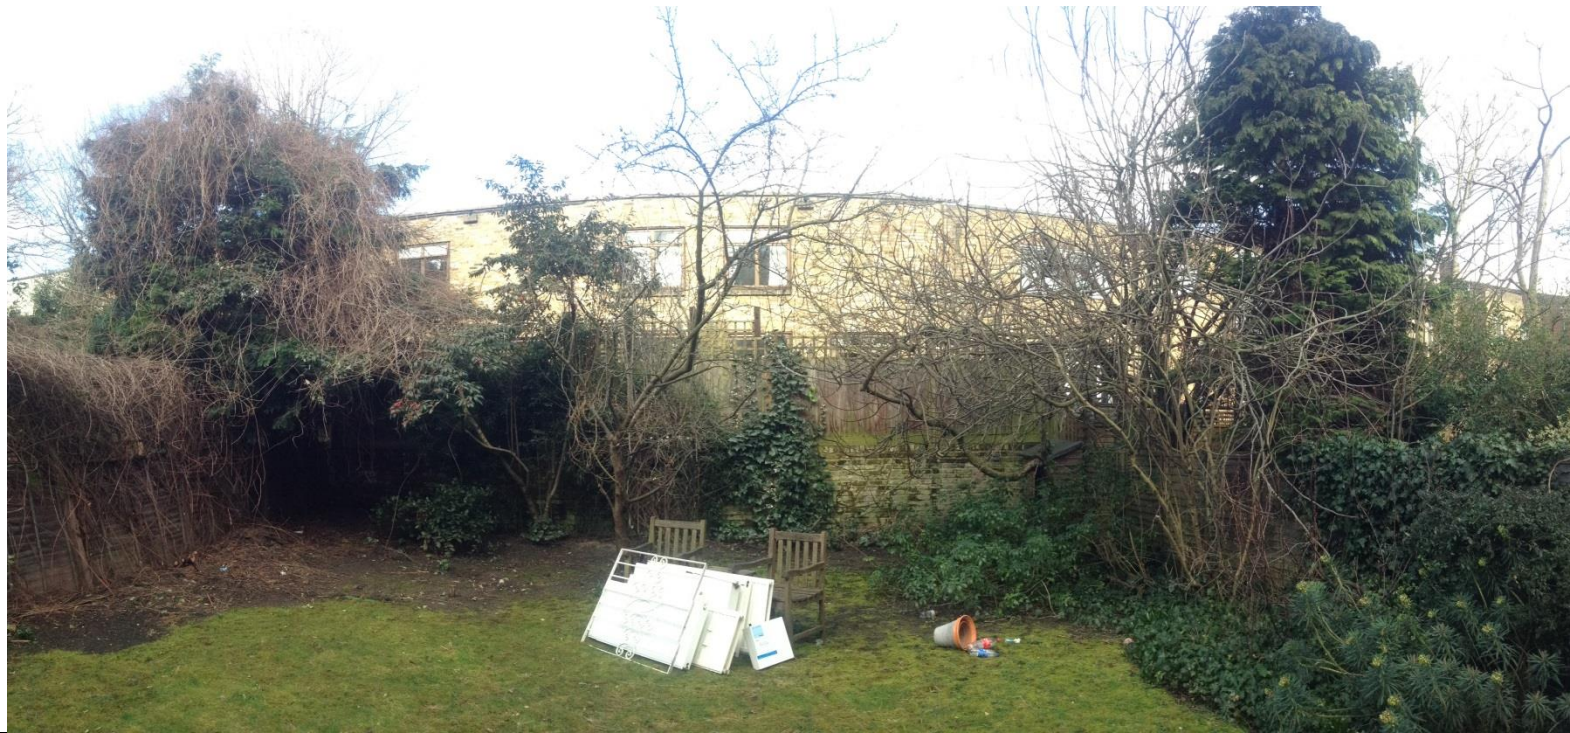
Image 6 – Image showing location of proposed garden room
