Heritage Statement Incorporating Photographic Images for repair works to the wall at Holly Terrace, N6 6LX.

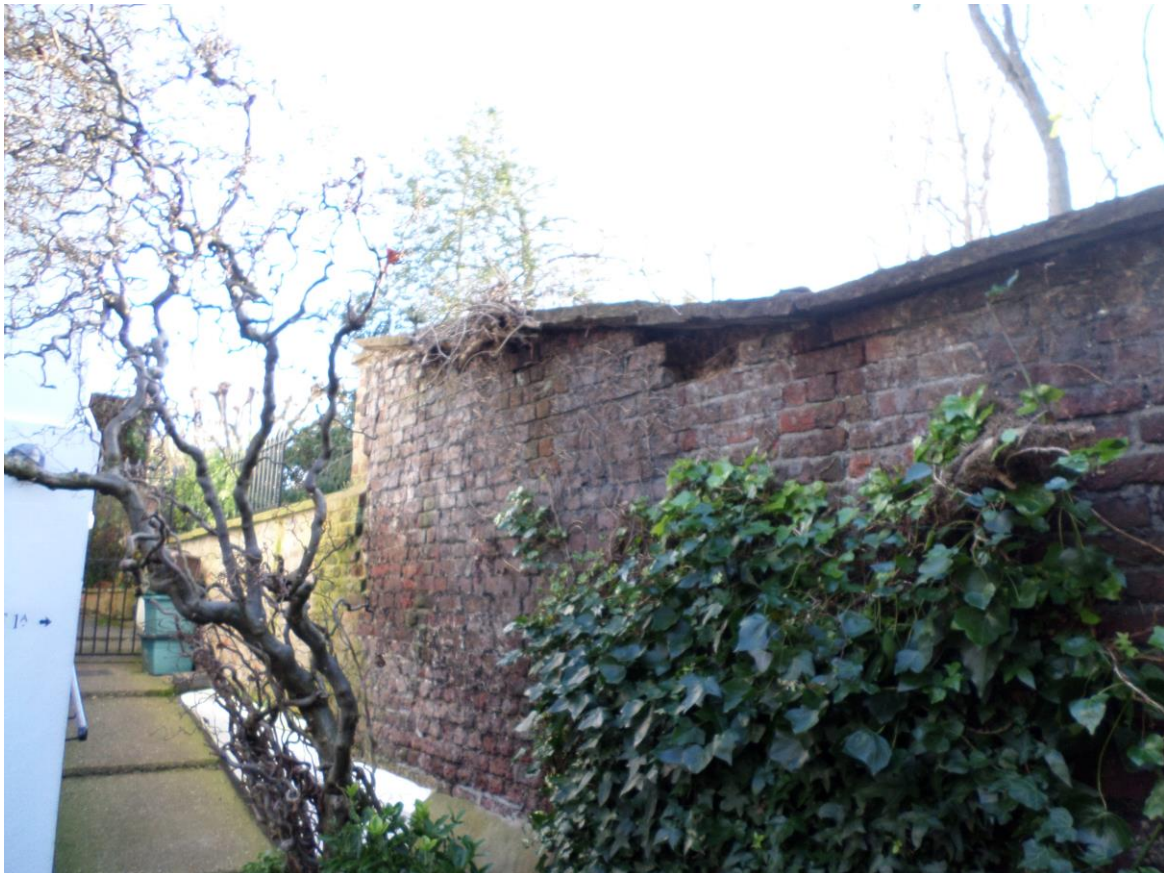
The wall was constructed circa early 19th Century and comprises of a brick built wall with stone coping stones. The wall is situated on the boundary of Holly Terrace and the grounds of 1 Holly Terrace which are grade II listed. The wall comprises lime based mortar, stone capping and cement render to low level.

The image below shows the existing wall (viewed from the grounds of 1 Holly Terrace).

The proposed wall repairs are straightforward and consist of roof alterations are straightforward and consist of repointing with a lime based mortar, replacing missing and defective bricks, as well as removing vegetation and replacing existing render. The purpose of the repairs is to improve the stability of the wall, therefore ensuring the safety of the residents when walking through Holly Terrace and within the grounds of 1 Holly Terrace.

The coping stones will be retained as well as the vast majority of the existing brick work. The wall will be cleaned to remove dirt and improve the look.
