BASEMENT IMPACT ASSESSMENT  
for  
REDEVELOPMENT  
Of  
MANSFIELD BOWLING CLUB SITE  
CROFTDOWN ROAD  
LONDON NW5 1EP

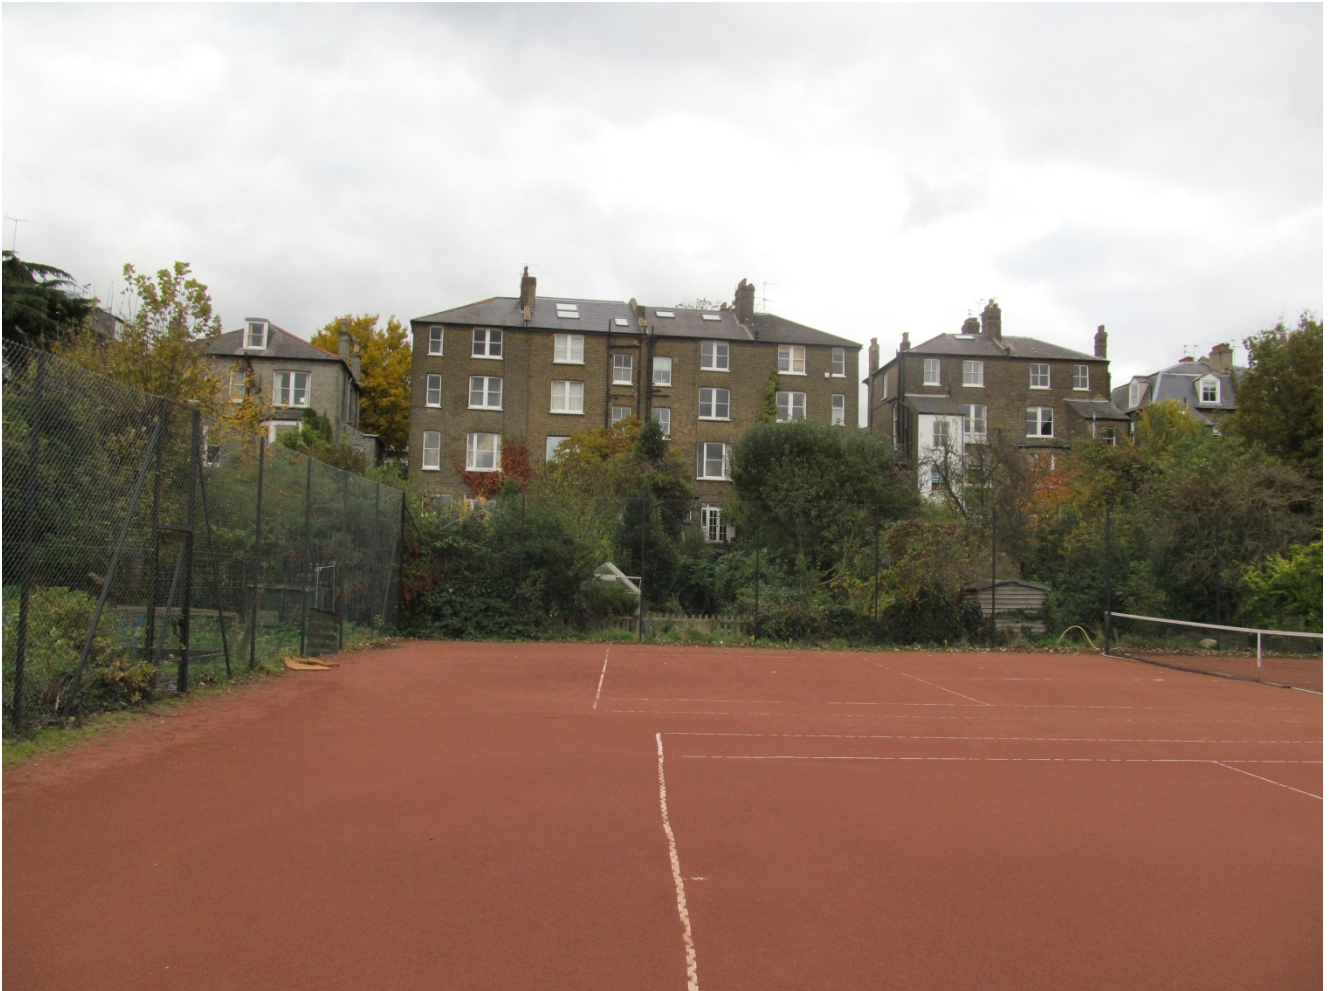
Photo 1 Rear gardens of houses to Dartmouth Park Avenue  
Note 1 No evidence of movement in rear elevations

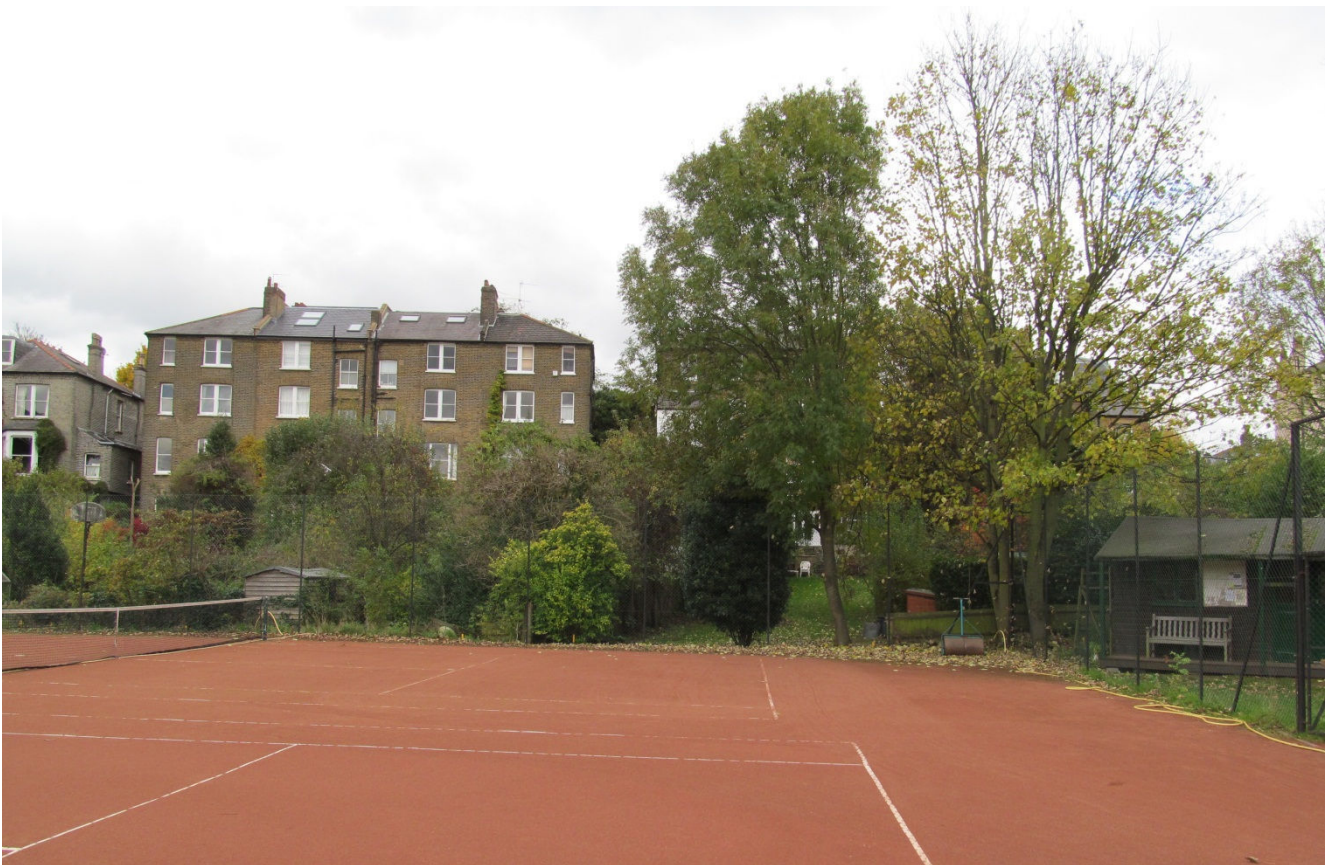
Photo 2 Rear gardens of houses to Dartmouth Park Avenue

Note 1 No evidence of movement to rear elevations

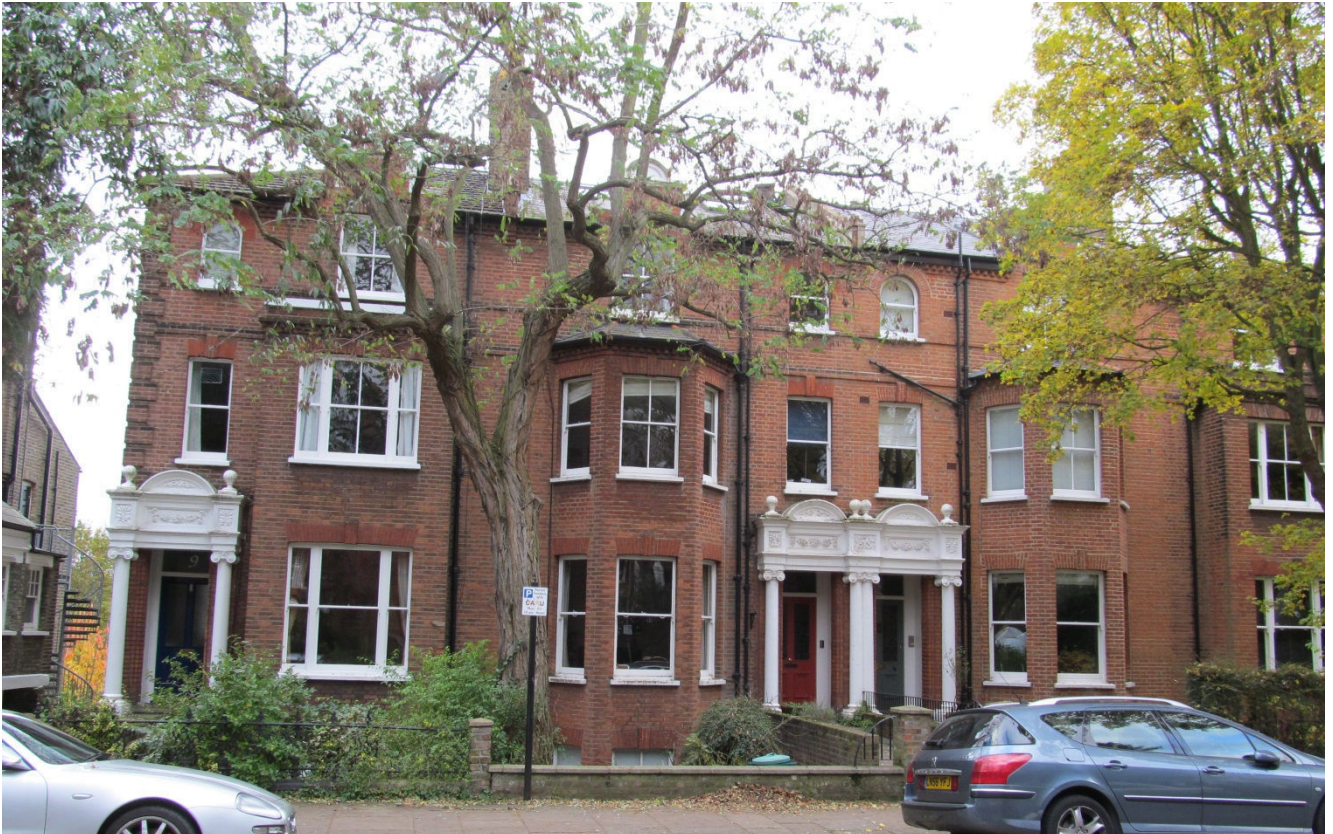
From the eastern boundary, a visual assessment was made of the rear of the houses along Dartmouth Park Avenue and Laurier Road. The houses are four storey to the rear and there is no evidence that these are exhibiting any significant movement or structural distress. Photos 1 to 2. The fronts of these houses were assessed along their road frontages from the pavement and again there is no evidence of any significant movement or structural distress. Photo 3.

Photo 3 Front elevation of houses on Dartmouth Park Avenue

Note 1 No signs of movement.
