Root barrier feasibility check.

Policyholder Name: Mr & Mrs S Brooks Croftway House, 298 Finchley Road, London, NW3 7AG

Brief history of the Claim

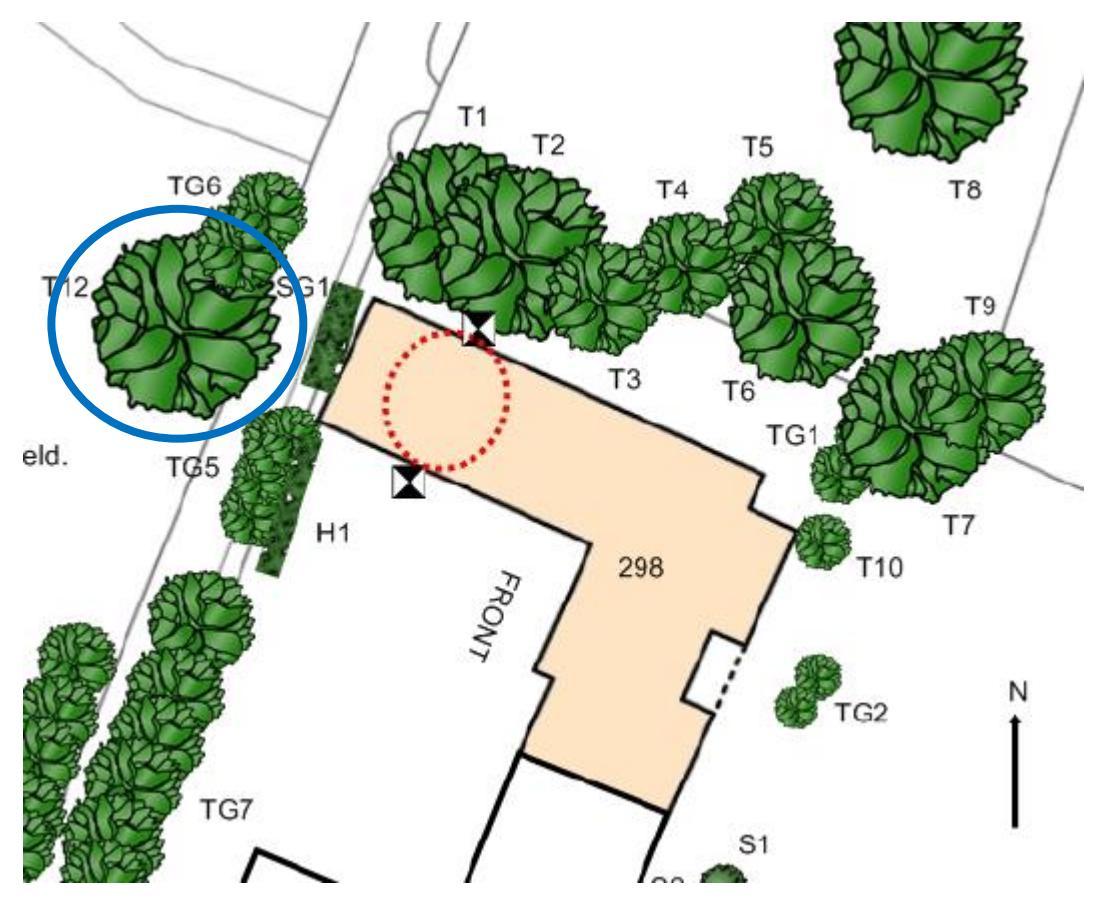
To date both the Ash and the Acer have been removed, leaving only the Oak remaining within the grounds of the neighbouring property - a block of flats managed by Westfield.

The hedge. TG5 (a type of Hawthorn) is in the PH's garden and this has been reduced and managed by the PH in line with the recommendations.

Tree species	Current Height	Mature Height	Distance	Water Demand	Owner
T12 Oak	20m	20-22m	4.5	High	Private with TPO

Do any of the trees have TPO's or conservation restrictions: YES ROOT SEVERENCE REQUIRED.

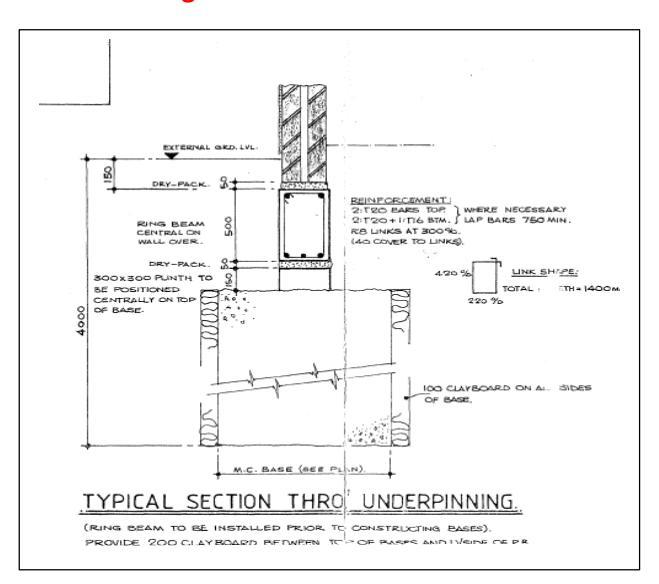
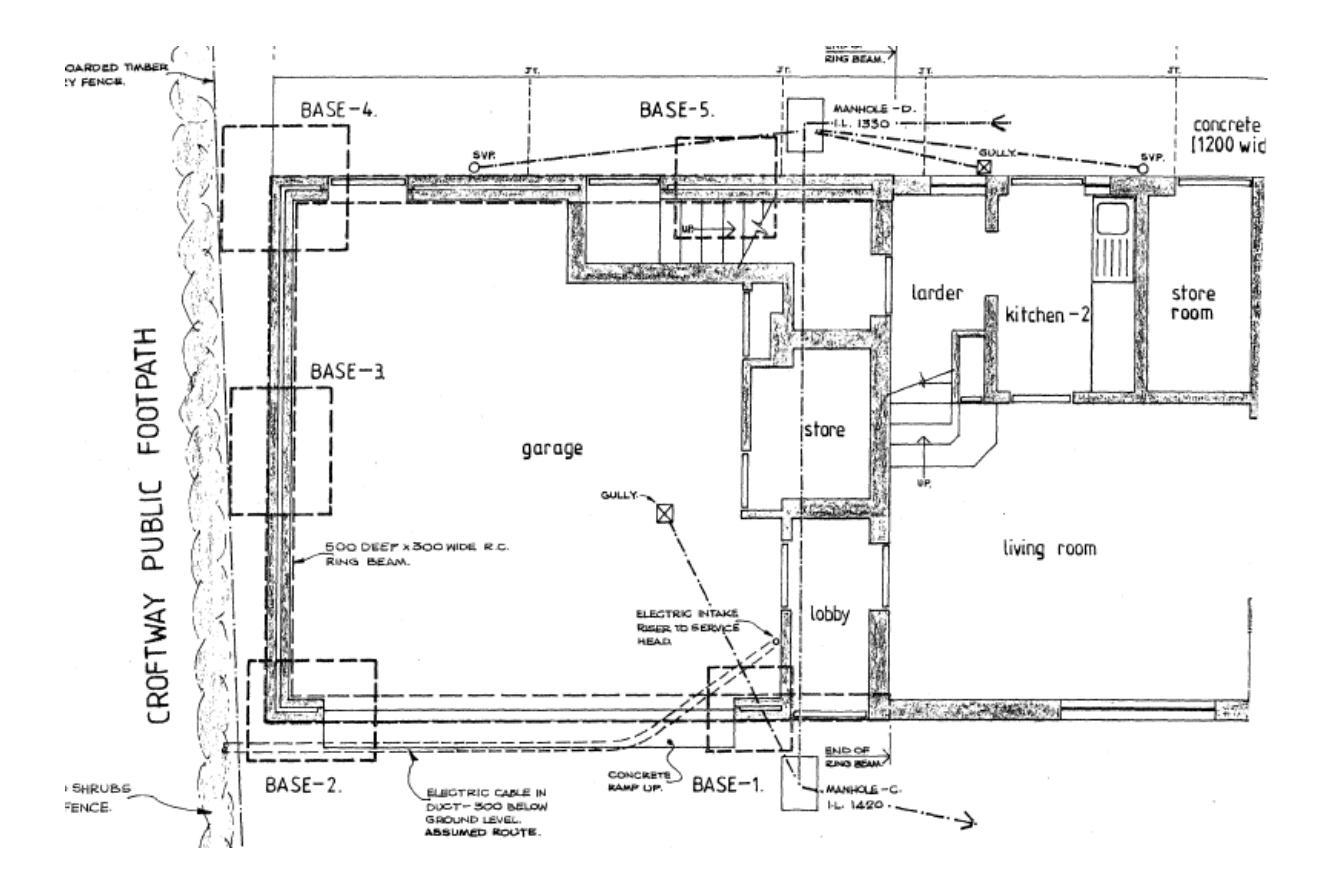
Has the property been underpinned previously ? If yes, please state the type, depth and location Of previous stabilisation works.....

Yes Garage. Pad and beam solution

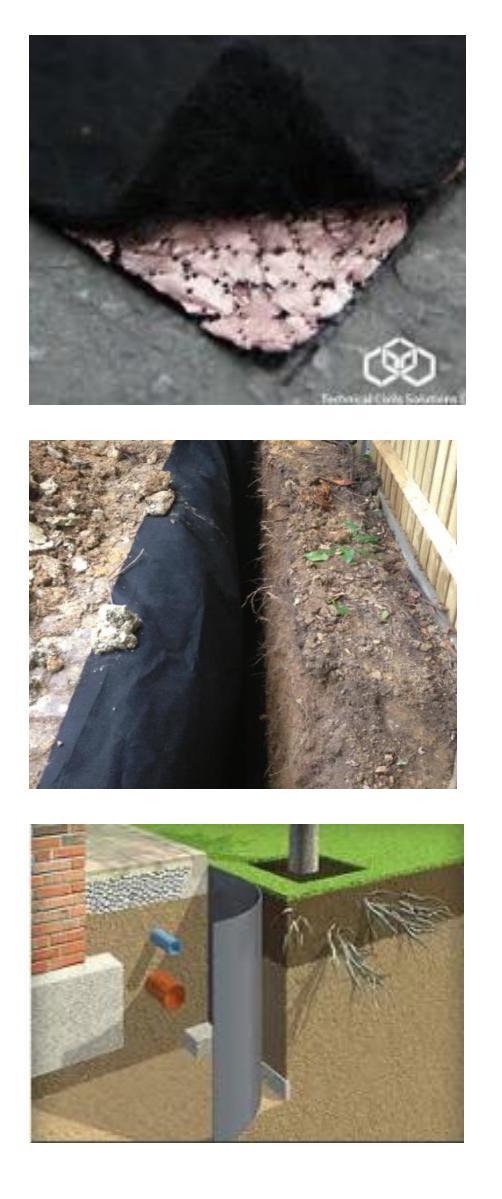
The Copper signal barrier details a cooper foil securely bonded between porous geotextile, releasing copper ions and forming copper carbonate (verdigris) that signals an adverse reaction to roots deflecting them away from the barrier. The presence of copper do not constitute an eco-system burden or impact on groundwater

This solution is multipurpose and ideally suited to the current application. Traditional impervious barriers divert rather stop roots and may block moisture movement. Also roots getting under such barriers can grow back to the surface. Therefore the use of this permeable barrier stops roots either by engaging and constricting them or by chemically inhibiting them.
