2 & 3 AKENSIDE ROAD NW3 5BS

A geotechnical and structural assessment of basement planning applications 2015/0851/P and 2015/1207/P and their potential impact on 4 Akenside Road NW3 5BS

Report reference G1504-RP-01-E1

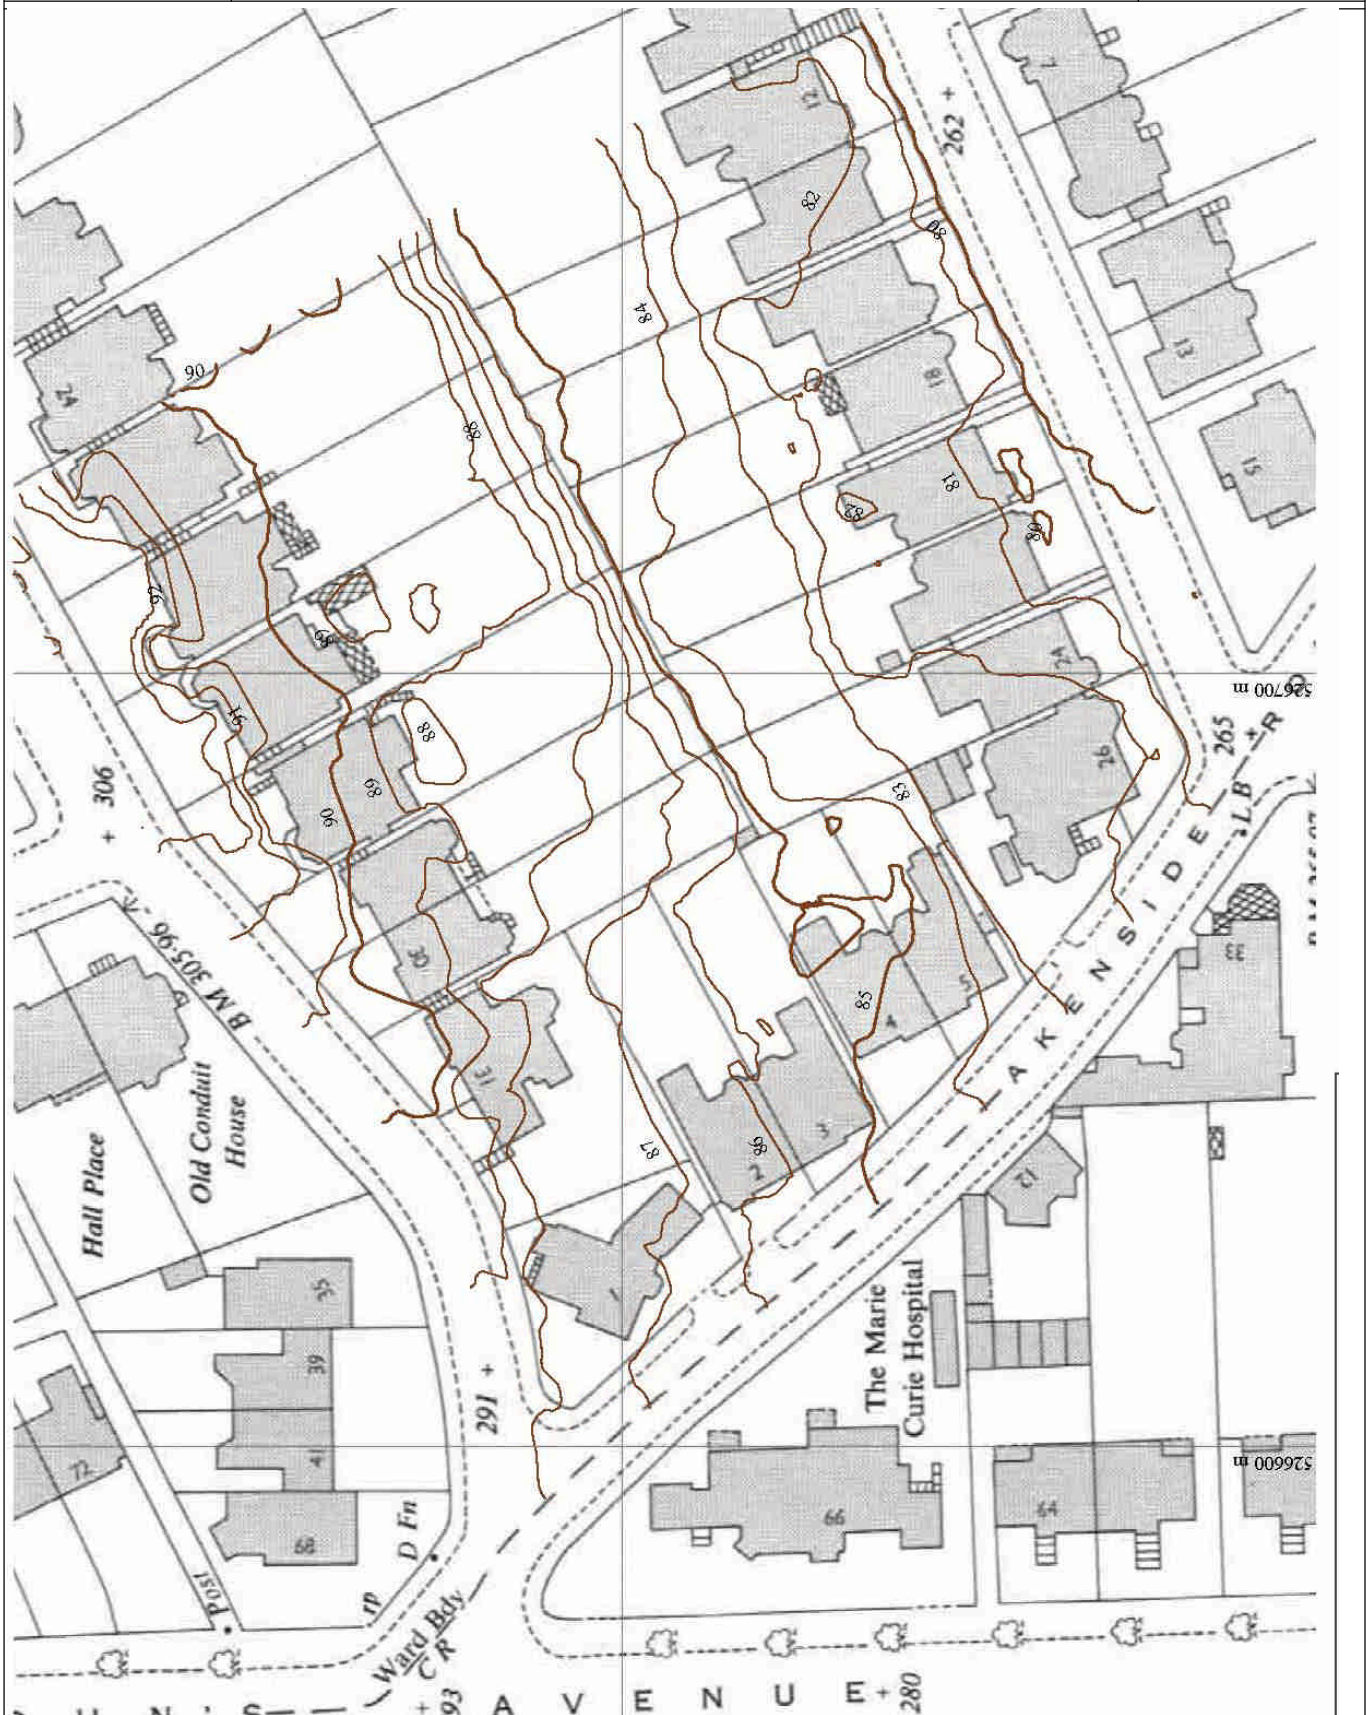
Project Ref. G1504	Project Title. 2-3 AKENSIDE ROAD NW3 5BS	Indicative North  
Sheet Ref. Figure 1	O.D. Surface Contours at 1m Intervals of Height

23. Appended Figure 1 will assist the following description.
24. Akenside Road slopes down to the south east and both Lyndhurst and Wedderburn Roads rise from it in a north east direction. Ground surface levels in the area fall in an approximately southerly direction at a general gradient of 1 in 9.5 (6 degrees). From Lyndhurst Road, for about half the distance towards Wedderburn Road, the land was filled and ground levels were adjusted to create individual plots as the area was redeveloped for housing at the end of the 19th Century. There is now an approximately 1m drop between each of the four plots of Nos 2 to 5 Akenside Road.

The change at the boundary between Nos 3 and 4 occurs as a sharp step down to a surface level of 85mOD in No.4.

There are also sharp drops in level from the gardens of 29-30 Lyndhurst Road to those of both 4 Akenside Road and 22 and 24 Wedderburn Road. Before its recent redevelopment, ground in Nos 29 and 30 Lyndhurst Road stood slightly more than 1m above the gardens of No.4 Akenside Road and 22 and 24 Wedderburn Road. From there it rose towards Lyndhurst Road at the general 6 degree gradient. I understand from Mrs Wilson that ground levels in No.30 were slightly raised with excavated soil during its redevelopment. The current Google Earth image still shows construction there in progress. Vegetation near No.4 has been cleared and the ground surface appears to be covered by subsoil.

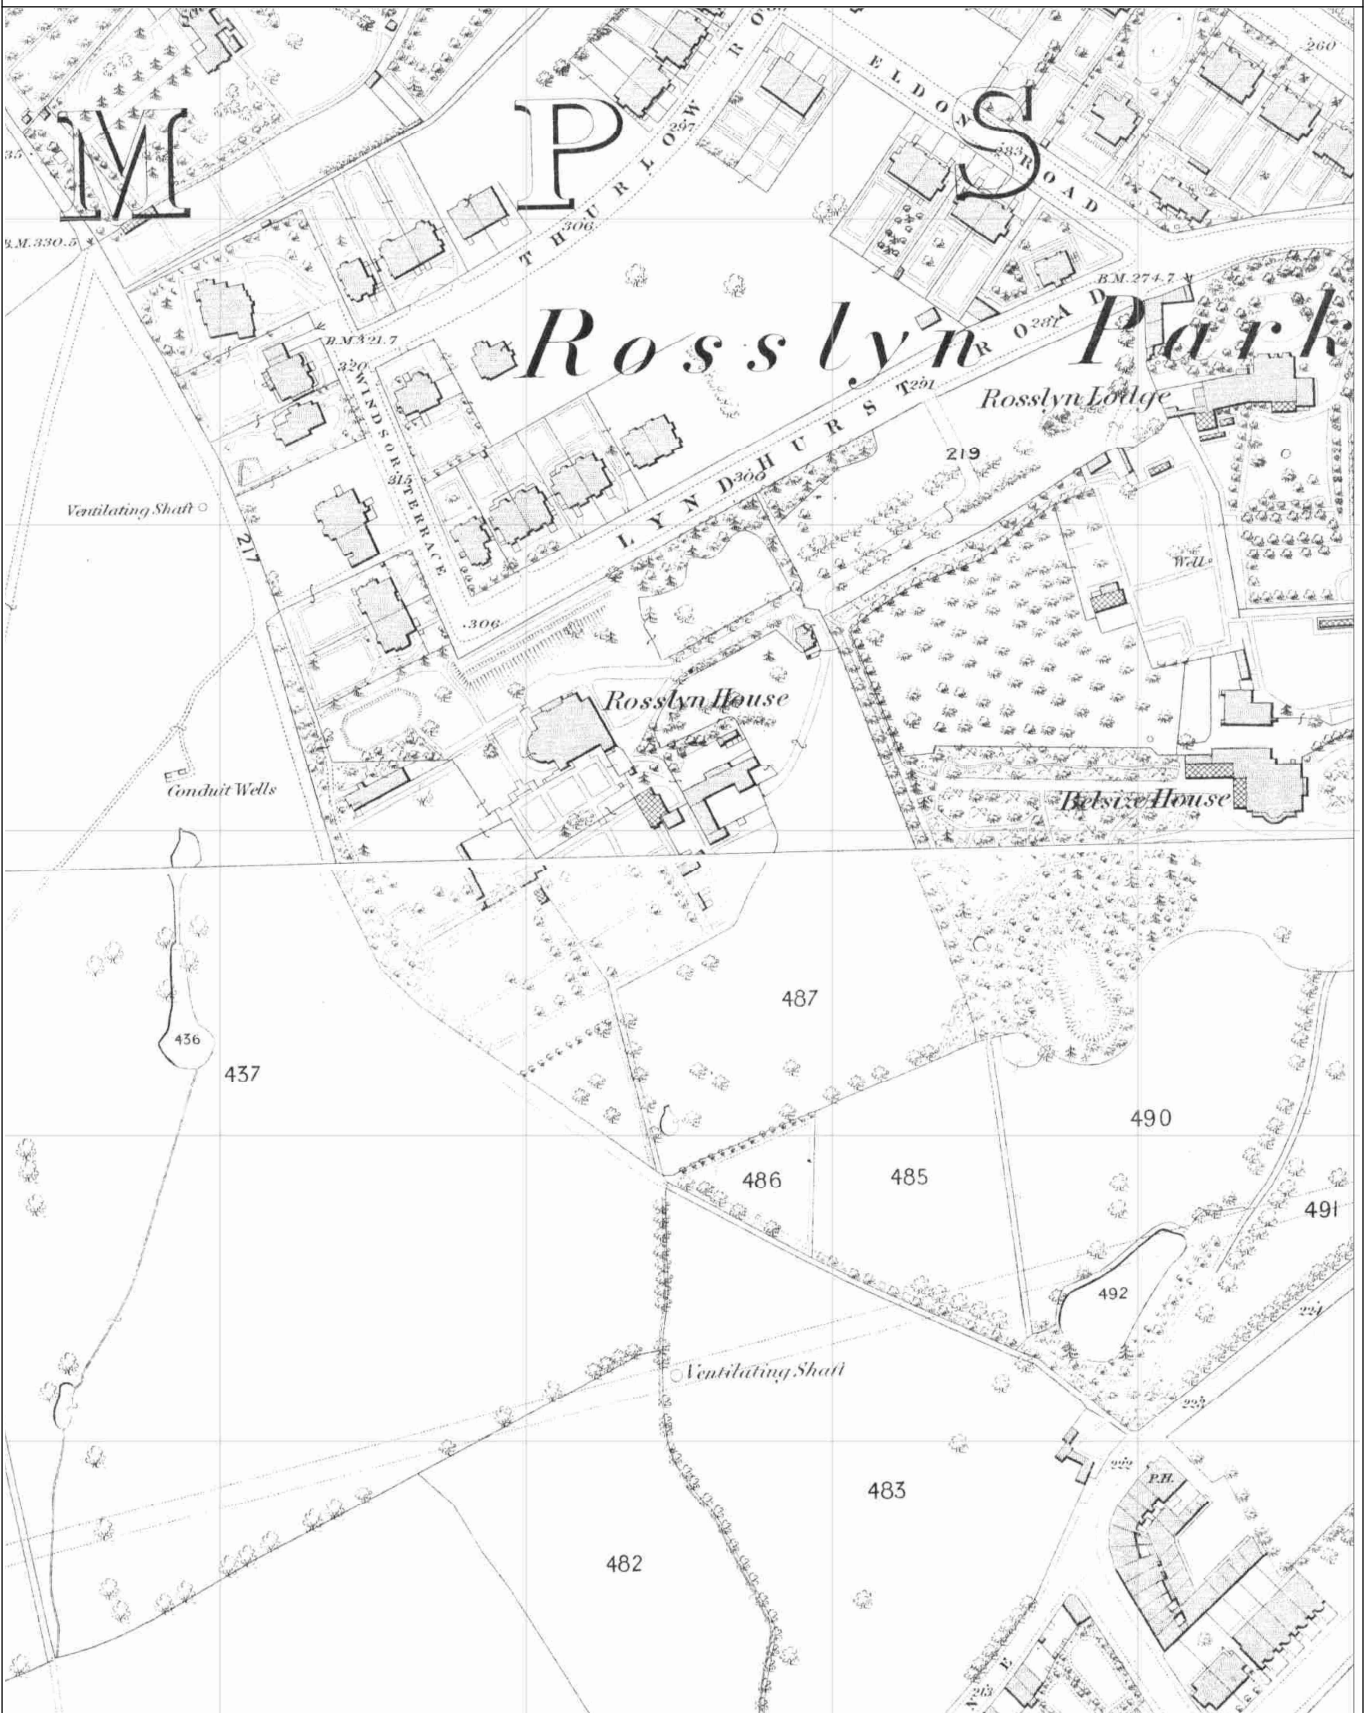
Project Ref. G1504	Project Title. 2-3 AKENSIDE ROAD NW3 5BS	Indicative North N ↑
Sheet Ref. Figure 2	1871 O.S. Map Extract

26. Figure 2 is an extract from the 1870-1871 Ordnance Survey map. Akenside Road had not been constructed, Lyndhurst Road extended only as far as Windsor Terrace and the area now contained between Lyndhurst Road and Wedderburn Road was occupied by Rosslyn House and Belsize House. Ground next to Lyndhurst Road sloped down steeply into the grounds of Rosslyn House, suggesting that the road was built on an embankment so as to make its cross fall less than the general ground slope. Ground at the front of 29 and 30 Lyndhurst Road is now at the same level as the carriageway, which accounts for the depth of fill encountered by a borehole excavated there for the recent development.

29. Figure 2 shows conduit wells on the north side of what is now the junction of Akenside and Lyndhurst Roads and another well in land east of what is now the return of Lyndhurst Road linking it to Wedderburn Road. By the end of the 19th Century the first of these was labelled a drinking fountain and a fountain was shown in the grounds of Rosslyn House, approximately in the current location of 29 and 30 Lyndhurst Road. These are all likely to have been supplied by shallow groundwater flow and springs as described by reference [1].

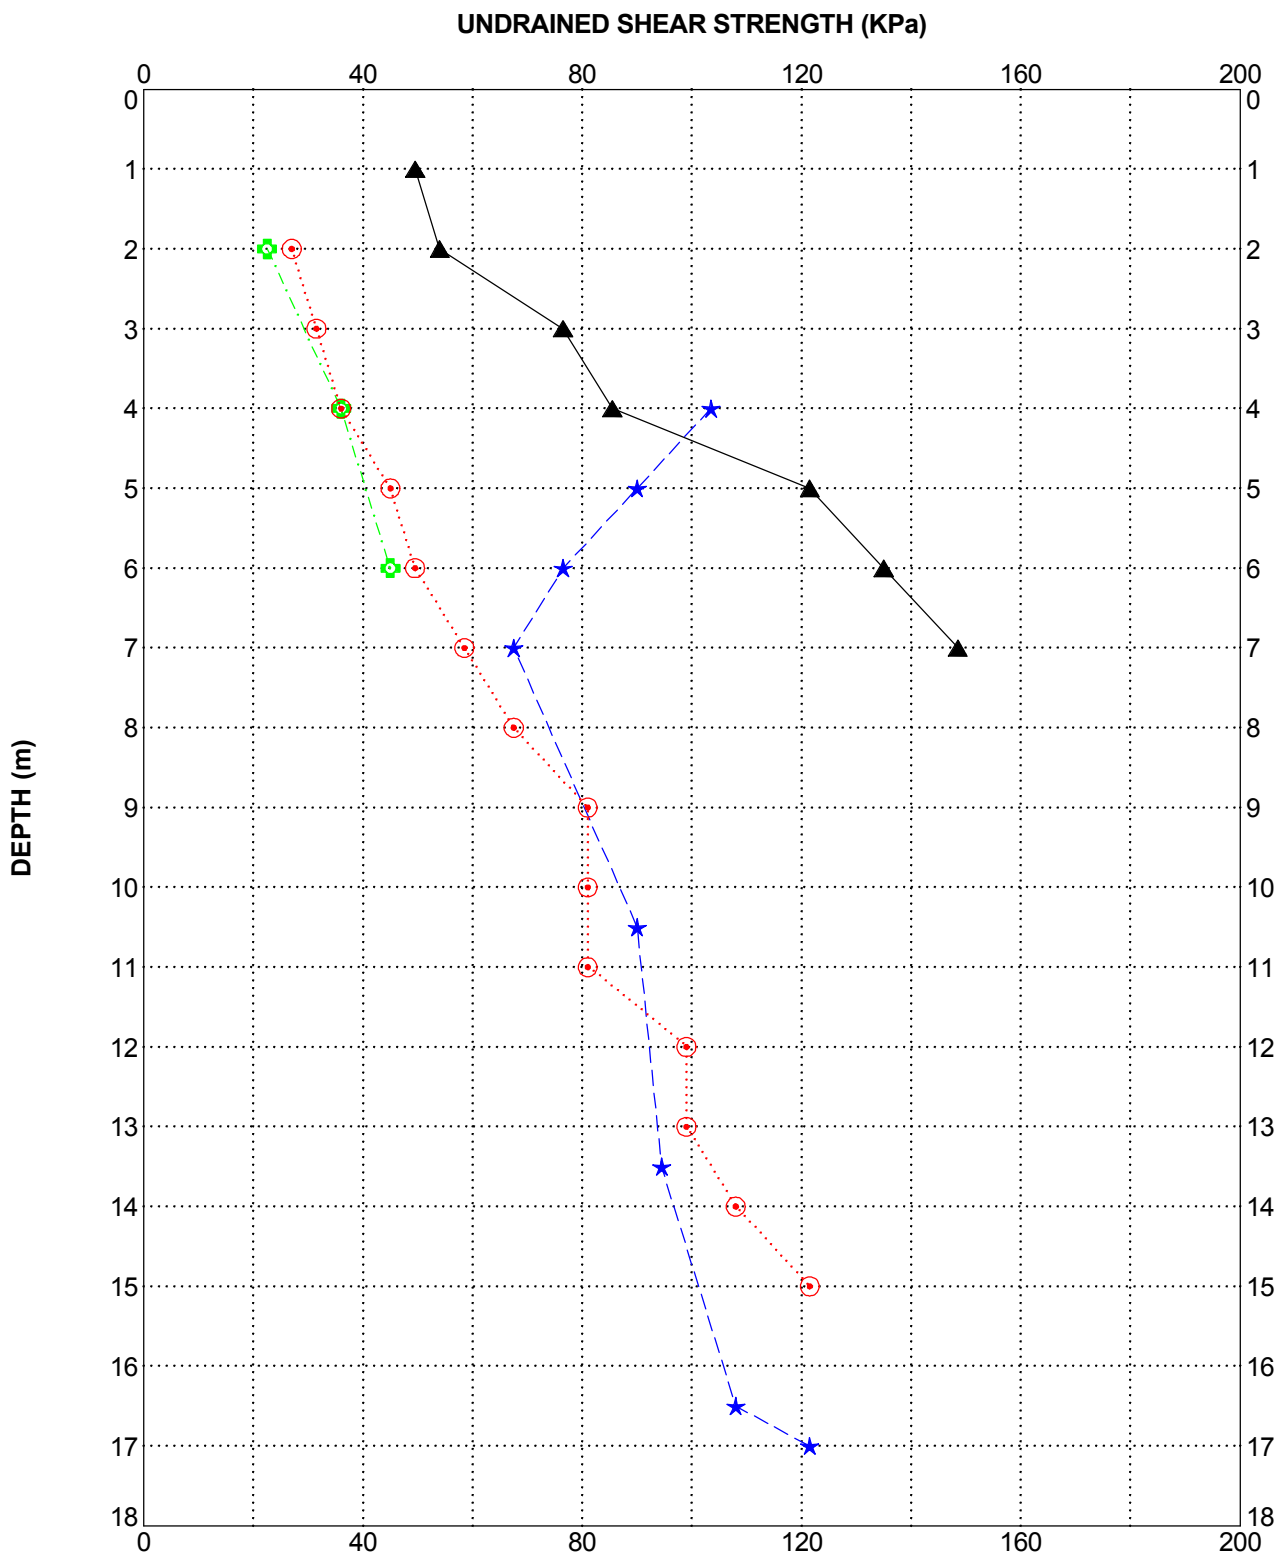
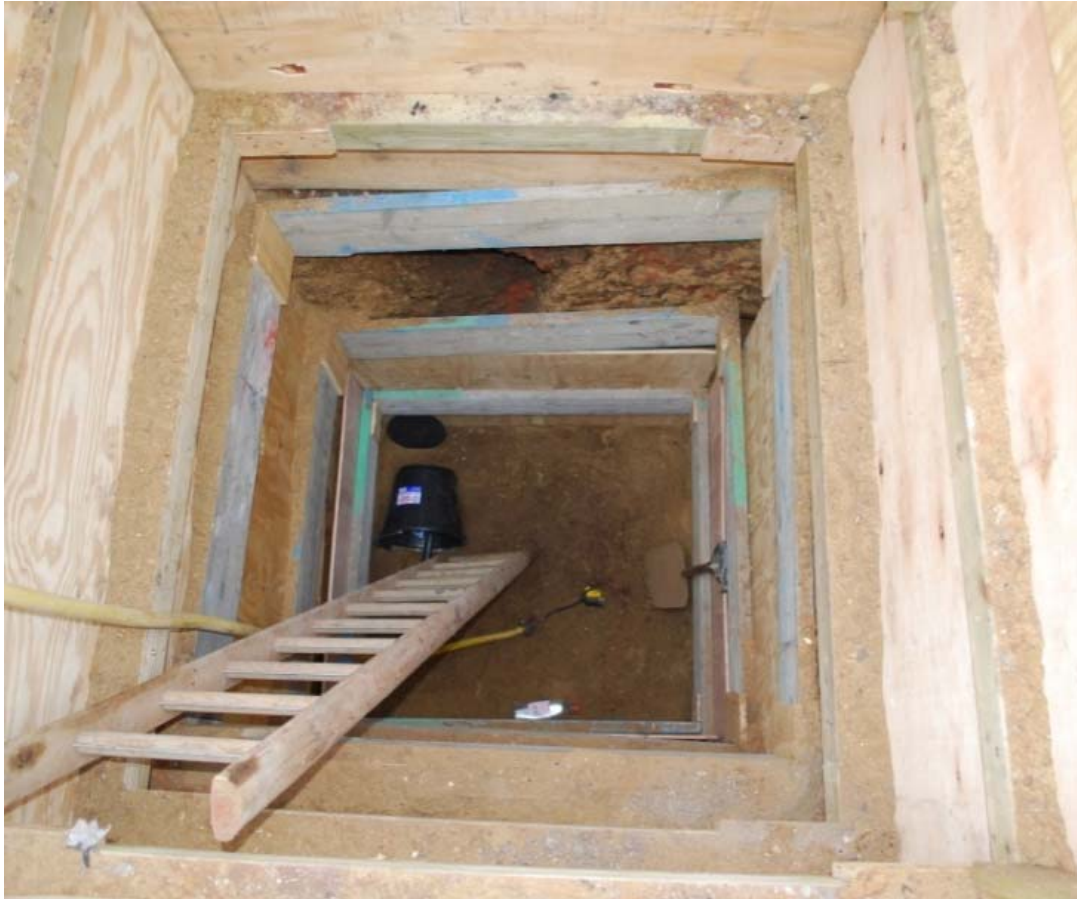
Project Ref. G1504	Project Title. 2-3 AKENSIDE ROAD NW3 5BS	Sheet Ref. Figure 3
	UNDRAINED SHEAR STRENGTH vs DEPTH

28. Borehole records for 2 and 3 Akenside Road show considerably higher than expected ground strengths and soil descriptions that are at variance with both test results and the written account. To assess their reliability the records were considered in relation to records for some other local sites which exhibit the same mapped geology as Akenside Road, and which are available via the Camden website. Brief details are as follows.

Application documents posted for 6 Wedderburn Road did not include original investigation records; only the BIA account. Ground strength profiles derived from the records for the other four locations have been plotted in Figure 3.

Strengths at Maresfield Gardens and 26 Wedderburn Road fit well with those found by other investigators of the Claygate Member elsewhere in Hampstead but are much lower than those recorded at 2-3 Akenside Road. At the base of the filled ground, the ground strength at Lyndhurst Road was approximately the same as at 2-3 Akenside Road. But strength then decreased quite rapidly with depth, joining the Maresfield Gardens profile at 7m below ground level. No explanation of the upper part of the Lyndhurst Road profile or of a note on the record sheet stating that the borehole was terminated due to groundwater inflows.

The inescapable conclusion is that the results of the ground investigation at 2-3 Akenside Road are unreliable, that the soil descriptions provided are at variance with both test results and the written account and that the information provided is of little or no use for the engineering design of the proposed development or for assessing damage risk for other property.
