No. 1 Oak Hill Way. Hampstead . NW3 7LR

Tree Survey and Arboricultural Method Statement.V2. April 2015

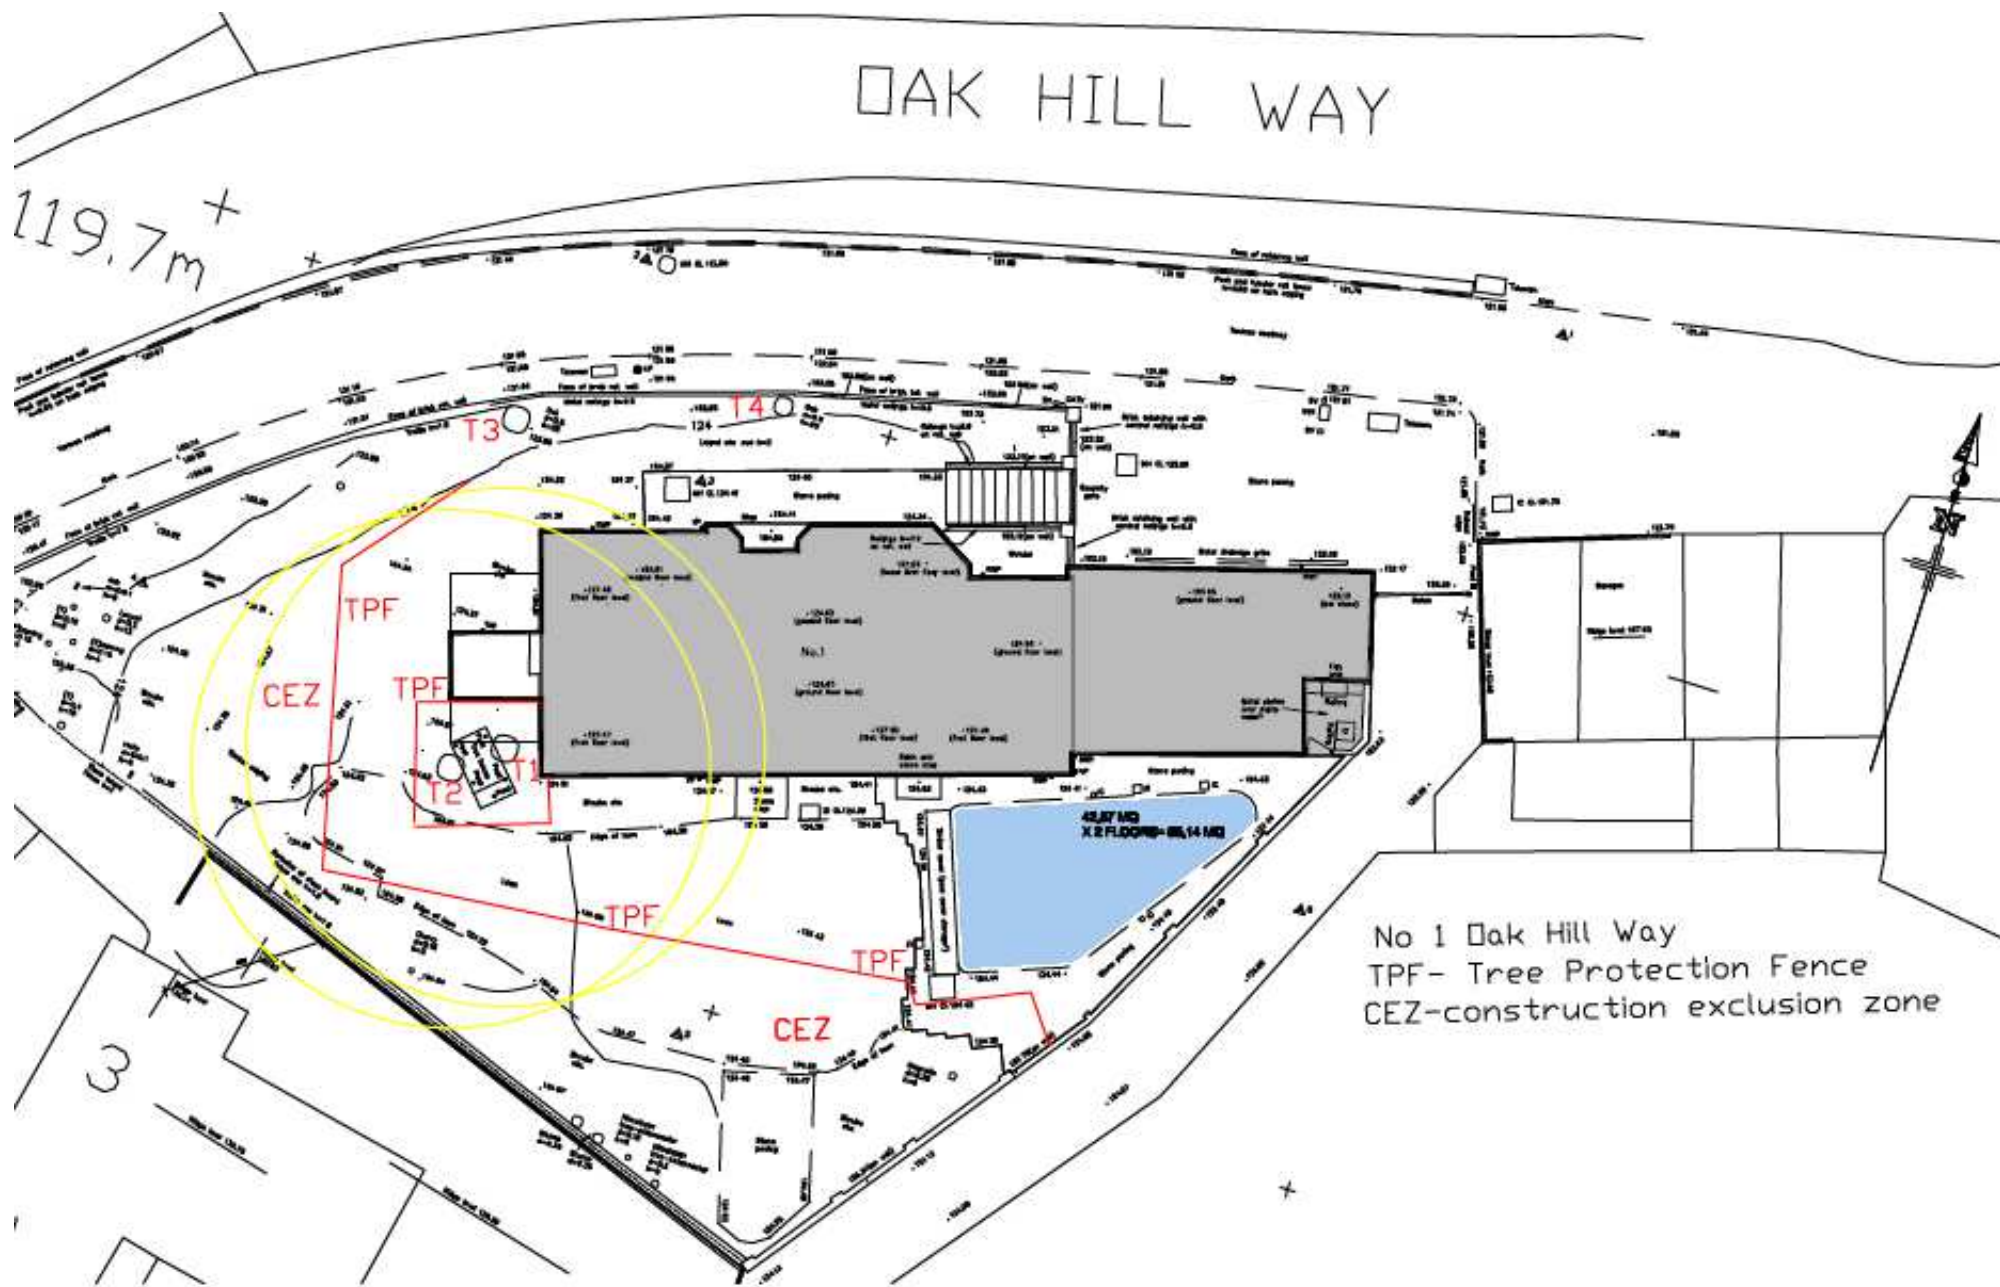
The position of these trees are shown on the tree protection plan below.

No 1 Oak Hill Way
TPF- Tree Protection Fence
CEZ- construction exclusion zone

Tree protection fencing and ground protection will be placed prior to any work being carried out on site.
