TECHNICAL REPORT ON A SUBSIDENCE CLAIM

Crawford Reference: SU1304913

SUBSIDENCE CLAIM

51 Redington Road

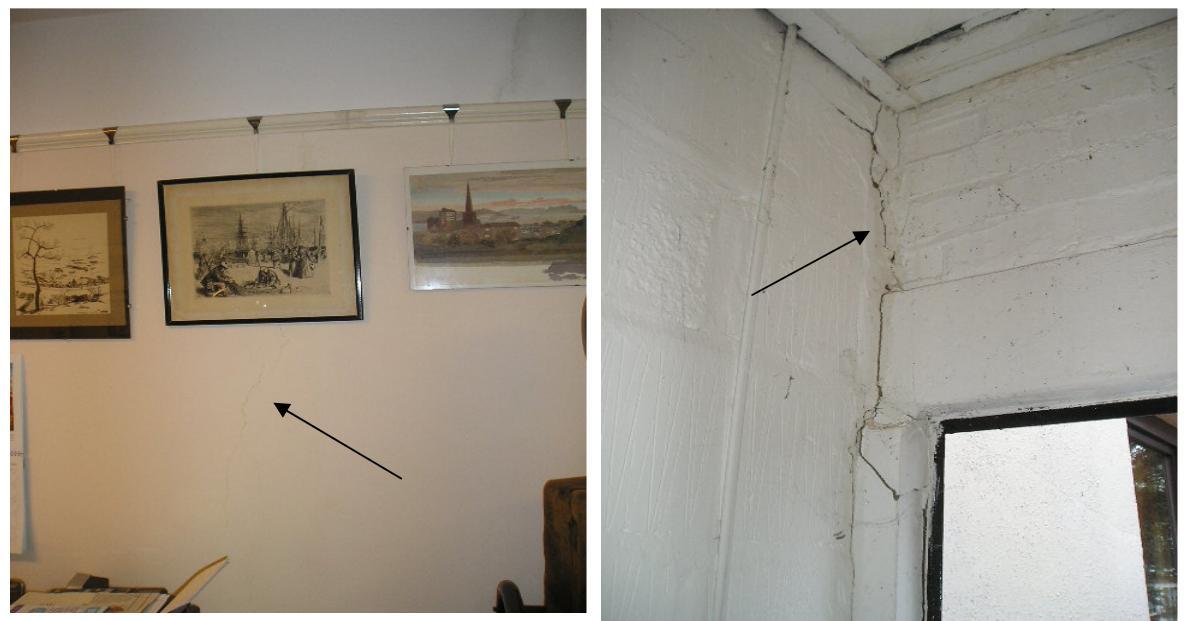
Cracking in Study

Cracking in workshop

Study - 1mm vertical tapering crack to garage partition, cracking to ceiling, 3mm vertical crack to entrance hall partition junction, evidence of previous flat roof leaks in front corners, 1mm vertical crack to front right hand corner.

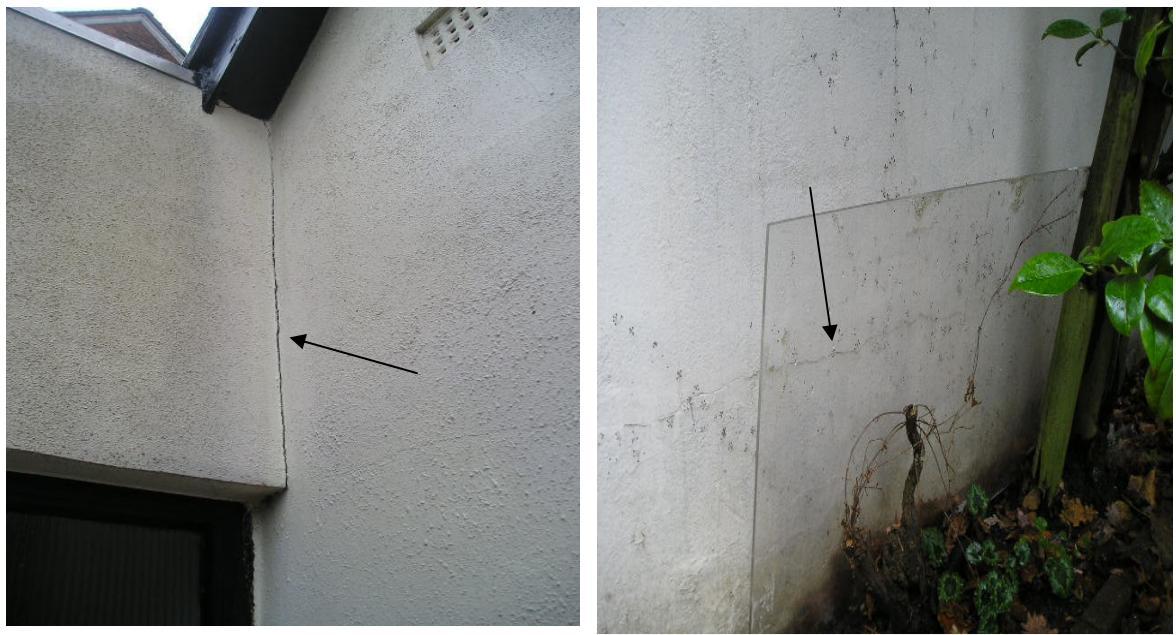
Cracking at workshop junction

Cracking to front elevation

Front Elevation - 1mm horizontal crack along dpc level.

Workshop Addition - 3mm vertical tapering separation at junction with main house.

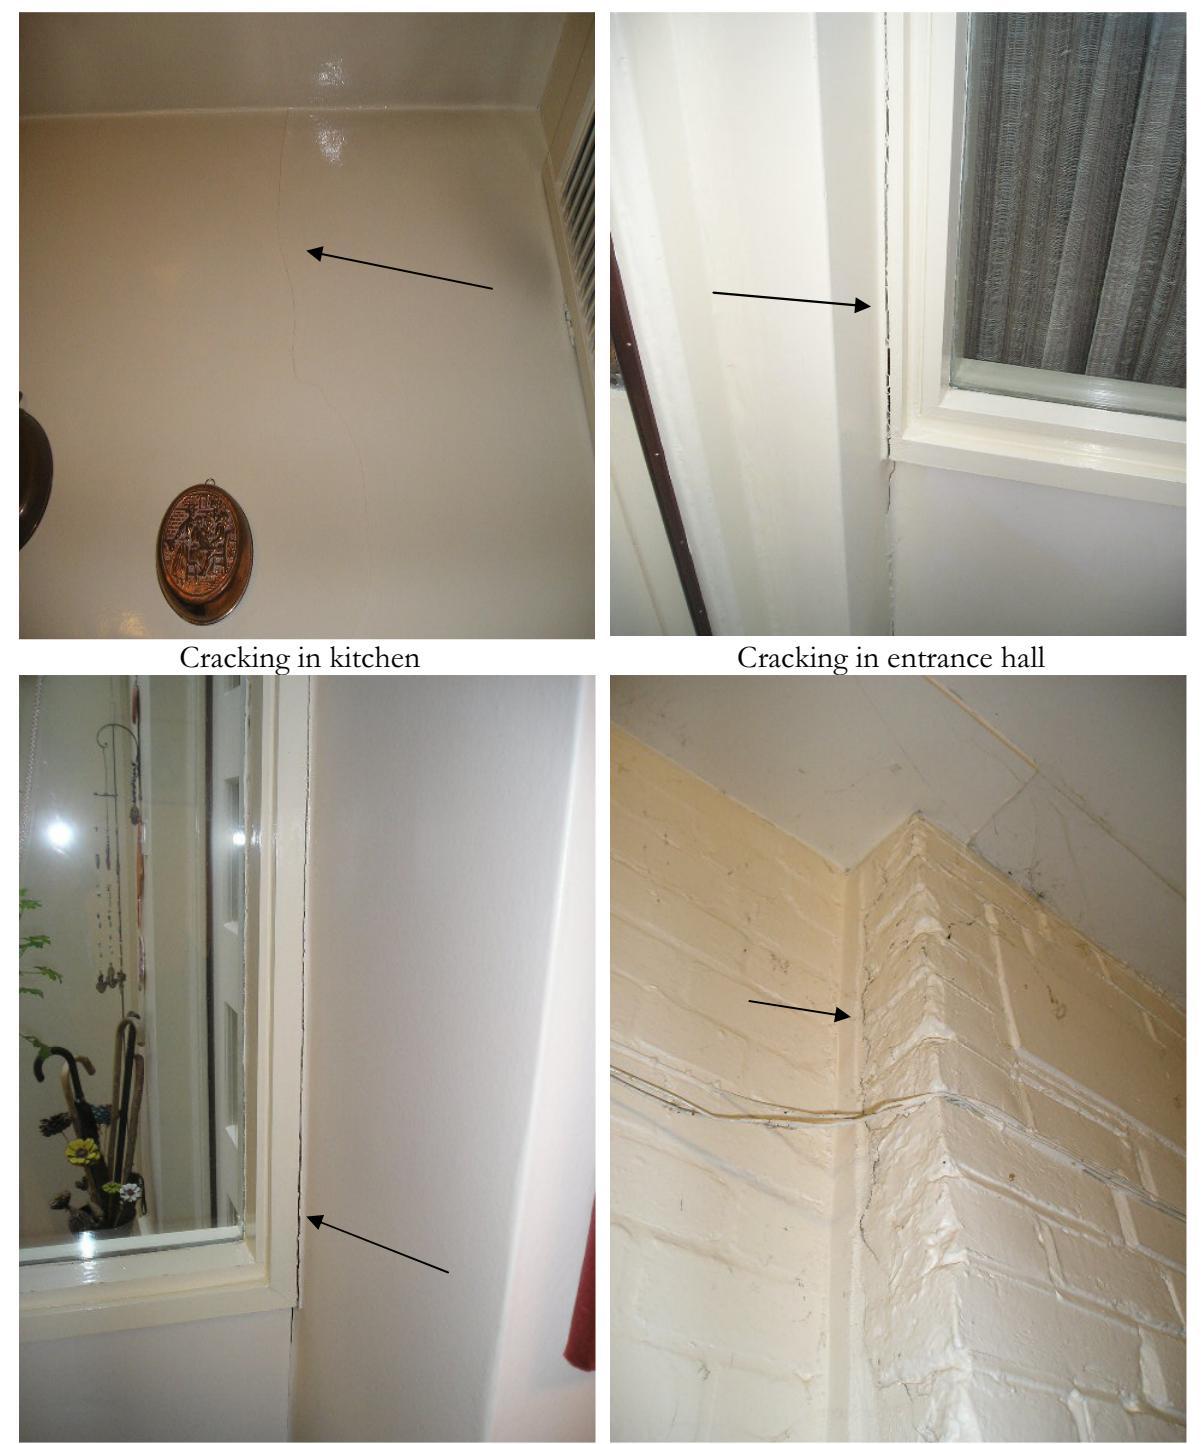
Garage - 2mm vertical crack to left hand wall at junction, historic cracking to ceiling boards.

Cracking in study

Cracking in garage

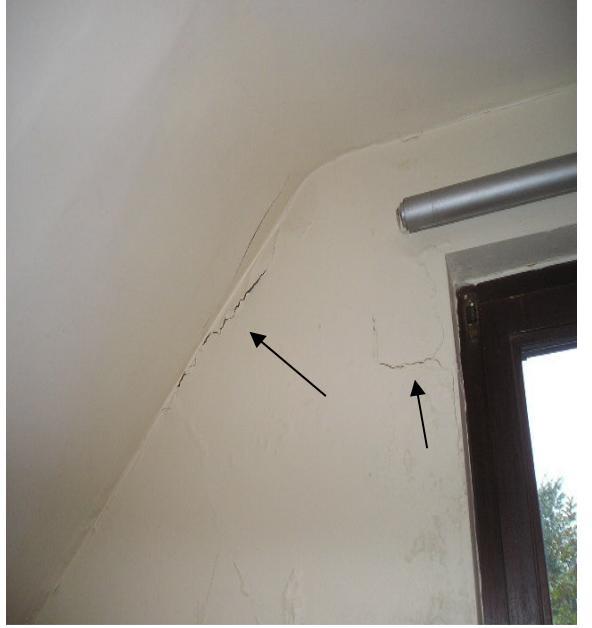
Front Bedroom - Wall / ceiling junction cracking along front wall, damp problem to front wall from parapet area.

Cracking in front bedroom

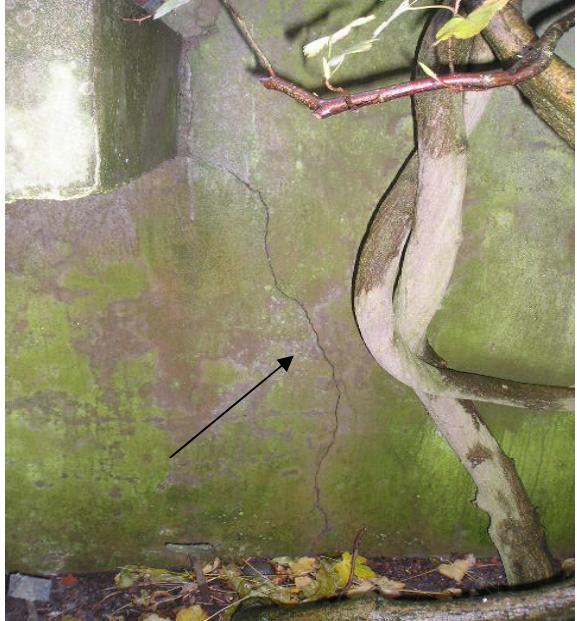
Left Hand Flank - 2mm vertical crack to rear corner at terrace junction.

Cracking to left hand flank at terrace junction

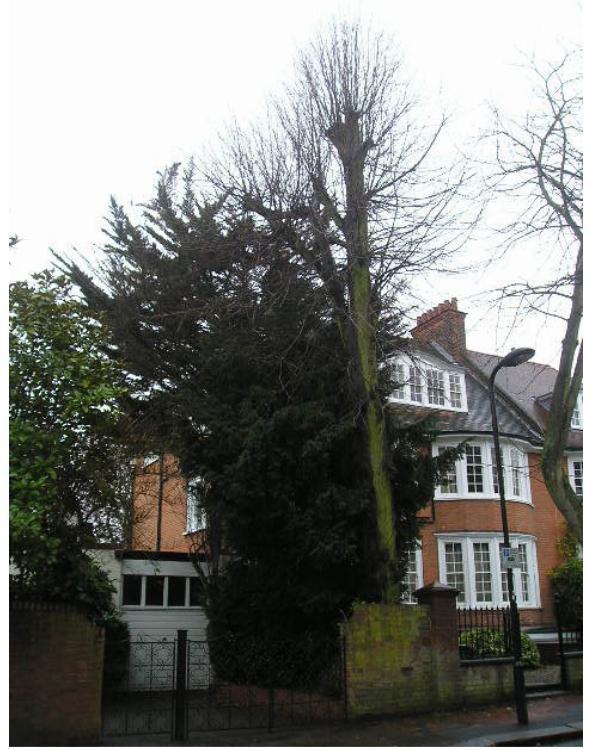
The timing of the event, the presence of shrinkable clay beneath the foundations and the proximity of vegetation where there is damage indicates the shrinkage to be root induced. This is a commonly encountered problem and probably accounts for around 70% of subsidence claims notified to insurers.

View of insured's vegetation to front of property

Although the cause of the movement needs to be dealt with, we note that some of the vegetation is subject to a Preservation Order. Unfortunately, current legislation requires certain investigations to be carried out to support an application for the tree works.

Typically, these investigations would involve trial pit(s) to determine the depth and type of footings, boreholes to determine the nature of the subsoil/influence of any roots and monitoring to establish the rate and pattern of movement. The monitoring data provided must be sufficient to show a pattern of movement consistent with the influence of the vegetation and therefore it may be necessary to carry out the monitoring for up to a 12 month period.

It will also be necessary to obtain a specialist Arboricultural Report.
