March 2015
CBA10274 v1

ARBORICULTURAL DEVELOPMENT STATEMENT

Site:
5-7 Lancaster Grove, London NW3

Arboricultural Implications Assessment and Method Statement

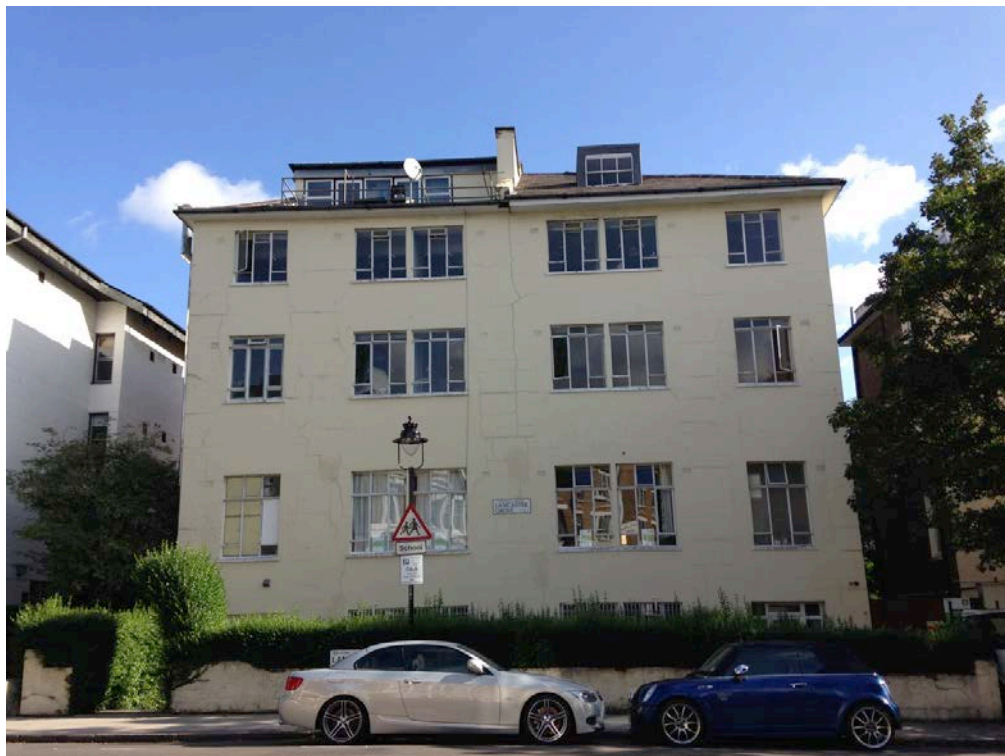
- 3.2 **Photograph 1:** A view of the existing building from Lancaster Grove

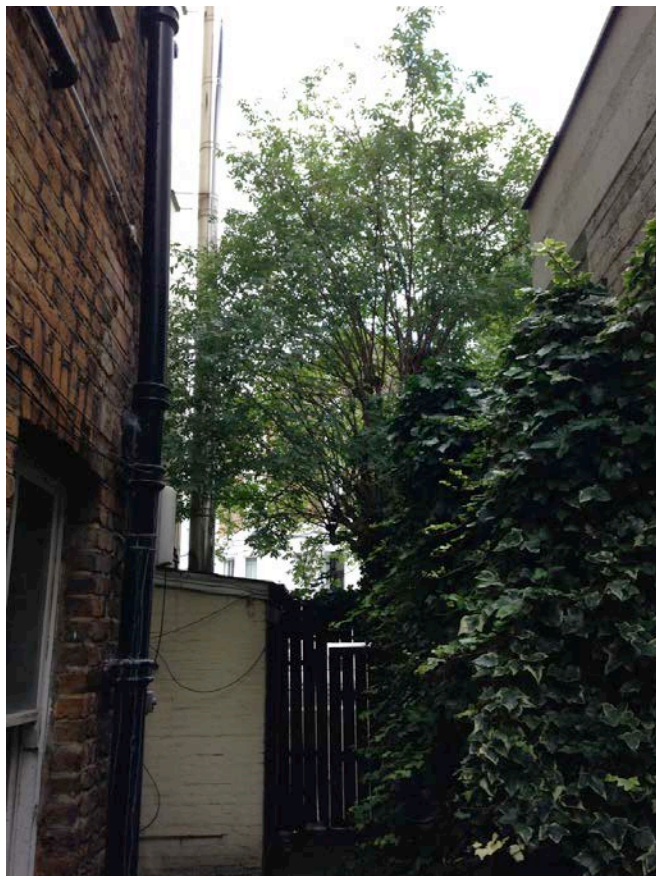
6.6 **Photograph 2:** A view of Tree 2 from the North

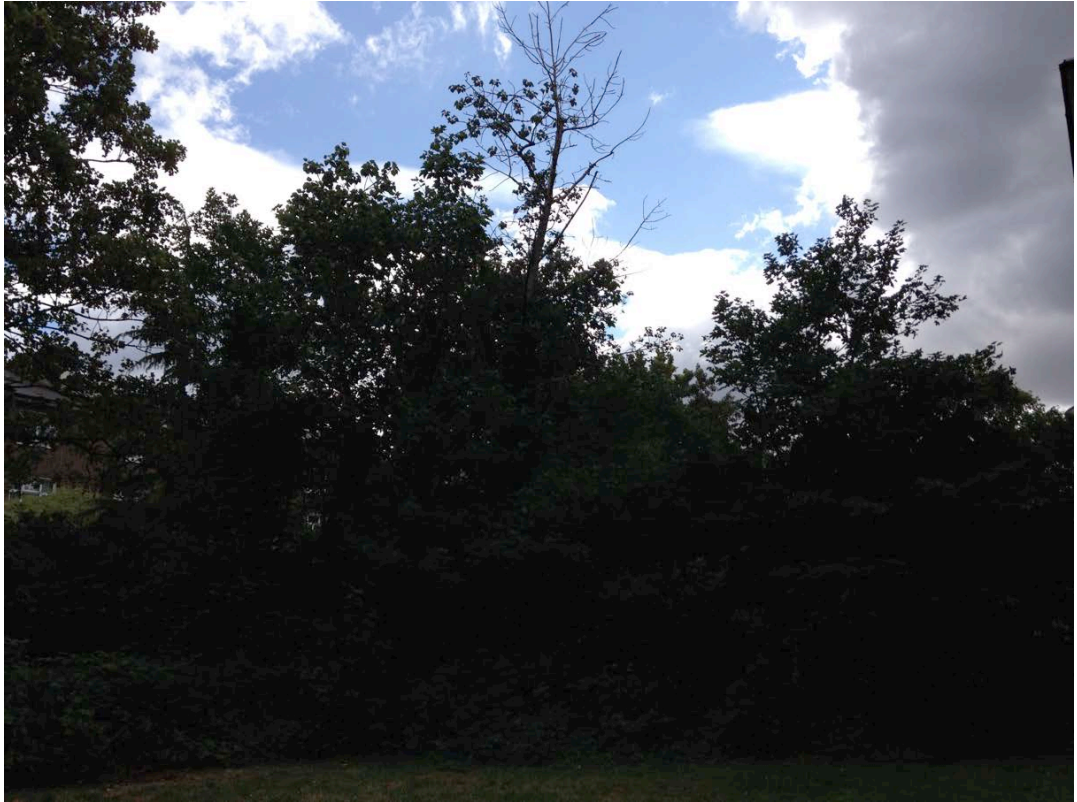
6.7 **Photograph 3:** A view of Trees 3-7 from the West

3	Sycamore <i>Acer pseudoplatanus</i>	9	S	180	15	2.2	N 3 E 4 S 5 W 3	N 3 E 3 S 3 W 3	Young	Good	Structural Condition - Fair Developing tree Crown shape distorted due to group pressure Trunk kinks at 3m above ground level	None required at time of survey	20+	C1+2
4	Hybrid Black Poplar <i>Populus x canadensis</i>	14	S	500	113	6.0	N 2 E 4 S 2 W 2	N 3 E 3 S 3 W 3	Semi-mature	Poor	Structural Condition - Poor Boundary line tree In decline Apical dieback Crown density reduced Poor quality tree	Advise removal	<10	U

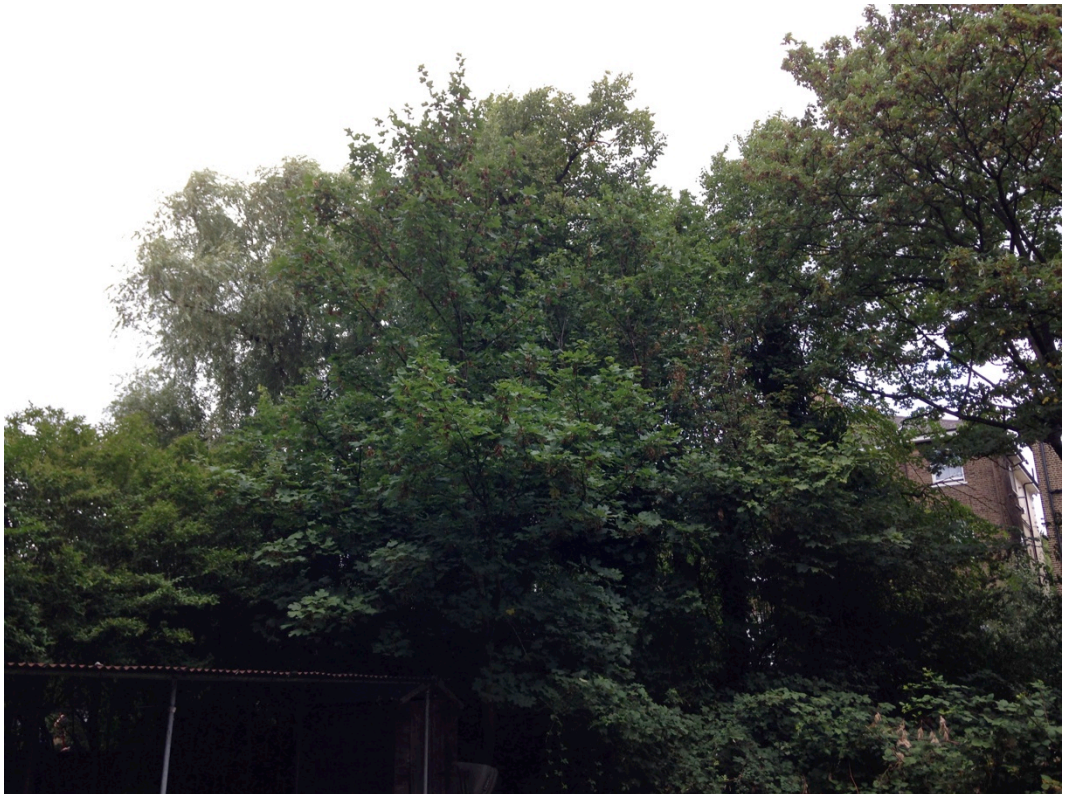
6.8 **Photograph 4:** A view of Trees 11-14 from the South

11	Sycamore <i>Acer pseudoplatanus</i>	8	S	140	9	1.7	N 0 E 2 S 4 W 1	N 0 E 2 S 2 W 2	Young	Fair	Structural Condition - Fair Developing tree Suppressed and stunted Poor quality tree	None required at time of survey	10+	C1+2
12	Sycamore <i>Acer pseudoplatanus</i>	8	S	140	9	1.7	N 0 E 1 S 2 W 1	N 0 E 4 S 4 W 4	Young	Fair	Structural Condition - Fair Developing tree Suppressed and stunted Ivy on trunk Self set tree	None required at time of survey	10+	C1+2
13	Sycamore <i>Acer pseudoplatanus</i>	10	S	210	20	2.5	N 1 E 5 S 4 W 3	N 3 E 3 S 3 W 3	Semi-mature	Fair	Structural Condition - Fair Ivy on trunk and in crown Crown shape distorted due to group pressure Poor quality tree Of limited value	None required at time of survey	10+	C1+2
