BS5837 Arboricultural Impact Assessment

27 College Crescent, London, NW3 5LH

Job Reference: 02306Rv2

May 2015

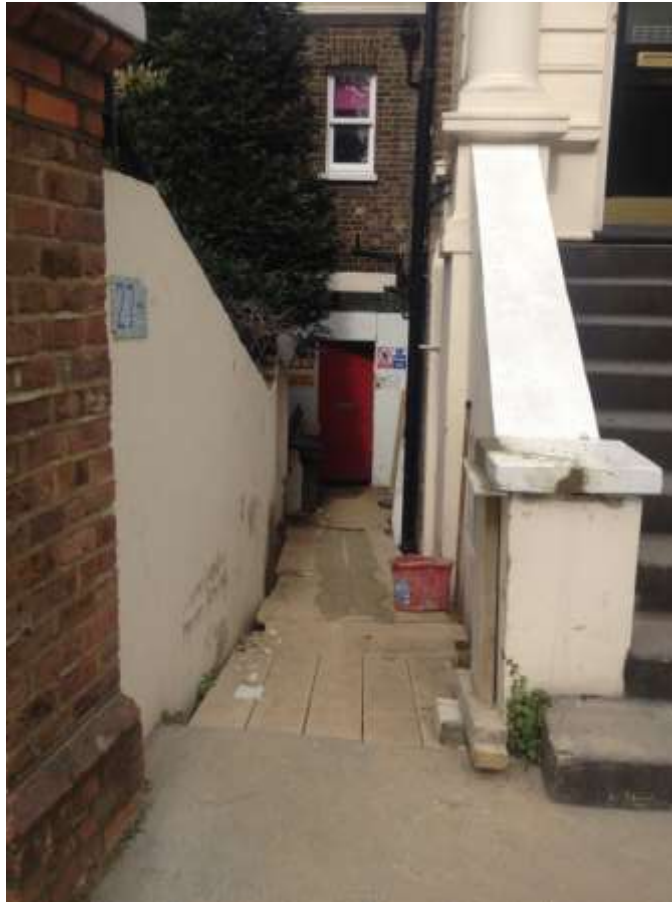
Image 1 – Pedestrian access point. No heavy machinery can or will be brought on site.

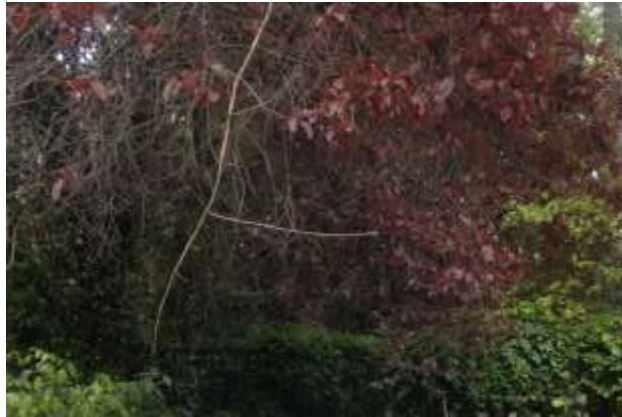
Image 2 – T1 showing overhanging branches

Tree No.	Species	Proposed Tree Works	BS Cat
T1	Purple Leaf Plum	Crown lift overhanging branches to 2.5/3m. All works to accord with BS3998	C1
T3	Cherry	Cut back branches to create 1m clearance. All works to accord with BS3998	C1

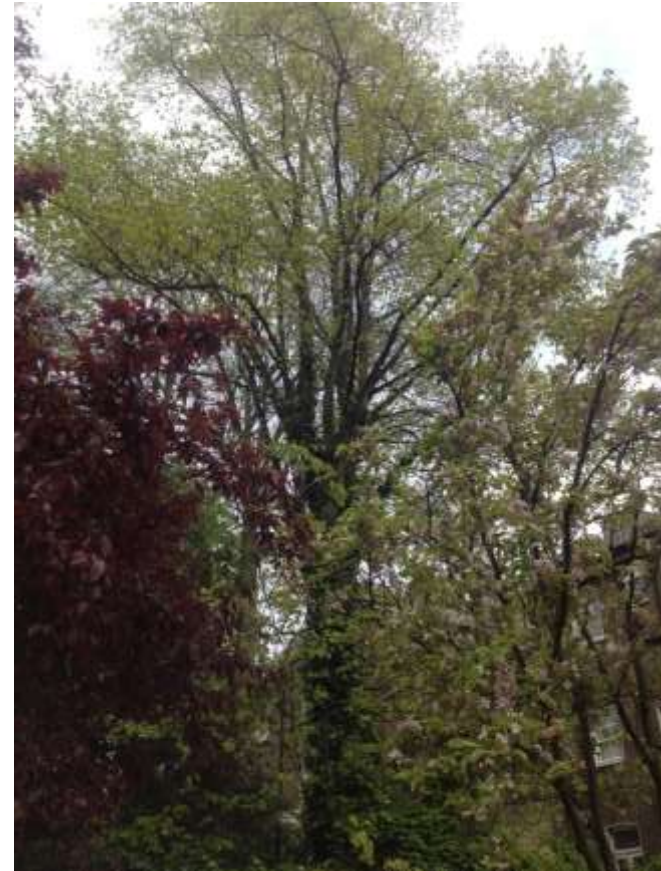
Image 3 – T2 (Lime)

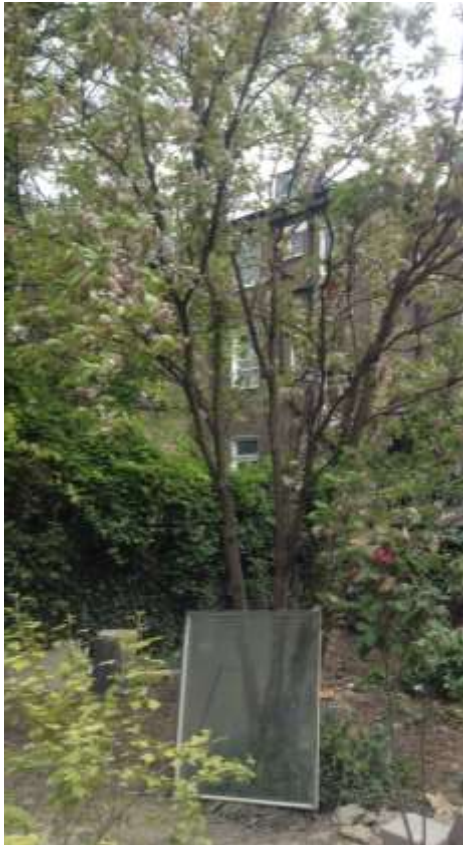
Image 4 – T3 (Cherry)

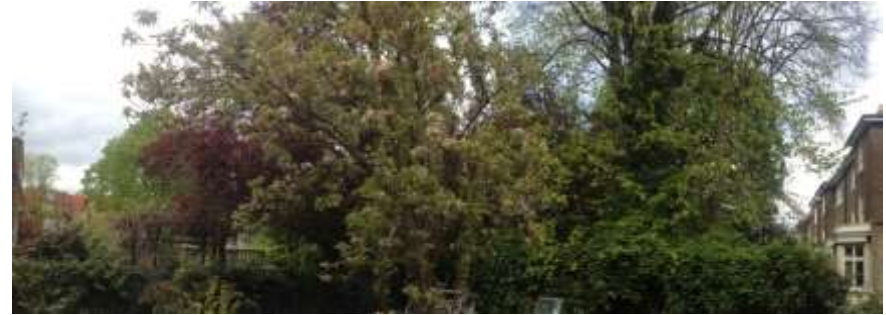
Image 5 – Rear garden
