Tree Survey and Impact Assessment

Centre Heights

ARBORICULTURAL IMPACT ASSESSMENT REPORT:

Centre Heights 139-150 Finchley Road London NW3 6JG

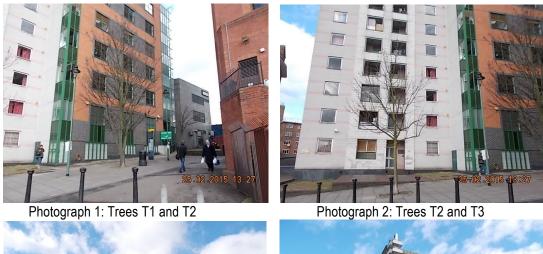
Photograph 3: Tree T4

- 3.2.4 Full details of the surveyed trees can be found in Appendix 1 of this report.
 3.2.5 There are recommended works to fell the category U tree T5, in addition to Category U tree T6 (third party tree). There are also recommendations for further investigation of the basal cavity in T4. These are listed in Appendix 2.
- 3.3 Planning Status

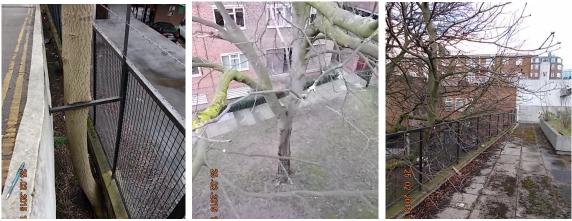
- 1.3 There are no RPA encroachments from the proposals. The proposals though will affect the aerial parts of two category U trees, T5 and T6. The recent survey has confirmed that both trees should be removed on the grounds of sound husbandry, independent of the proposals; the on-site tree, T5, is a self-sown tree of heaven that is unsuited to the position (growing in and grafted into small gap between ramp and wall). The off-site tree, T6, is irremediably cankered and leaning with a life expectancy of less than 10 years, and should therefore be removed and replaced in the short term. However, the tree is prominent within the housing site and was considered to provide a significant level of visual amenity for local residents in previous correspondence. It is therefore proposed that the fate of this diseased tree be set-aside / bracketed off from the considerations of this application, since largely immaterial to it. Instead, the existing crown spread overhanging the car park could be cut back to the legal boundary, with some further allowance made for working space for construction (scaffolding etc); a reduction in radial spread of circa 2 metres would be appropriate. NB it is entirely up to the third-party owners what they do with their tree, nor is it of any significance either way to the applicant, but it is important I discharge my duty to make prudent recommendations, including felling and replacement where appropriate. Therefore such professional recommendations remain in my report.

Photo 5: Category U tree T5

Photo 6: Category U tree T6

6.3.2 The immediate canopy encroachment can be avoided with a 2 m radial crown reduction of T6 (subject to the tree being retained).
