BS5837 Arboricultural Impact Assessment

110 Savernake Road, London, NW3 2JR

Client: **Nathalie Deacon**

Job Reference: 02311Rv2

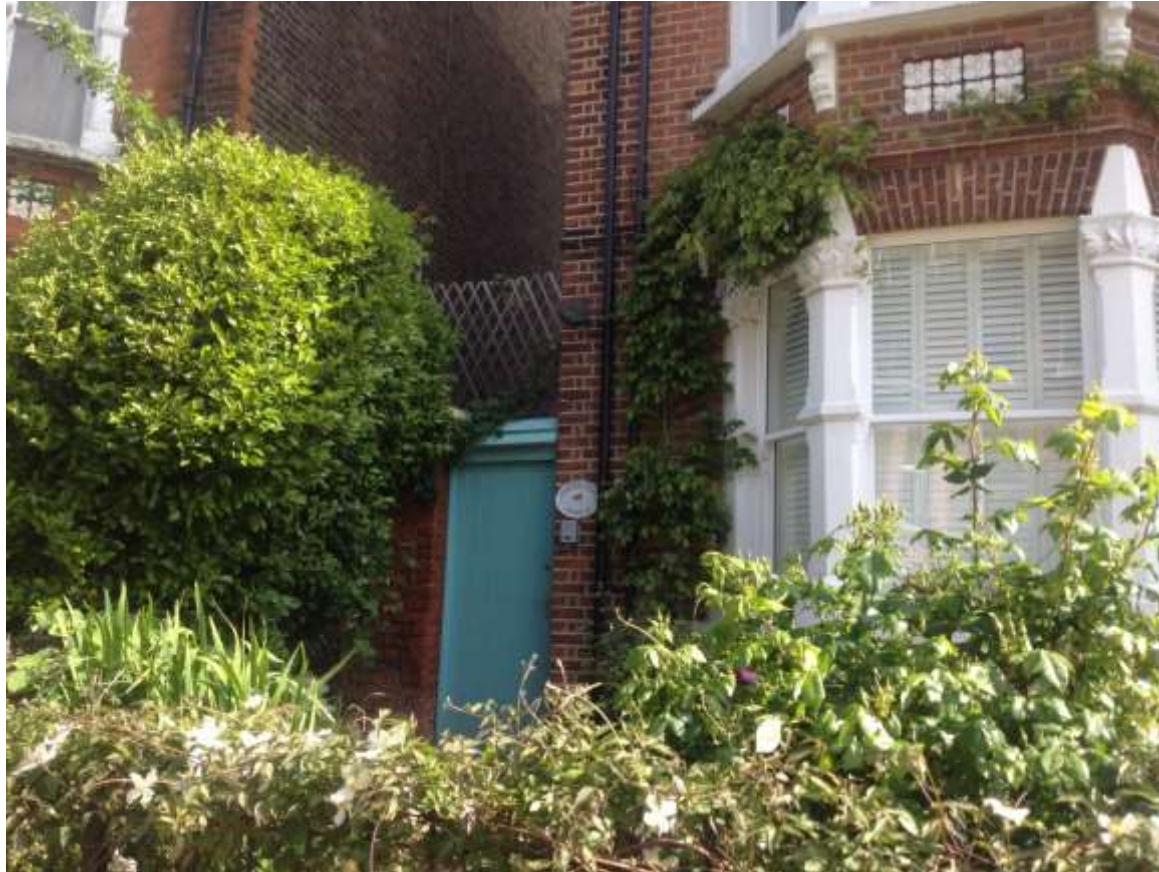
Image 1 – Pedestrian access point. No heavy machinery can or will be brought on site.

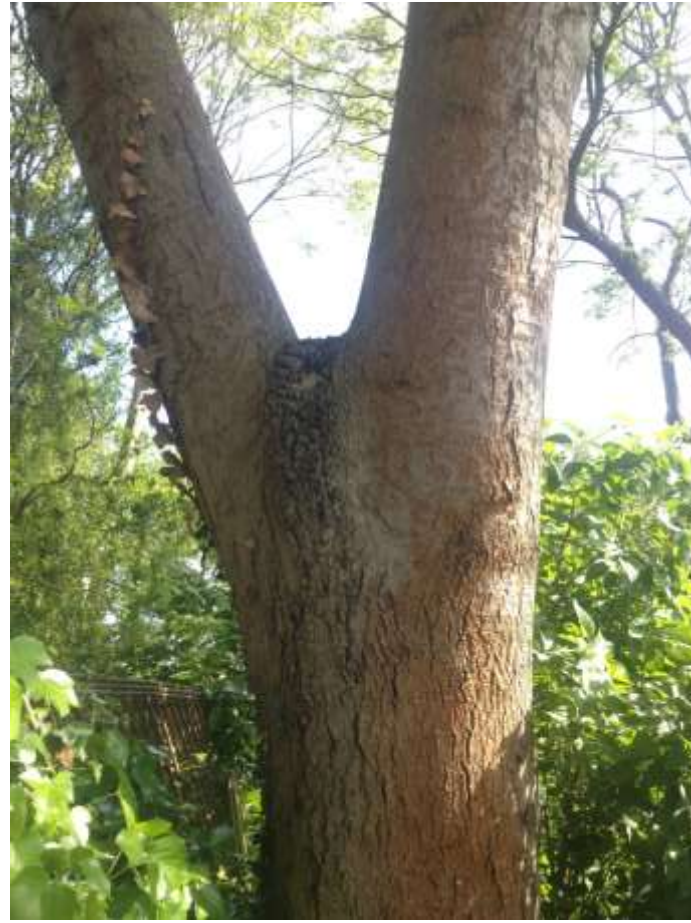
Image 3 – T1 showing V union at base of canopy

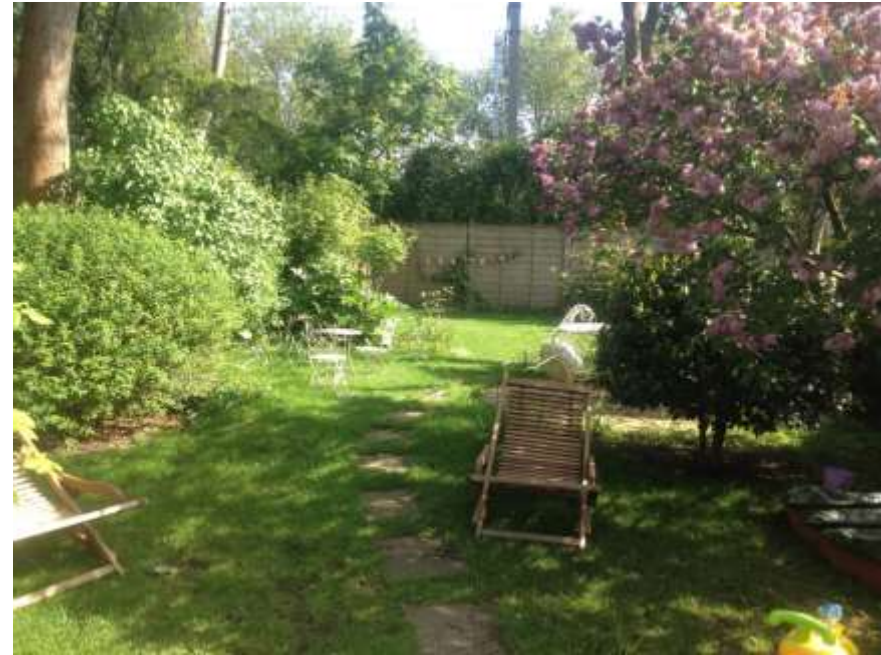
Image 5 – Image showing pedestrian access route and sufficient low branch clearance for T1.

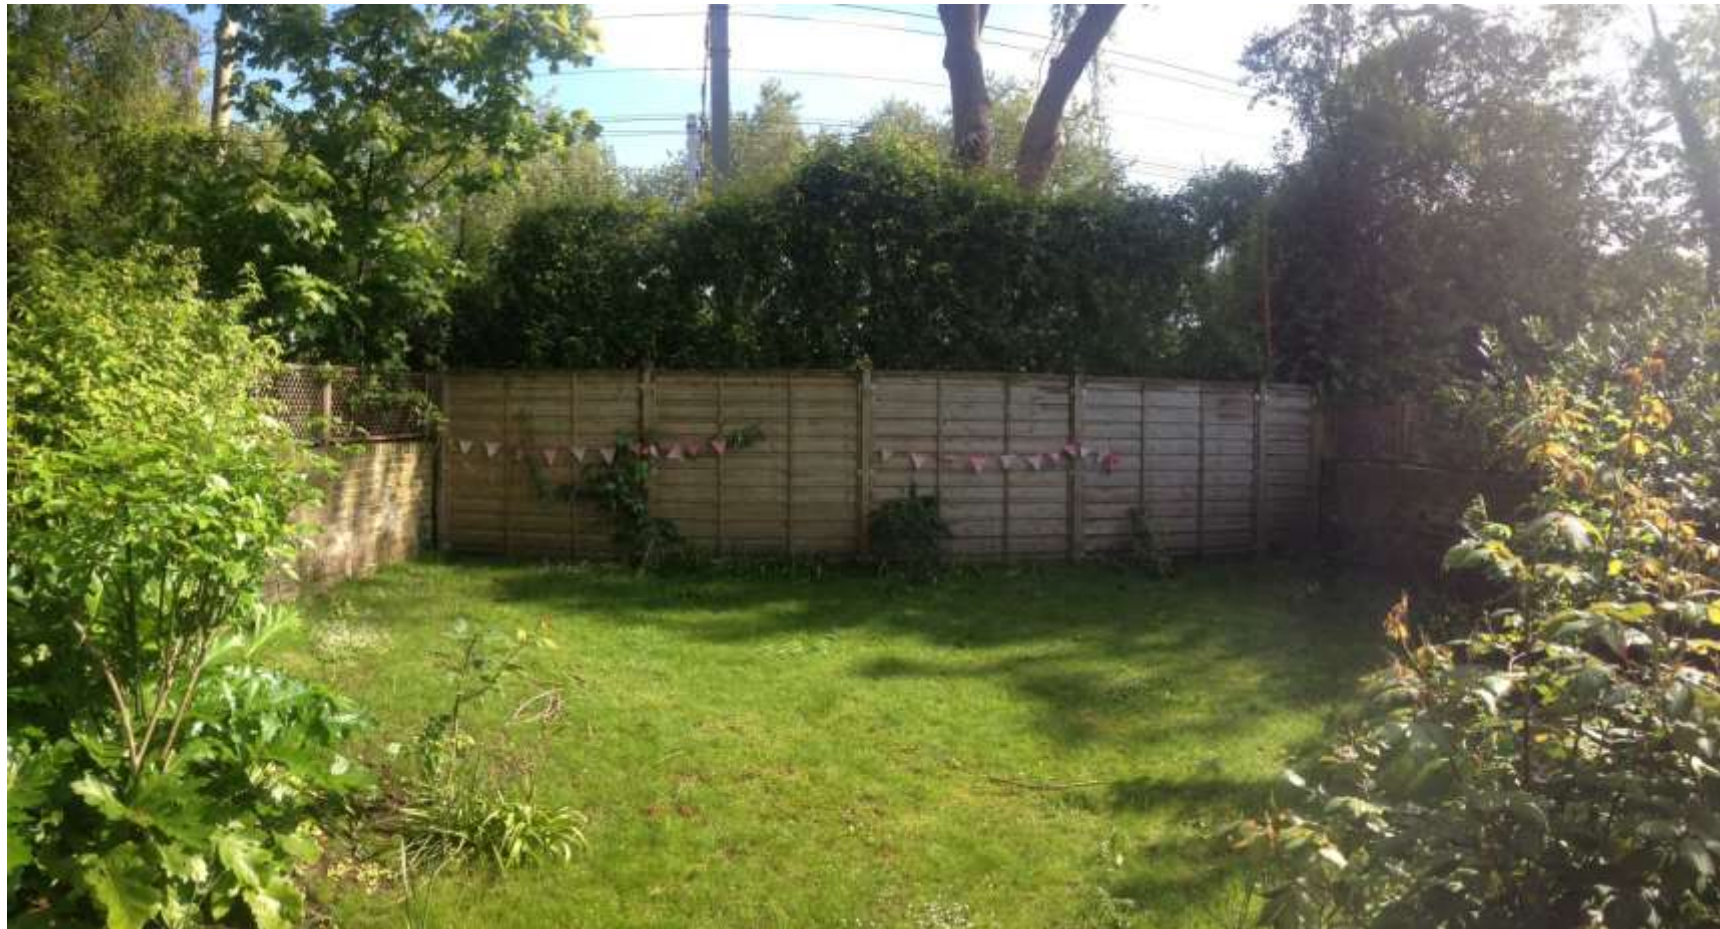
Image 6 – Rear boundary fence and stem of 3rd party tree T2 (Ash) visible to rear.
