Landmark Trees

**ARBORICULTURAL IMPACT ASSESSMENT REPORT:**

73-75 Avenue Road  
London  
NW8 6JD

**Ref:** BWR/75AVR/AIA/01a

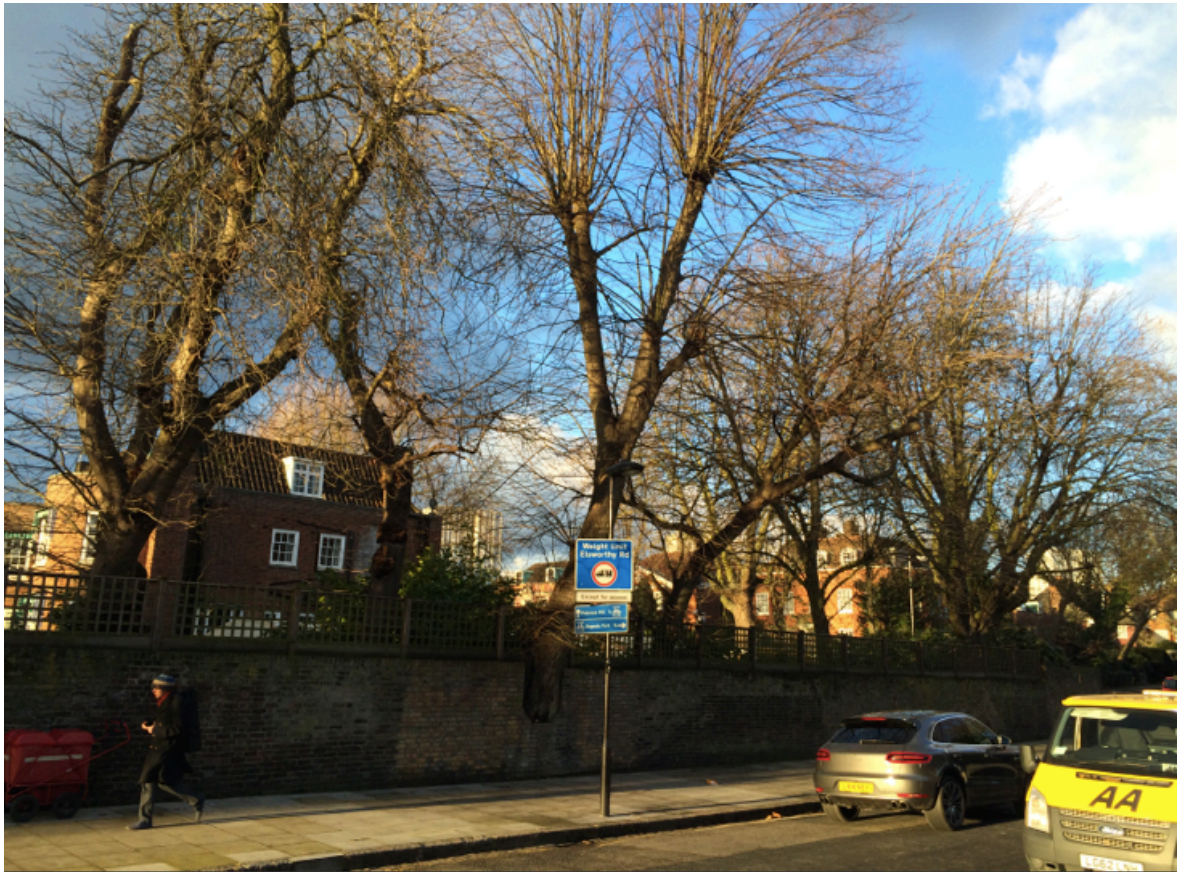
Photograph 2: Trees T18 – T24 along south eastern boundary

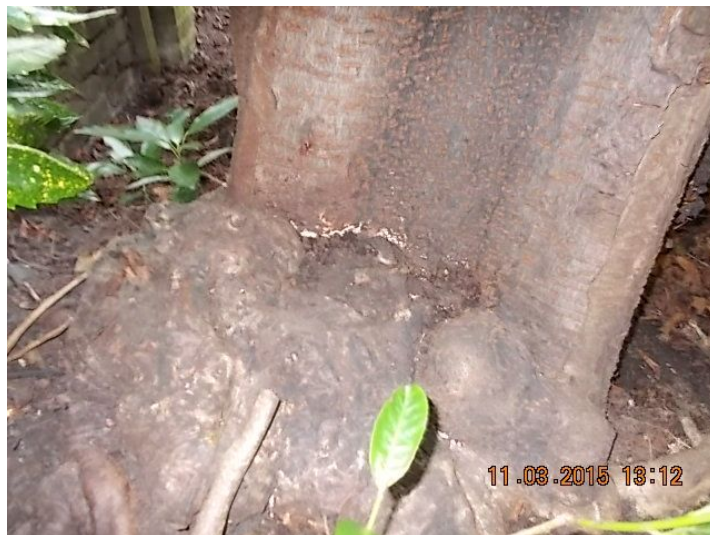
3.2.5 There are recommended works for 9 trees, including the urgent investigation of the decay on the category U tree T19 (see photograph 3 below). These works are listed in Appendix 2.

Photograph 3: Decay on T19

18	Chestnut, Indian Horse	C	14	4.0	4634	FInv Climbing inspection	Branches extend over road significantly Canker & decay through crown Cankered limb over road recently reduced Recommended husbandry 2
19	Chestnut, Indian Horse	U	15	6.0	6422	FInv Likely to be felled given the presence of substantial decay in the graft union at the base of the tree	Canker on main trunk Honey fungus at base / graft Blunt probe penetrates 100mm through graft union Recommended husbandry 1

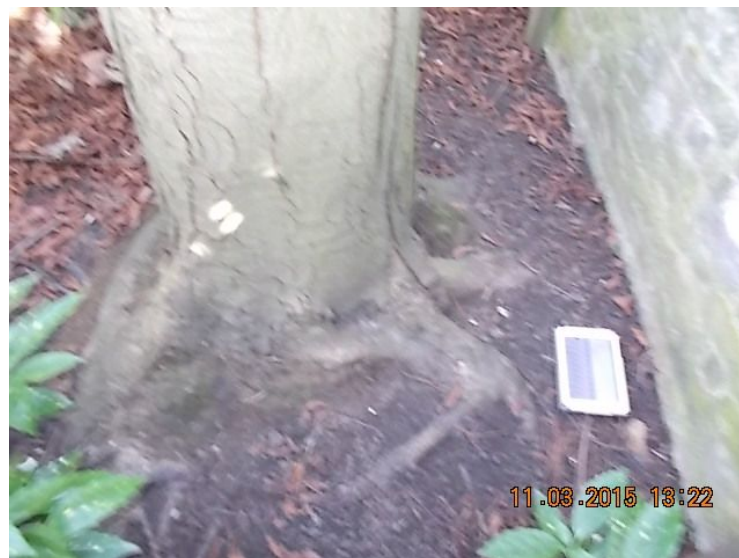
Photograph 4: Stem of T22 illustrating pattern of buttressing

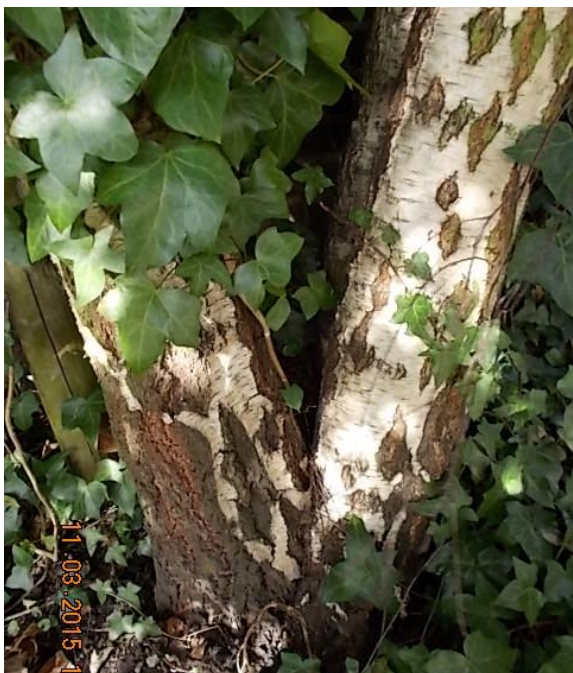
Photograph 5: Co-dominant stems of T2

- 7.3 The tree that is recommended for felling has co-dominant stems and is of little individual significance, such that its loss will not affect the visual character of the area. The loss will be mitigated within the proposed landscaping scheme by Boyles and Wyre.

Tree No.	English Name	B.S. Cat	Height	Ground Clearance	Crown Spread	Recommended Works	Comments/ Reasons
2	Birch, Silver	C	10	4.5	3244	Fell	Co-dominant stems Included bark in main stem unions To facilitate development
8	Plane, London	C	23	2.5	9998	CL9m CR15% FInv No substantial branches <10m abg	Large cavity at base 50cm deep, 1.5m in height, 40cm wide. Cavity in pruning wound 6mabg w Evidence of fibre buckling  To facilitate development
22	Chestnut, Indian Horse	B	13	6.5	5534	CB Minor trimming to facilitate piling works	A tree with insignificant defects To facilitate development

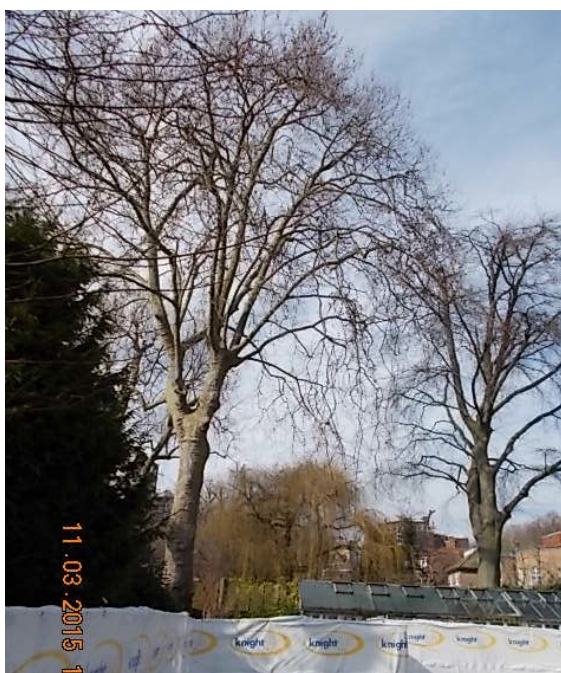
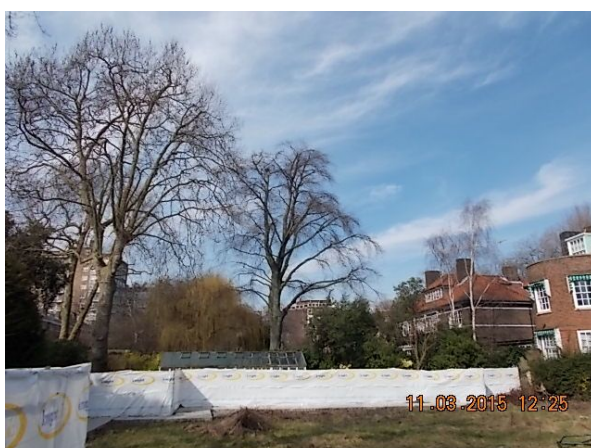
Photograph 6: Current overhanging branches of T8

Photograph 7: Current overhanging branches of T8

- 6.3.5 The immediate canopy encroachment can be avoided with minor tree works (See Appendix 3). Nuisance deposition can be mitigated with regular crown cleaning and filtration traps on the guttering (see Figure 5 below). Alternatively, elements of green roof construction might be considered, where applicable.

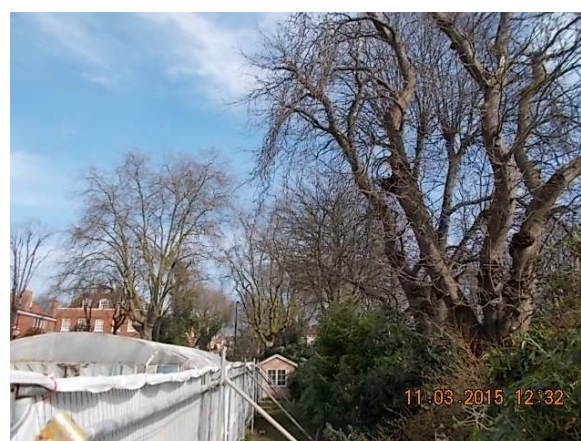
Photograph 8: Current overhanging branches of T22

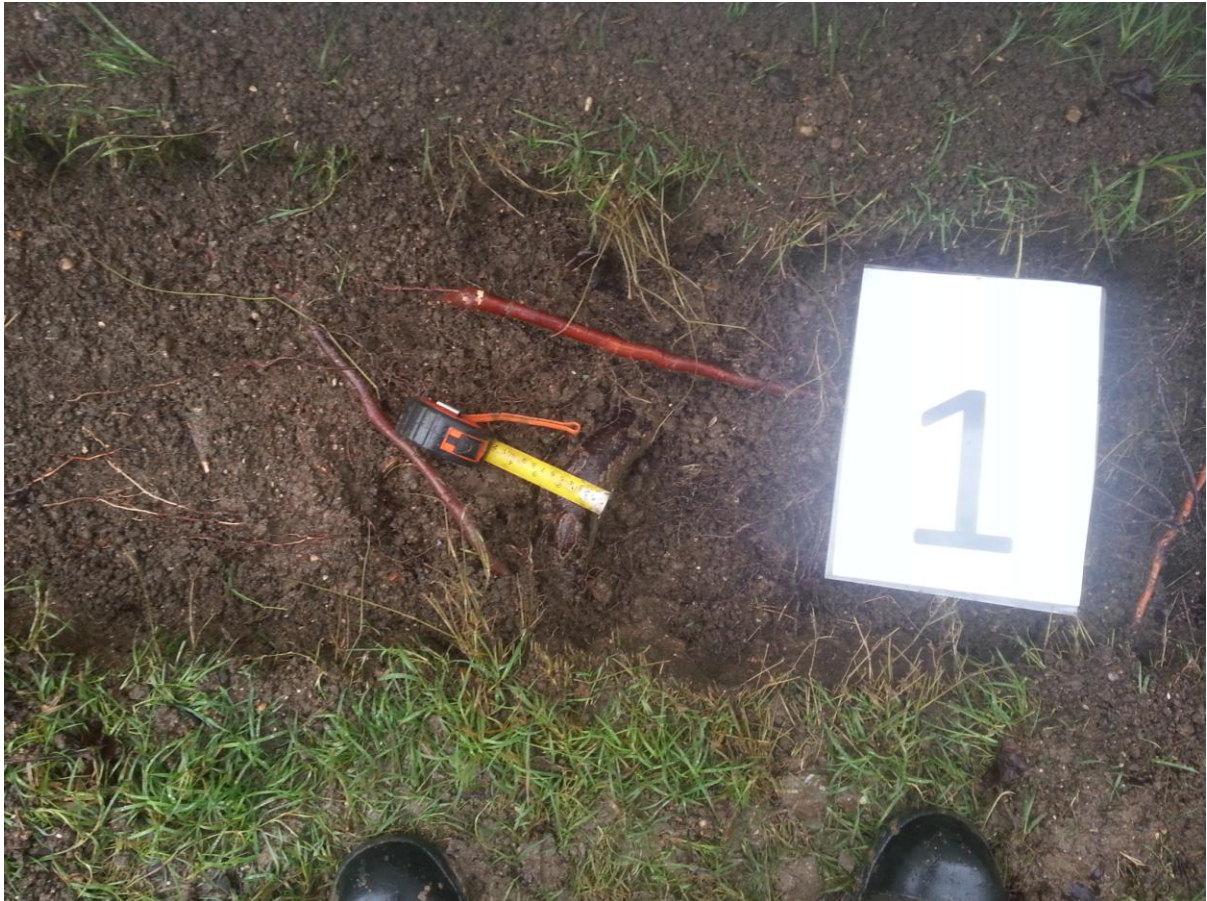
Trial Pit 1	1.5m Long, 40cm Wide, 12cm Deep. 1x60mm root Number of fibrous roots
Trial Pit 2	1.5m Long, 40cm wide 18cm Deep. 1x 50mm Root
Trial Pit 3	1.5m long, 35cm wide, 13cm Deep 1x45mm root 1x50mm root
Trial Pit 4	90cm long, 40cm wide, 12cm deep 2x30mm roots 1x25mm root
Trial Pit 5	1.5m long plot containing 2x 40mm roots, Chased this back into the lawn to determine point that roots reduce <25mm. 2.5m out from initial plot (11m from boundary wall) roots are still 30mm in diameter.
Trial Pit 6	1.5m long, 40cm wide, 20cm deep 1x45mm root 1x30mm root
Trial Pit 7	1.5m longx1.5m long "L", 40cm wide, 70cm deep No Roots

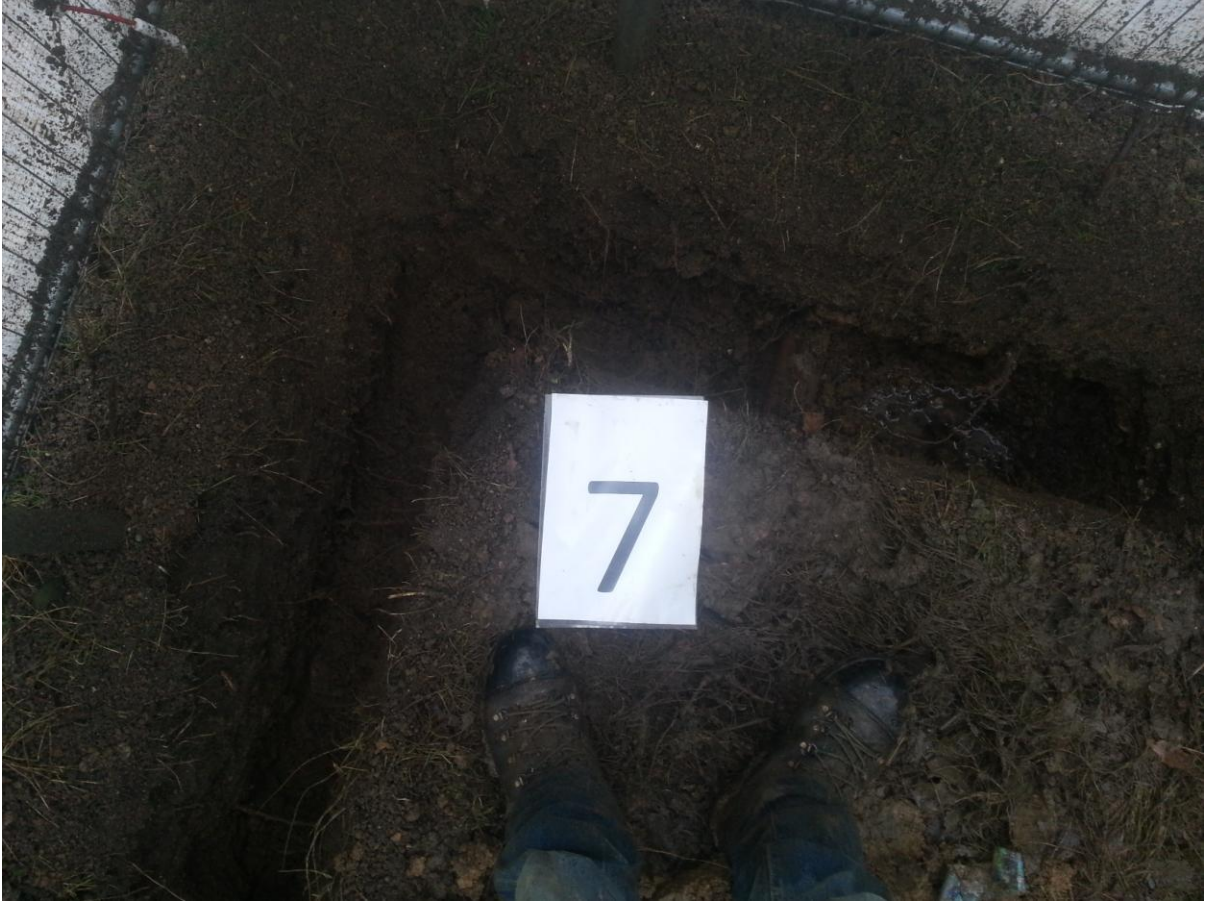
Trial Pit 7

- 4.1.4 Similarly, the trial pit 7 on the tree side of the existing TPB was inspected by both parties and agreed to contain no roots. The tree T8 has been left with a conventional RPA, since it would appear either that it is freely rooting below boundary walls (quite conceivable for the species) or its boundary hugging RPA is too eccentric to plot.
