### Method statement for cleaning and repair of existing brickwork

BAM Construction have been appointed by Argent (King's Cross) Limited (on behalf of the King's Cross Central General Partner Limited) to refurbish the Fish & Coal Offices and the ten most easterly Wharf Road Arches, known as the 'Eastern Wharf Road Arches'. To support the Planning Application we have prepared this Method Statement detailing the strategy we will adopt to clean and repair the external brickwork. We have been working with Argent at Kings Cross for several years and have completed similar work on the Granary Building complex and the East and West Transit Sheds. We have past experience of working closely with Camden Conservation officers. We understand the aspiration to retain the character of the existing buildings. This Method Statement will set out the techniques we intend to use to clean and repair the Fish & Coal Offices and Eastern Wharf Road Arches. First we will outline the Architect's brief. We will then describe the existing condition of the buildings highlighting specific issues which need attention and finally we will propose the methods we intend to use to deal with the issues presented. We

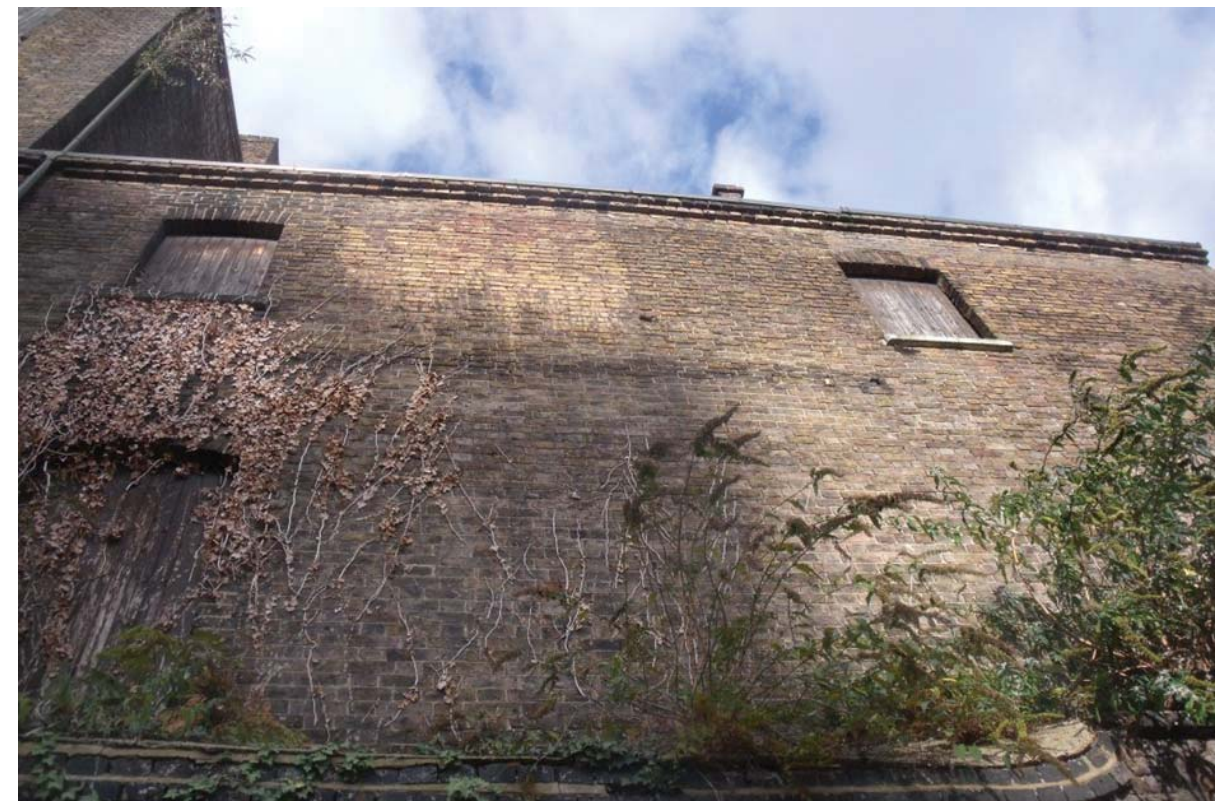
The surface of the bricks has weathered and changed over the years due to atmospheric and local conditions resulting in the build-up of carbon deposits. The distribution of these deposits is by no means uniform. Different events have created different conditions and treatment will vary depending on particular issues. These can be broken down as follows:

- General grime/pollution accumulating on the brickwork over time.
- Graffiti / paint overspill from poorly completed decoration.
- Blackened areas of brickwork caused by dirt accumulation on damp areas. There are several causes of damp, i.e. missing or faulty rainwater goods, projecting brick string courses, poorly performing flashings, etc.
- Plant and algae growth caused by either self-seeding or poorly fitted and maintained rain water goods.
- Soot/smoke damage caused by fire.
- Rendered areas of brickwork
- Patchiness caused by graffiti removal carried out in an unsympathetic manner.

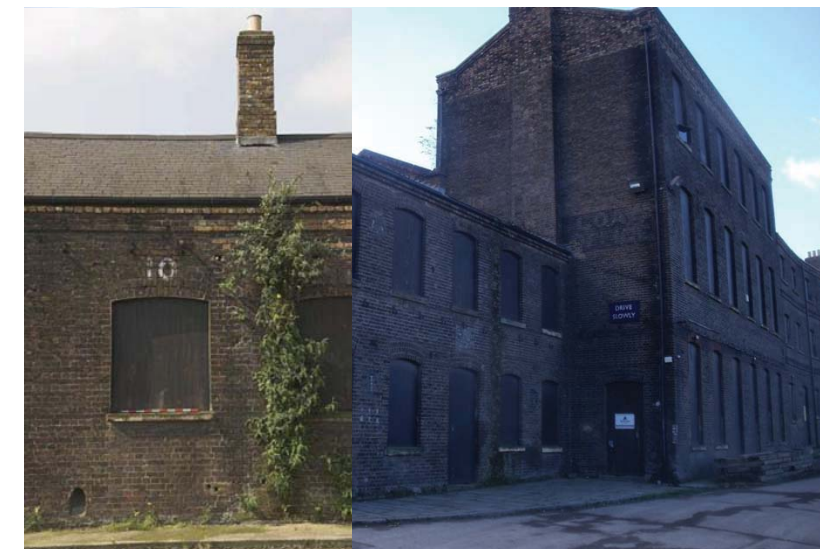
On the north and east elevation there are faint outlines of historic signage. Above the entrance door in the east gable of Block 2 the words "Coal Office" can be clearly seen.

Remains of white painted numbers also survive over several window openings, of which the number "10" is the most visible.

The painted signs are generally over window openings. It is considered the numbers and signs are best left uncovered during the refurbishment of the building. The external walls will be carefully cleaned as part of the refurbishment taking care to preserve the signage in their current condition. Scaffold will be erected around the buildings to allow access to the roof and external walls. Access routes onto the scaffold will be positioned away from bay numbers or signs as an additional protective measure. All scaffold erected to the elevations where bay numbers and signs are located will be protected with debris netting to prevent the risk of adjacent activities causing dust or splashes to contaminate the surface of the bay numbers and signs.

We will work with care when cleaning and repairing the walls to preserve the remains of these signs.
