The Honourable Society of Lincoln's Inn

Internal Bat Inspection

July 2015

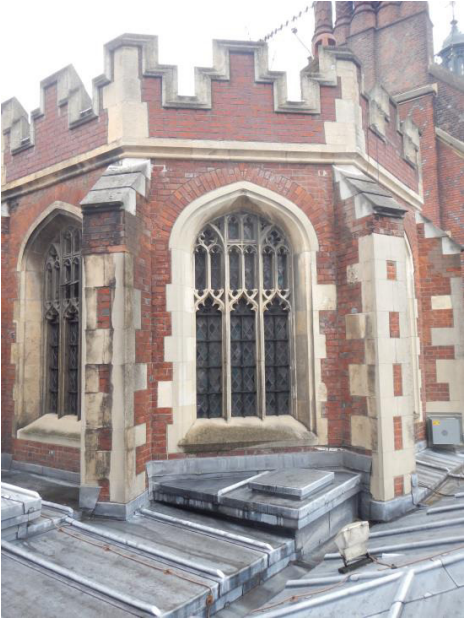
<p>PHOTO 1 The roof of the Great Hall with visible halogen lighting.</p>

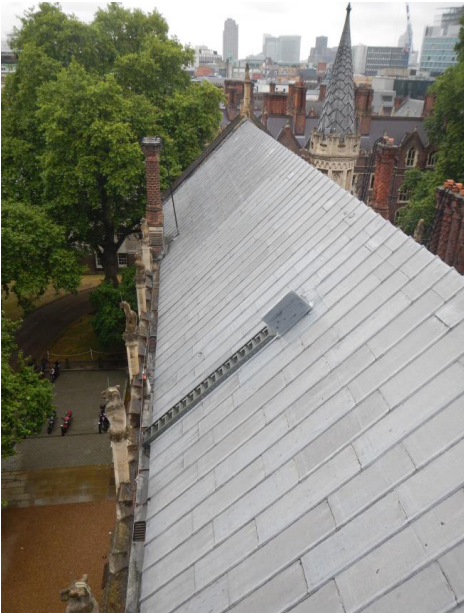
<p>PHOTO 2 The roof of the great Hall, very well maintained with no gaps or crevices.</p>

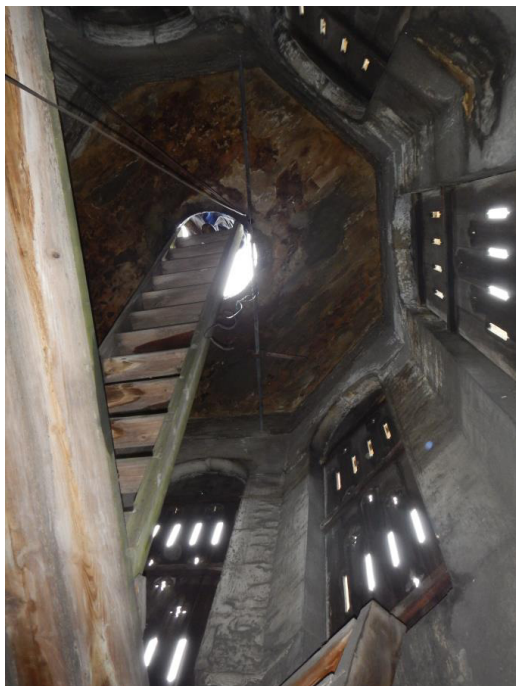
PHOTO 3

Inside one of the towers of the Great Hall. The tower was very light with no cracks, crevices or suitable roosting features.

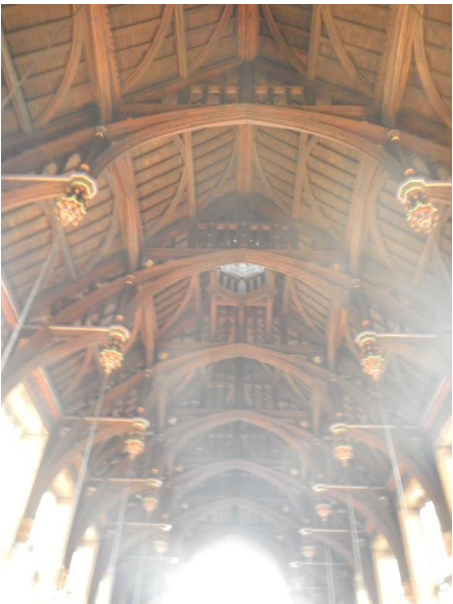
<p>PHOTO 5 Inside the Great Hall. No roof space and no access areas for bats to enter.</p>

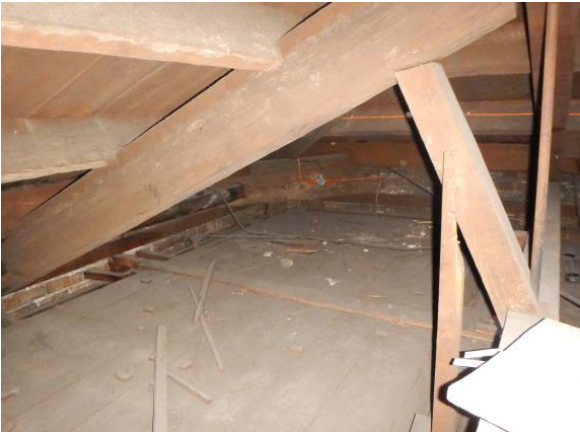
The loft space was accessed and assessed for the potential to support bats. The loft space was dry with no visible entry points. The roof was well sealed with tight slates. No signs of bats were seen (see photos in Appendix A).

<p>PHOTO 6 The roof space in The Under Treasurer's House. Very well maintained with no access points for bat entry. No signs of bats.</p>

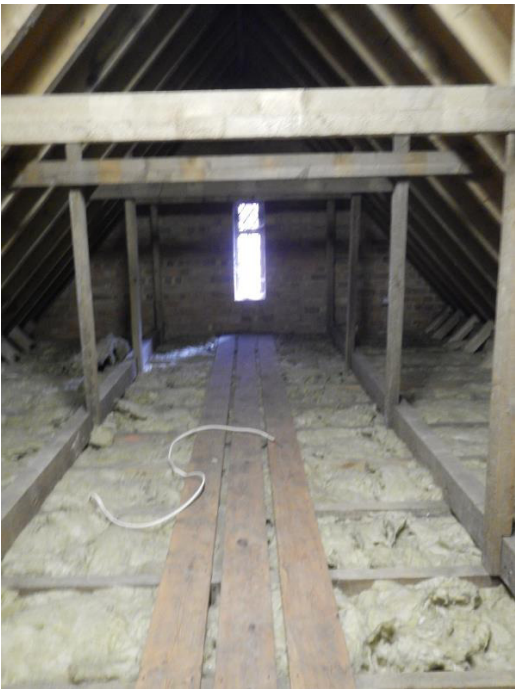
<p>PHOTO 7 The roof space within The Under Treasurer's House. No signs of bats.</p>

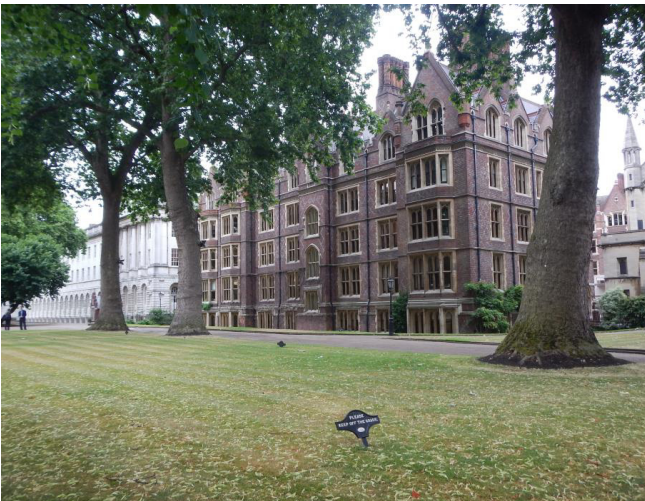
The trees were inspected in full by using tree climbing equipment and an endoscope. Only one feature was identified on the west of the tree tagged no.975. The feature, a rot hole on the branch, is situated approximately 15m above ground level. This was investigated and found to be dry to about 200mm in length. It had cobwebs over the hole showing no recent signs of use. This is unlikely to be used by bats. The trees were well lit with both up and down lighters fixed to the east side, reducing the potential for bats (see photos in Appendix A).

<p>PHOTO 8 The London Plane trees surrounding the Great Hall. Only one feature which is classified as negligible potential for bats.</p>
