## Application 2015/2795 – Additional Information

### Document purpose

### Overview

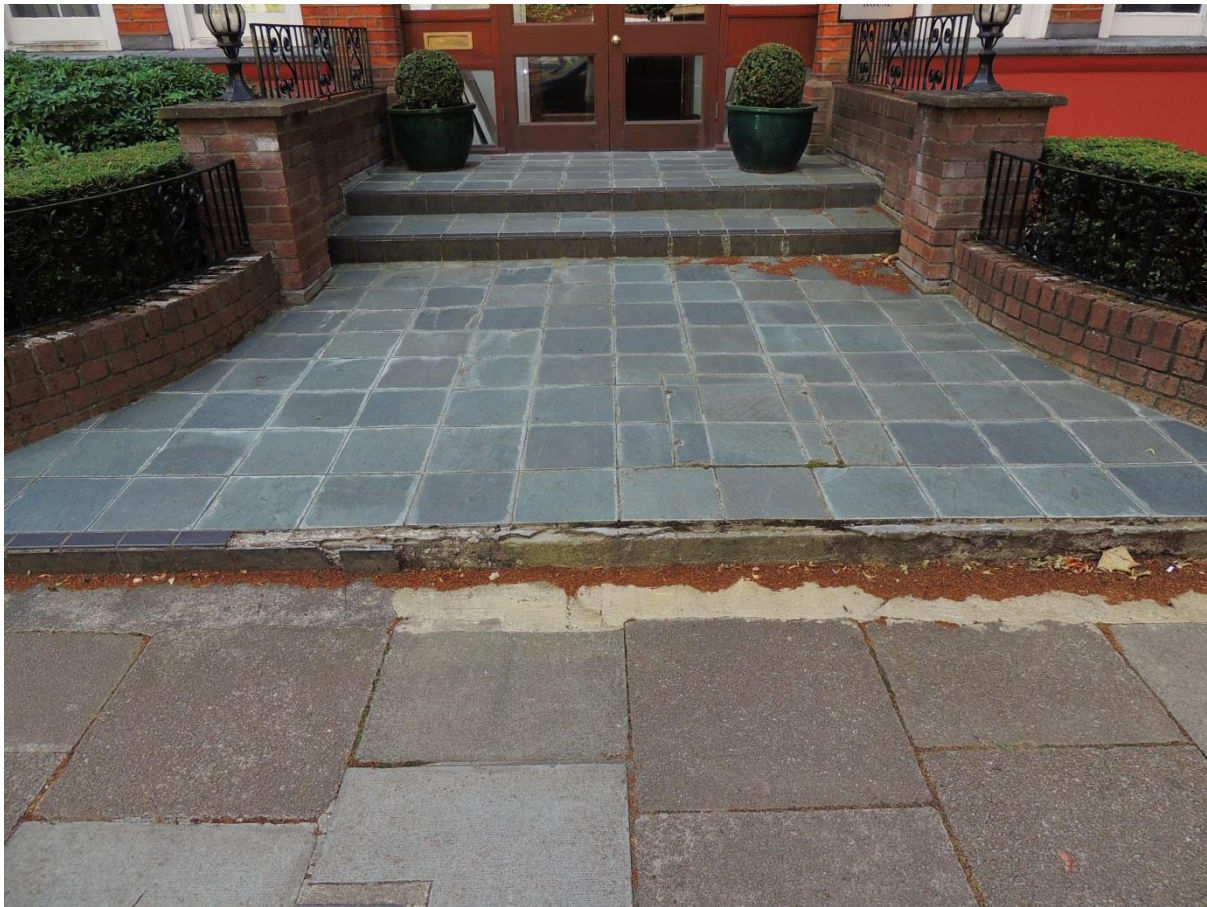
The tiles on the walkway at the front of the building need to be lifted in order to replace the damaged waterproof membrane underneath, in order to prevent further seepage into the kitchen of the lower ground floor flat below, which extends out underneath the walkway. The garden walls to the sides of the walkway may also need to be rebuilt as part of this repair work, dependent on the layout of the waterproof membrane.

Current tiles to be replaced

While these tiles are lifted, it is proposed to replace the tiles with a lighter colour – please refer to “Tile Changes” below.

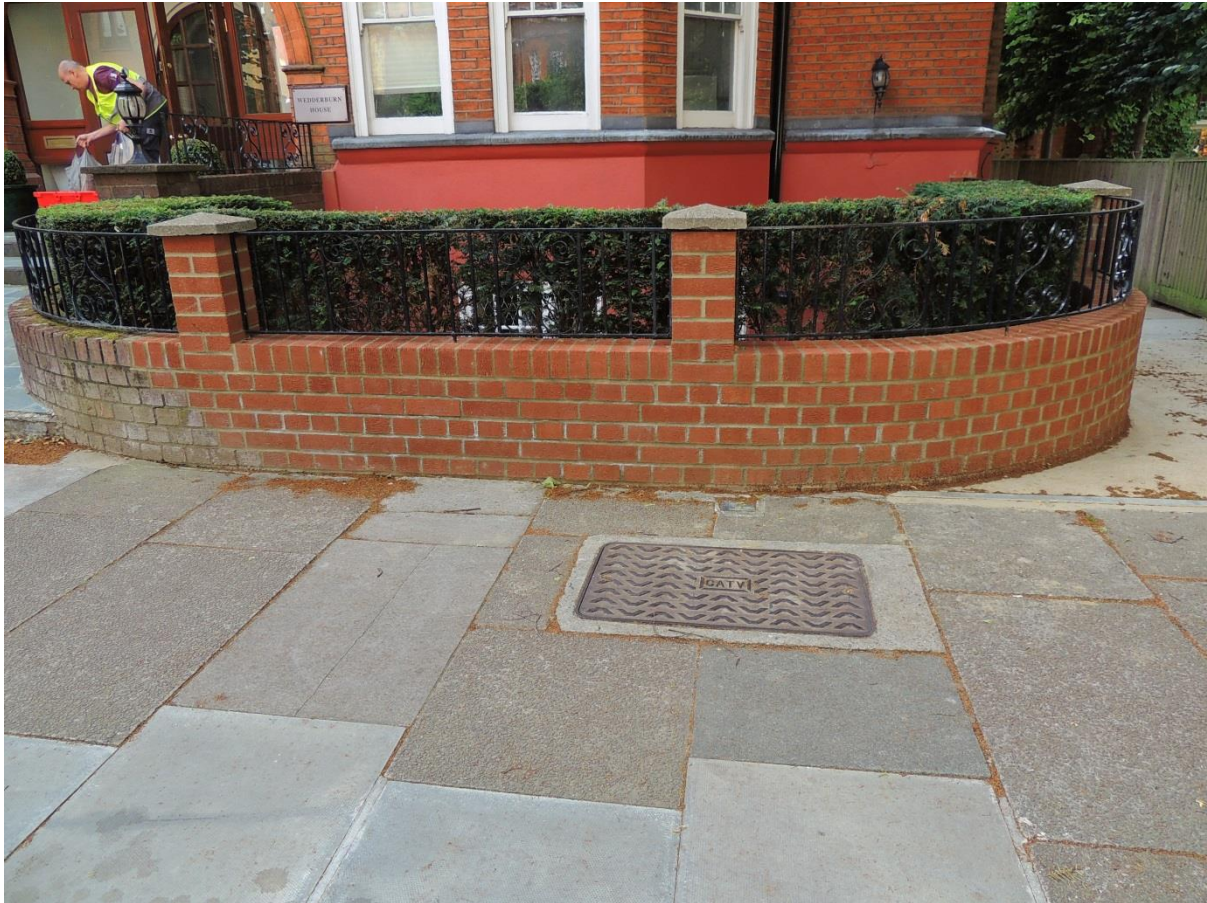
The garden walls to the front of the building have been undermined and require repair. One section of the garden wall adjoining the footpath has already been repaired, as has the lower-level wall behind it, as part of emergency works.

Repaired wall

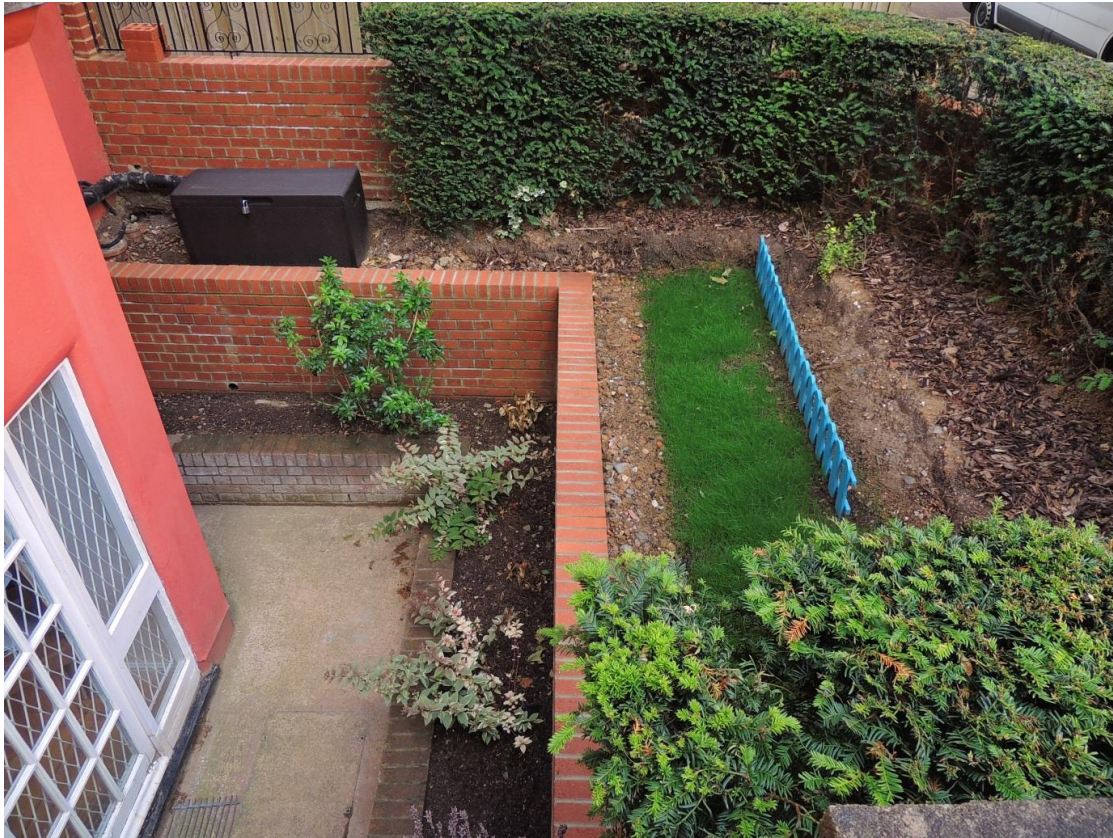
The lower-level wall has been rebuilt with a concealed concrete core, in order to sustain the forces incident on the wall. Engineers' calculations of incident loads are attached. This has not affected the outward appearance or profile of the wall. This can be seen in comparison with the remaining original wall in the picture below.

Rebuilt lower-level wall

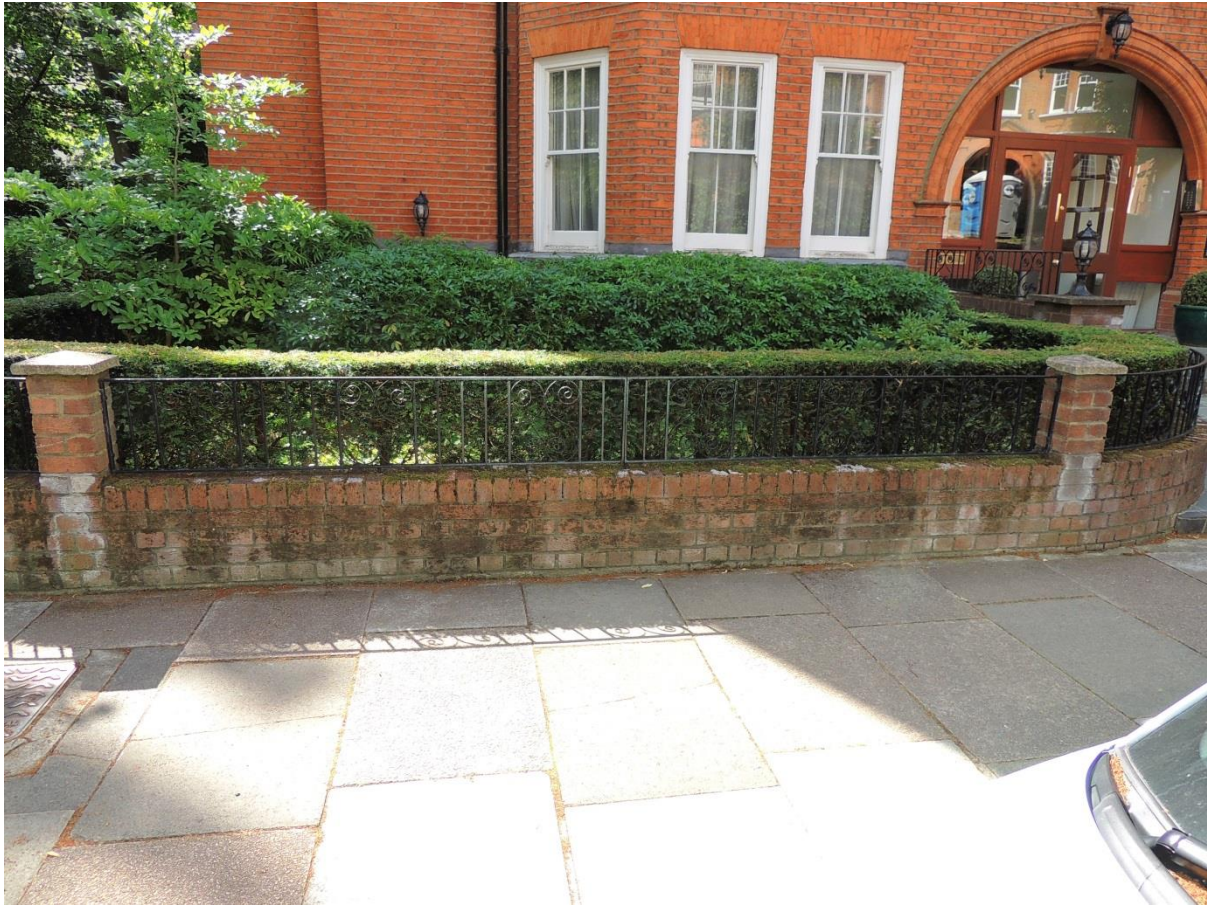
The garden wall on the left-hand side of the walkway also need to be repaired. Again, this will not change the height, profile and shape of the wall, and using bricks matching as closely as practicable to the existing, where existing bricks cannot be re-used.

Left-hand wall to be repaired

The existing iron fence panels will be removed, safely stored, and replaced after the wall repairs are complete.

The yew hedge along the outer wall will be retained, with the bushes removed and cared for during the works, then replanted after the repairs. Any bushes that die during this process will be replaced with bushes of the same size, in order to maintain the hedge.

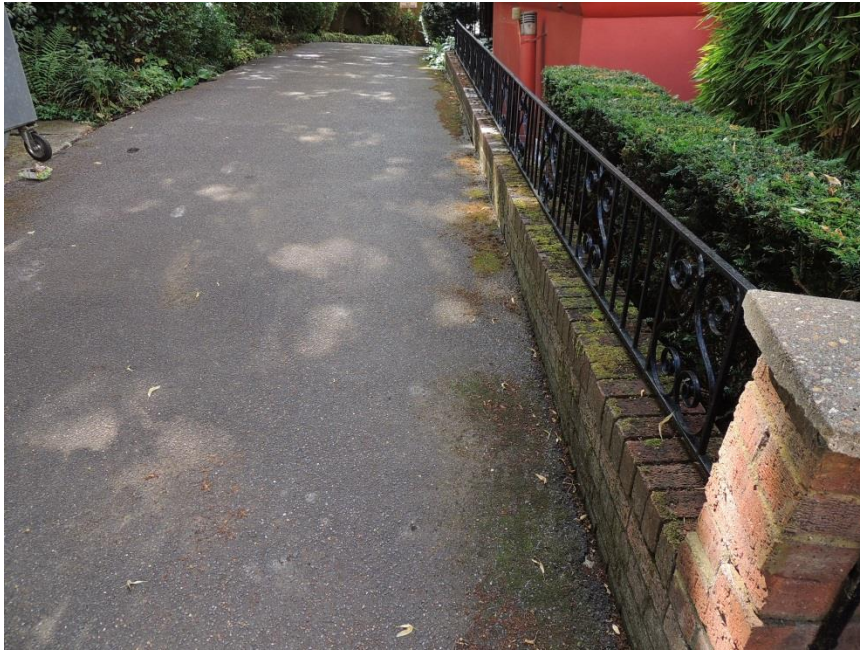
The retaining wall to the driveway runs alongside the building on the left side, with a void of approximately 1 metre between the retaining wall and the building itself. The front half of the wall varies in height from 42cm to 21cm, due to the slightly uneven pitch of the driveway. The rear half is generally 10cm (single brick height). There is a single pillar, 90cm in height.

This wall needs to be rebuilt and reinforced in order to prevent collapse, as it has already separated from the driveway. As the wall is separate from the main building, the retaining wall takes the entire weight of the driveway. According to the attached engineer's report, the current wall construction is not suitable to withstand the loads incident on it in the long term, even without the additional damage from the leaking water main.

Driveway wall upper section

Therefore, the proposed solution is to take down the wall, insert a concealed concrete wall recessed into the side of the driveway, then rebuild the brick wall in front of the concrete reinforcement. This will mean that the wall will be (as closely as possible) identical with the existing wall, but the concealed reinforcement will protect from future collapses. The concrete wall will be completely invisible to any viewer as it will be hidden underneath the driveway and behind the brick wall, and the height, profile, position etc of the brick wall will remain unchanged from the present.

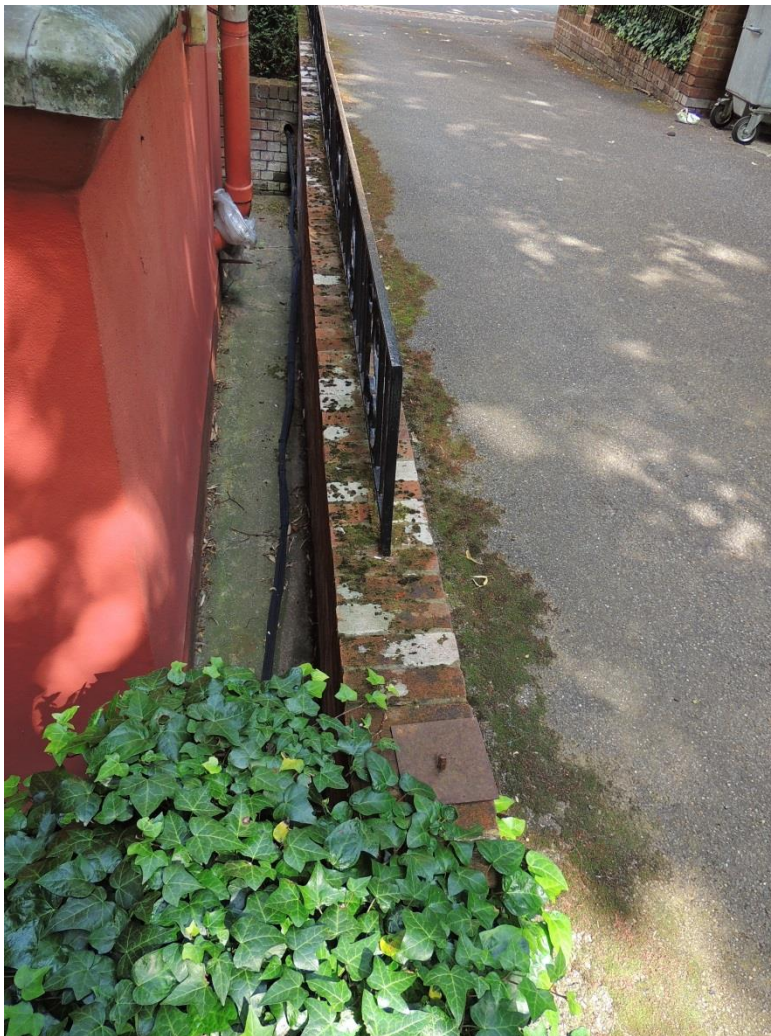
Upper section showing void behind

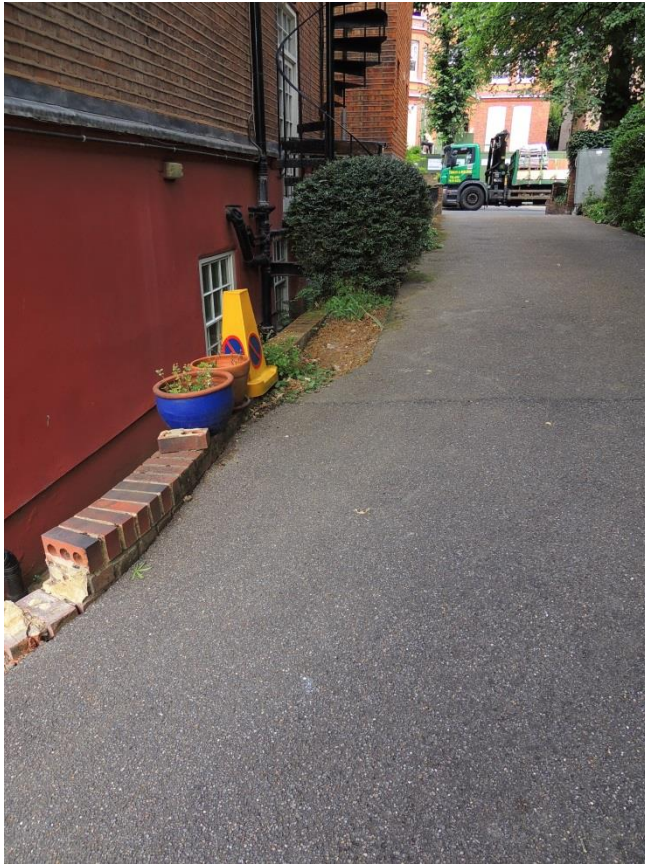
Driveway wall lower section

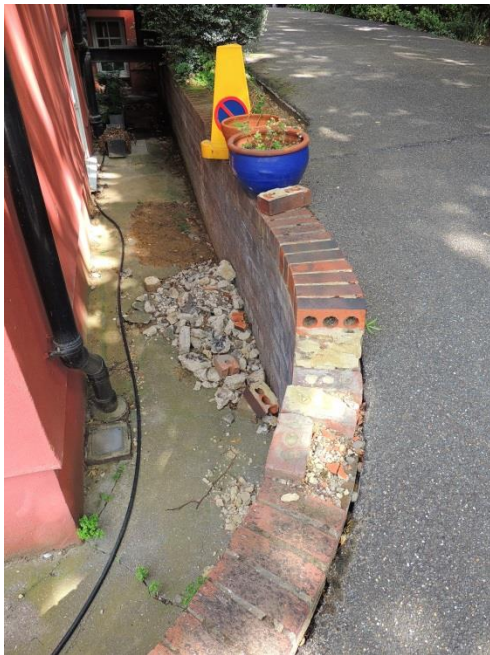
Lower section showing void behind

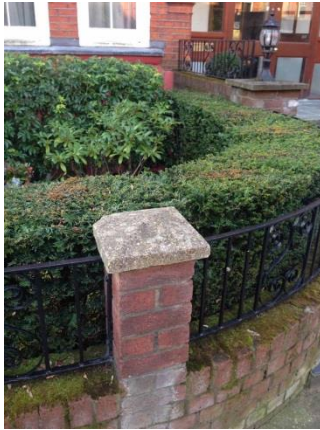
The existing pier caps on the garden walls are poor-quality concrete, and some are damaged. It is not known at what stage they were fitted to the walls, but they do not match any other element of the building. As with the walkway tiles, the repair of the walls provides an opportunity to replace these with something more in line with the neighbouring Horace Field buildings.

Existing pier caps

It is proposed to use exactly this same stone for replacement pier caps on the garden walls. This will provide visual continuity along the street.

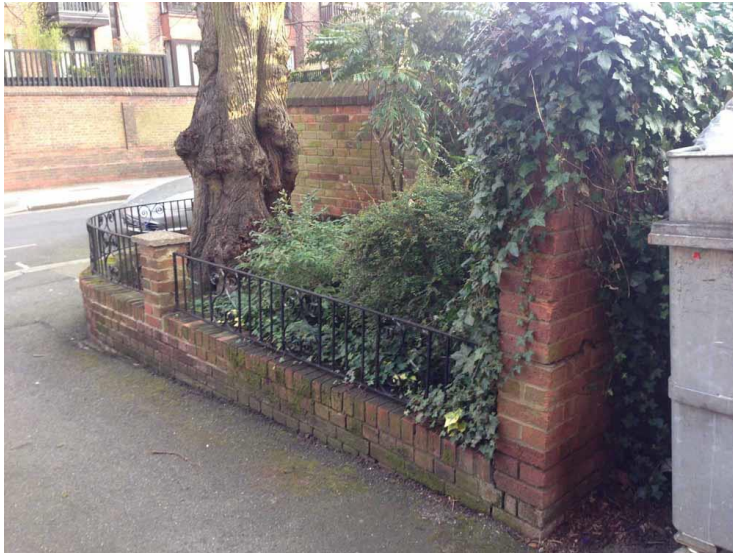
Facing driveway wall. No repairs to be done to this wall. Lights to be installed to match driveway wall opposite.
