Camden Lock Market

Arboricultural Report

August 2015

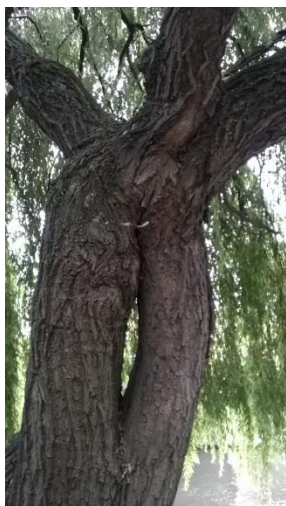
Ref. No	Species	Est. Height (m)	DBH (mm)	Canopy Spread (m)				First significant branch (m)	Canopy Clearance (m)	Physiological Condition	Age	Structural Condition	Preliminary Management Recommendations	Estimated Remaining Contribution (years)	Category
				N	S	E	W								
1	Weeping willow (<i>Salix babylonica</i>)	12	800#	8	7	6	6	4/W	2	Good	M	Fair. Dog legged main stem at 1.5m. Rubbing/co-joined stem at 3.5m. Crown reduced historically.	Consider crown reduction by 3-4m to reshape crown and improve/mitigate structural form.	20+	B1, 3

Figure 1: T1 illustrating poor structural form

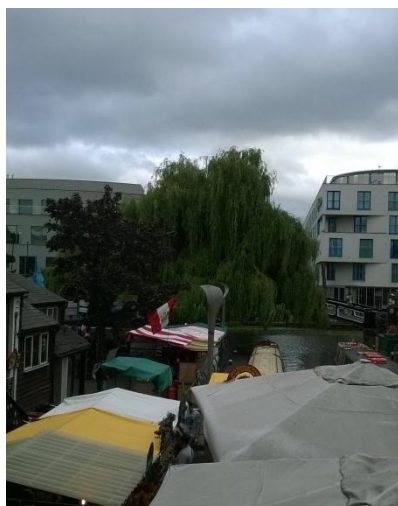
Ref. No	Species	Est. Height (m)	DBH (mm)	Canopy Spread (m)				First significant branch (m)	Canopy Clearance (m)	Physiological Condition	Age	Structural Condition	Preliminary Management Recommendations	Estimated Remaining Contribution (years)	Category
				N	S	E	W								
2	Weeping willow (<i>Salix babylonica</i>)	13	850	7	7	8	8	2/S	2	Good	M	Fair. Exposed surface root with impact damage to North. Rubbing branches in crown to north and west. Dead wood over market area to west. Electrical point and lighting cables attached to main stem.	Remove dead wood over market area (3 months). Consider crown reduction by 3-4m to reshape crown and improve structural form. Crown lift to north to 6m, removing crossing limbs. Crown reduce to north to provide a 1m lateral clearance of the proposed footprint, and 1.5m clearance of the proposed structure (this equates to a maximum reduction of the north and north eastern crown of 3-4m). Reduce the remaining crown by 2-3m to achieve a balanced form.	20+	B1, 3

3	Norway maple (<i>Acer platanoides</i> 'Crimson King')	8	220	2	4	3	3	2.5/W	2.5	Fair	SM	Fair. Electrical point attached to lower stem, lighting cables strung throughout stem and limbs.	Fell due to a direct conflict with the footprint of the proposed structure	10+	C1

Figure 2: T2 and T3 as viewed from the North.

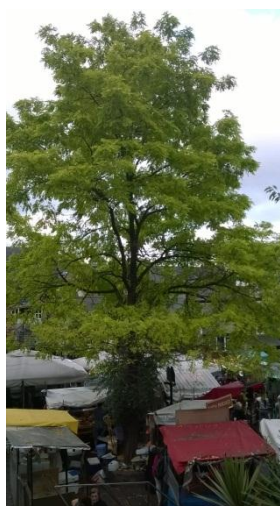
Figure 3: T4 located within the market stall area

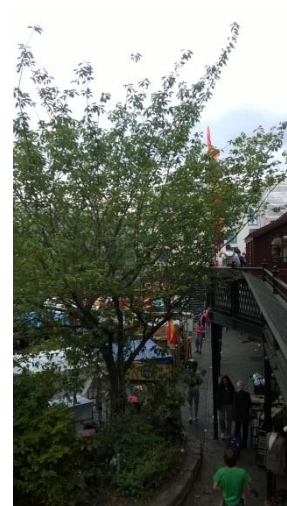
Figure 4: T5 located in a raised planter growing into the raised walkway.
