ARBORICULTURAL METHOD STATEMENT REPORT
BS 5837:2012 '*Trees in relation to design, demolition, and construction*' - recommendations

PURSUANT TO DISCHARGE CONDITION 5 OF
2015/2848/P

SITE: 25A Belsize Crescent

DATE: 19 August 2015

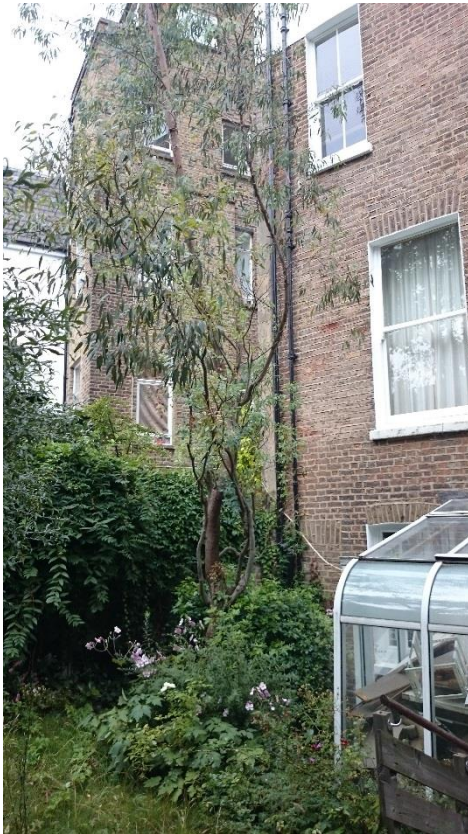
This tree is semi mature with a fair vitality. It is a tall, drawn up tree with a poor stem taper, which means that it will sway easily in the wind and whip against the building. The trunk twists at 2m up to 4m in a gentle helical pattern and there is a low, 'end loaded', branch on the south-west aspect. Eucalyptus is a very fast growing species and the tree will quickly outgrow the small space between the building and garden boundary. It is unsuitable for the location and the local landscape character. I recommend its removal, irrespective of the approved permission, as removing the tree in a few years' time would prove very complex in such a small space.

Photo 1 showing the poor stem taper

The tree can be retained, but I have shown its removal due to unsuitability for the location. It will be replaced with a variegated privet tree, as detailed at appendix 9.

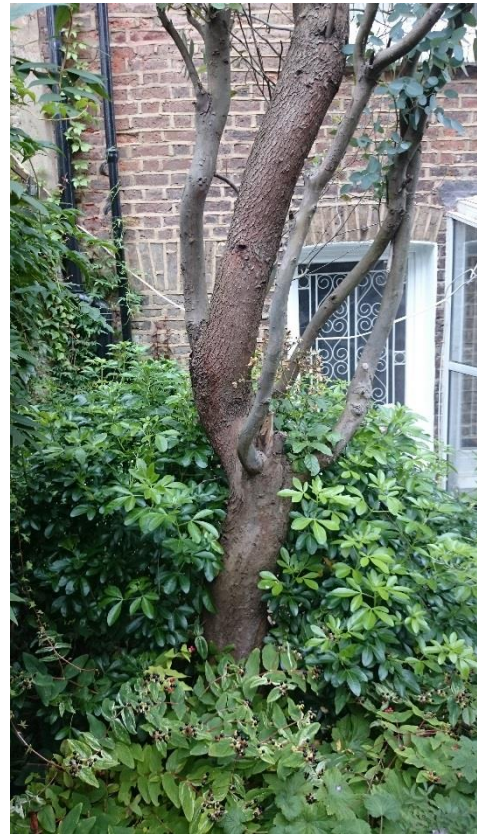
Photo 2 showing the helical twisting of the trunk

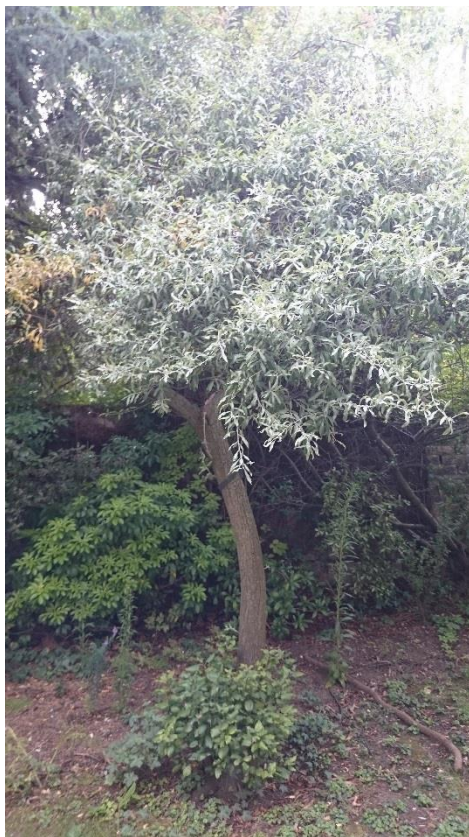
This tree has a longitudinal strip of decay from the base to the crown break. The fork between the main branches is cracked and there is a high probability that the tree will collapse. The tree is small and provides almost no visual amenity beyond the garden.

Photo 3 view of T2

The tree can be retained, but I have shown its removal due to its hazardous condition.

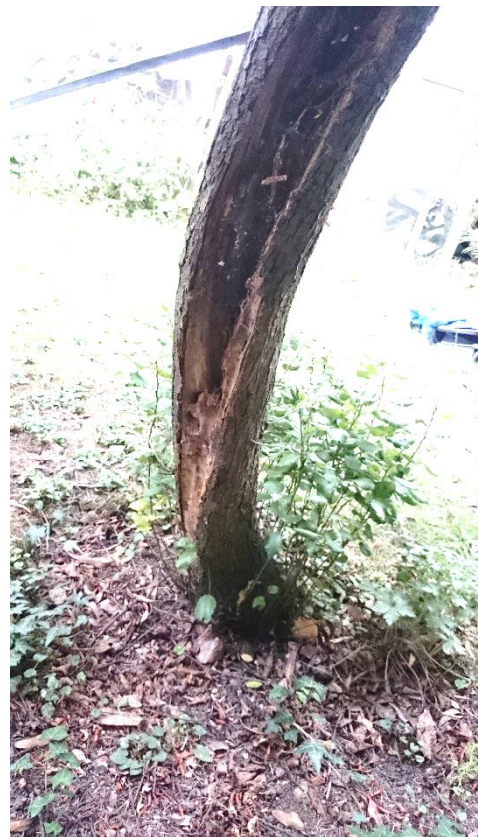
Photo 4 showing the decayed strip

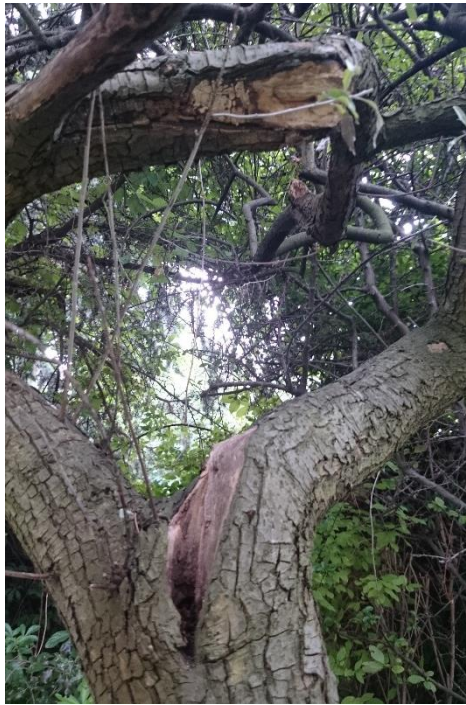
Photo 5 showing the crack in the fork between the main branches at the crown break

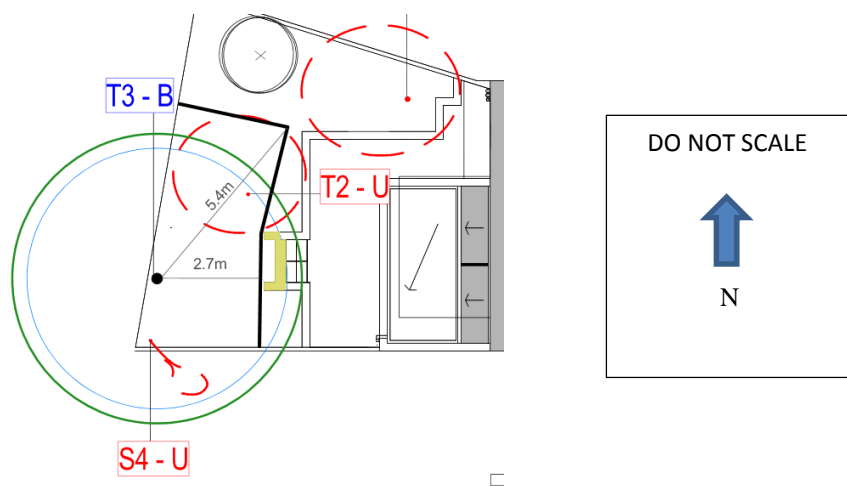
The tree will be retained and protected with tree protection fencing as shown on the extract of the plan SHA 077 TPP below:

The new steps impinge very slightly on the root protection area of the tree. This incursion is so modest (approximately 1 square metre on the very edge of the RPA) that I do not consider this to be harmful. As a precaution, the steps will be dug in accordance with the method statement at section 5.0.

The steps will be hand dug and any roots found will be cut cleanly with bypass secateurs. The edge of the trench will be lined with impermeable plastic sheeting to prevent the alkalinity of

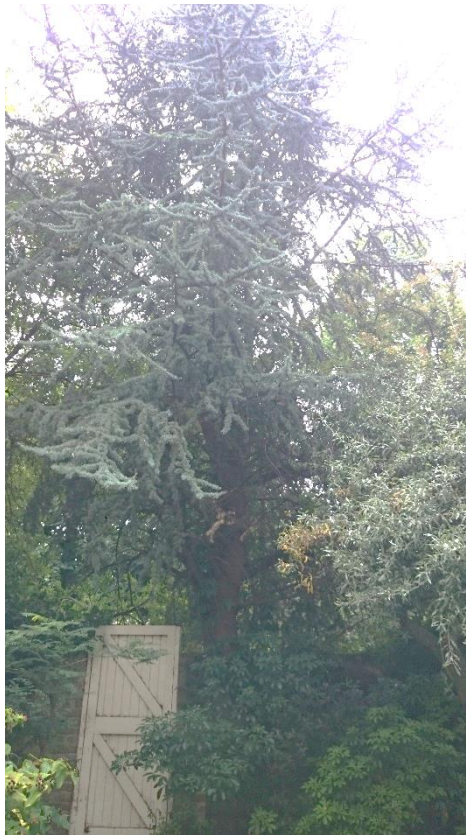
This tree is in good health and early maturity. There are no minor defects, other than a small amount of twig-sized dead wood (typical for the species). The tree provides a focal point for the garden and will be dominant once mature. The root protection area equates to a circle with a radius of 3.6m.

Photo 6 of T3

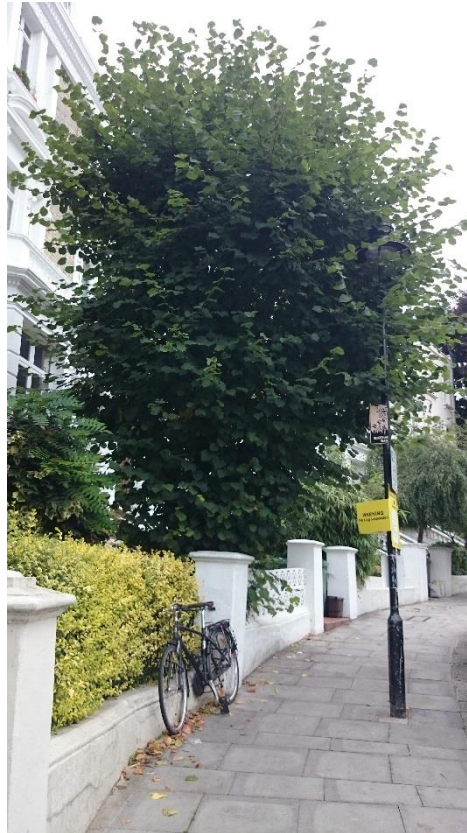
This lime tree is growing in the front garden of the property, close to a low rise boundary wall. It has been pollarded in the past and I understand that an application to re-pollard the tree has been made by the management company. I have included this work in the tree surgery schedule, together with removing the epicormic shoots, for completeness.

Photo 7 of T5 lime.

Providing the lower section of the boundary wall is retained, the replacement of the decorative upper half of the wall with balustrades (or similar) will have no arboricultural impact. There are no other works within the root protection area of this tree. I recommend that the tree is re-pollarded every 4 – 6 years (depending on rate of growth). A Section 211 notice will be required each time the tree is re-pollarded.
