No. 1 Oak Hill Way. Hampstead . NW3 7LR

Tree Survey and Arboricultural Method Statement. September 2015

1275/ AP2

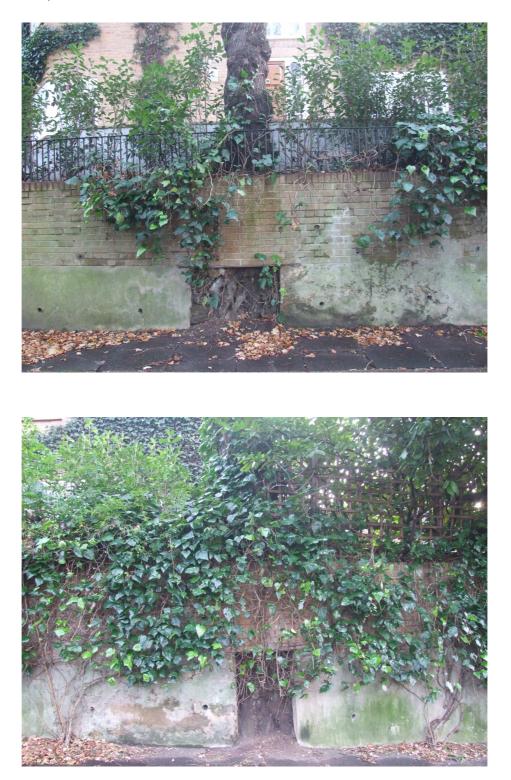
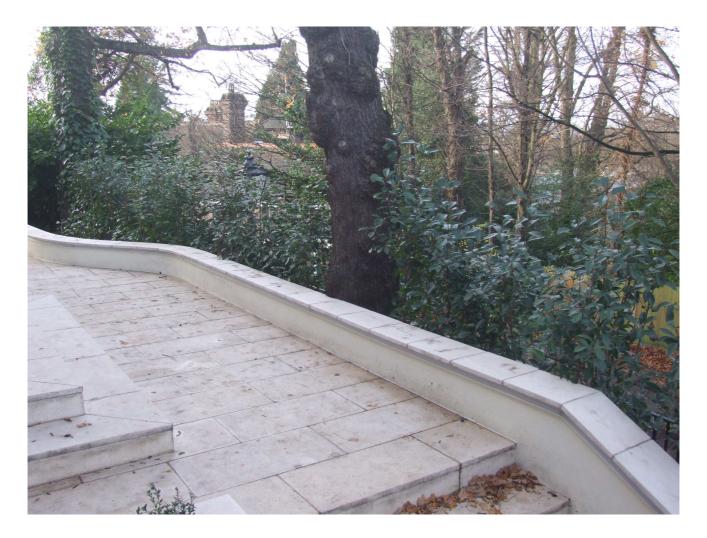
<u>Oaks T3 & 4</u>

The Oaks Ts 3 & 4 are in a most unusual position. Their stems have long since been buried up and although the trees have been heavily pruned on more than one occasion the trees are functioning normally.

The base of the Oaks are at pavement level and the spot levels on the tree protection plan indicate that circa 1.8 metres of the lower stems are buried up.

Due to the close proximity of the Oaks all demolition works here will be carried out using hand held tools only.
