# Arboricultural Impact Assessment

***5A Fitzroy Road, London NW1 8TU***

Project Number: P2353.1.3

Date: 6 October 2015

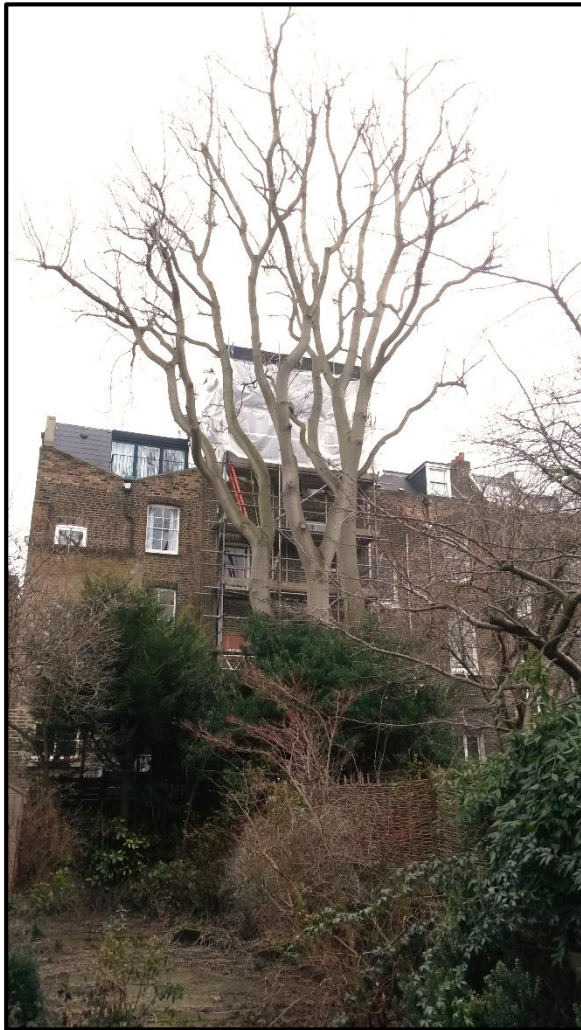
T1 is a large, mature tree, believed to be a Tree of Heaven, standing approximately one metre south of the site boundary, with a crown spread that extends virtually across the full width of the site (**Plate 1**). It is a tall tree, the upper crown of which is visible, with some difficulty, from surrounding publicly-accessible areas. The tree has been subject to some crown reduction, focussed on managing the tree's height. Lower limbs have been removed back to the trunk, providing extensive ground clearance, presumably to reduce shading to adjacent properties.

The tree is in apparent good health, with regrowth of good vitality. No major structural defects were visible, although direct access to the tree was restricted due to its offsite location.

**Plate 1** (left). T1 suspected Tree of Heaven, showing evidence of past crown clearance and crown reduction work.

T1 has been subject to previous reduction and crown lifting, presumably due to its impact on surrounding properties. Periodic repetition of this work can be anticipated to prevent the failure of regrowth, irrespective of development. The change of use of the garden as a result of development is considered to be minor: it is already has residential use and this will continue. Therefore the potential for development to increase pruning pressure on the tree is considered to be minimal. In any event, the tree is subject to TPO and therefore the LPA has considerable control over any work proposed.

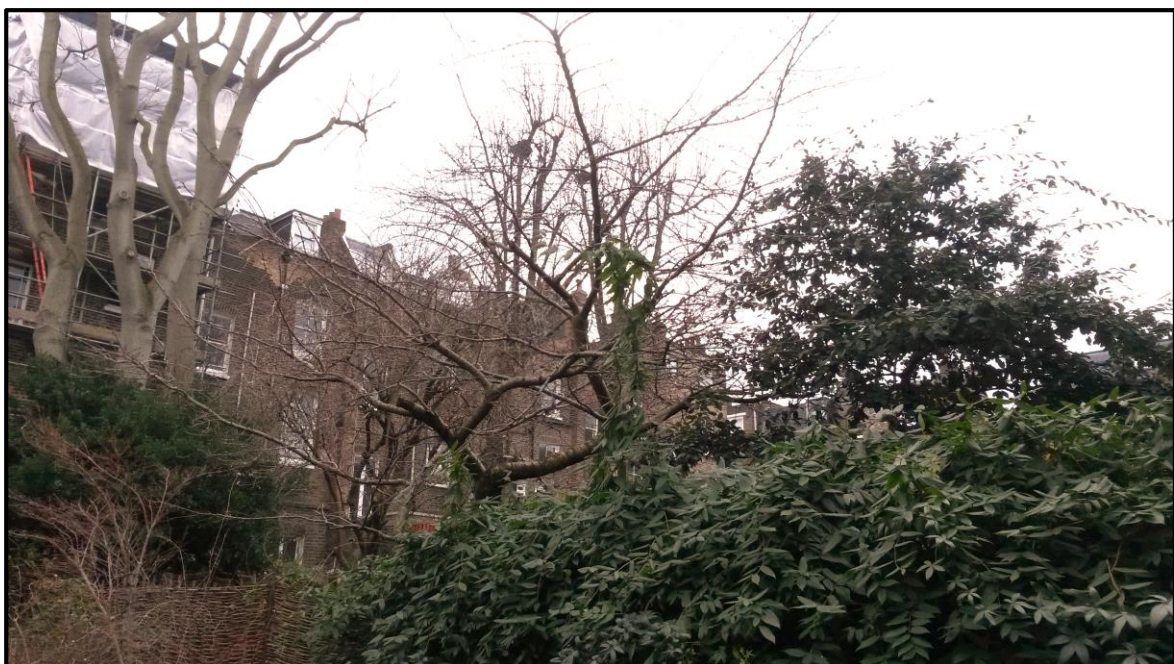
T2 is a much smaller flowering cherry, again located approximately one metre south of the site boundary in the adjacent garden. The upper crown development is largely horizontal, resulting in considerable spread that partially overhangs the site, but meaning that it has little amenity contribution and no public visibility beyond the rear of nearby properties (**Plate 2**).

The tree has typical form for the variety and appears to have good health. Access to fully inspect the tree was restricted due to its offsite location.

**Plate 2** (below). T2 cherry, showing horizontal growth of upper crown and low height.
