Arboricultural Impact Assessment

Gloucester Lodge, Gloucester Gate, Regents Park,
London, NW1 4HA

Iconic Properties Limited
Planning Application 'B'

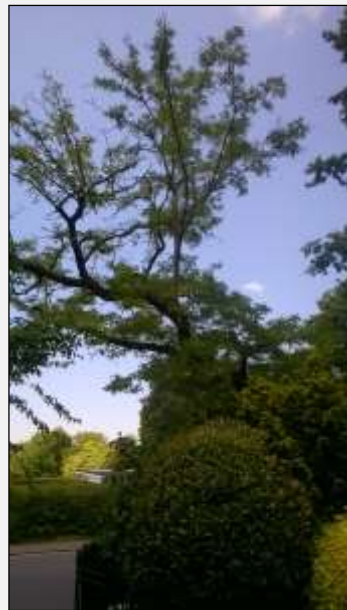
T5 False acacia

T5	False Acacia.	0.37	1	10.4	3	3	4	5	B1	Early-Mature	10_19	3	Average form, shape and condition. Dense crown, moderate crown deadwood.	No Works.	62

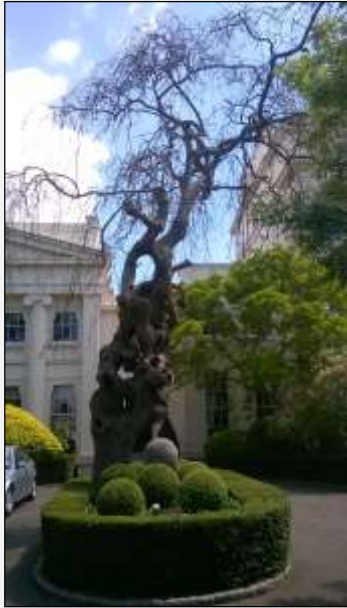
T1 Weeping Ash

Tree No.	Species	Proposed Tree Works	Observations	BS Cat
TG1	Hornbeam.	Fell to ground level.	Average form, shape and condition. Pleached Hornbeams maintained for screening, subjected to regular pruning. 5x trees in group.	B1
T1	Weeping Ash.	Fell to ground level. (To be replaced)	Dead gross defect (Should be removed due to hazardous condition).	U
T4	Cherry.	Fell to ground level.	Poor form (Asymmetric canopy), shape and condition. Dense crown, moderate crown deadwood. Co-dominant tree with included unions. Tree colonised by fungi thought to be <i>Phellinus igniarius</i> .	U
T10	Cotoneaster.	Fell to ground level.	Average form, shape and condition.	C1
T11	Rhododendron.	Fell to ground level.	Poor form (Asymmetric canopy), shape and condition. In close proximity to building, multiple pruning wounds on main stem, low quality landscape tree.	C2
T12	Lilac.	Fell to ground level.	Poor form (Asymmetric canopy), shape and condition.	C1

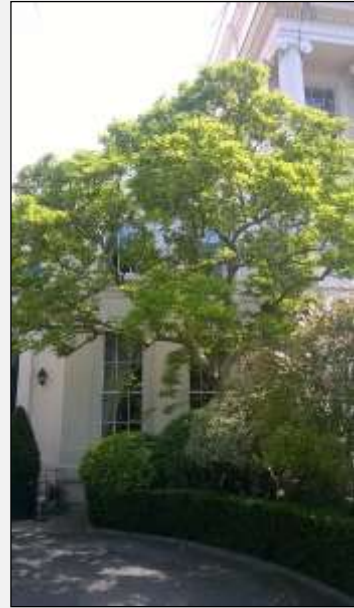
T2 Magnolia

- 7.3.1 The foundations of the proposal will slightly encroach into the RPA of T2. Please refer to the Tree Protection Plan for further information.
- 7.3.2 To minimise the impact on the trees it is proposed foundation installation will require close arboricultural supervision.

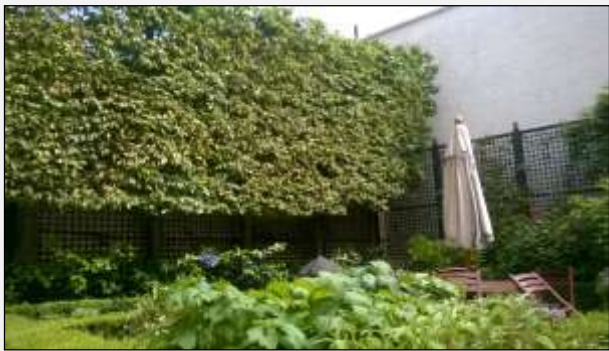
TG1 Hornbeam

Tree No.	Species	DBH	No of Stems	Ht (m)	N	E	S	W	BS Cat	Age Class	Life Expect	Cr Ht (m)	Observation	Recommendations	RPA (m2)
TG1	Hornbeam.	0.19	1	4.5	1.2	1.2	1.2	1.2	B1	Early-Mature	10_19	1.8	Average form, shape and condition. Pleached Hornbeams maintained for screening, subjected to regular pruning. 5x trees in group.	Fell to ground level.	16
T1	Weeping Ash.	0.65	1	8.7	3	3	3	3	U	Mature	<10	2	Dead gross defect	Fell to ground level. (To be replaced)	191
T2	Magnolia.	0.25	1	7.6	4.5	4	3.5	3.5	B1	Early-Mature	20_39	0	Average form, shape and condition. No significant recent crown management. Multiple pruning wounds partially occluded.	No Works.	28
T3	Ash.	0.36	1	12	4	4	4	4	B1	Mature	20_39	2.4	Average form, shape and condition. Unable to inspect due to restricted access. Minor deadwood, subject to previous branch failures.	No Works.	59
T4	Cherry.	0.27	2	4.7	2	3	3	3	U	Early-Mature	<10	1	Poor form (Asymmetric canopy), shape and condition. Dense crown, moderate crown deadwood. Co-dominant tree with included unions. Tree colonised by fungi thought to be Phellinus igniarius.	Fell to ground level.	23

B - TG1

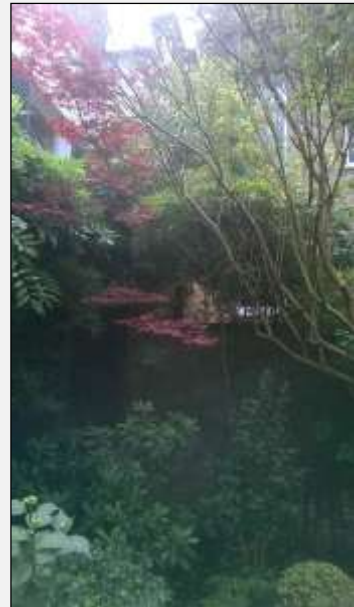
T13 Japanese Maple

T13	Japanese Maple.	Fell to ground level.	Poor form (Asymmetric canopy), shape and condition. Young newly established tree.	C1
H1	Yew	Remove part of hedge see TPP.	Average form, shape and condition. Maintained Hedgerow.	C2

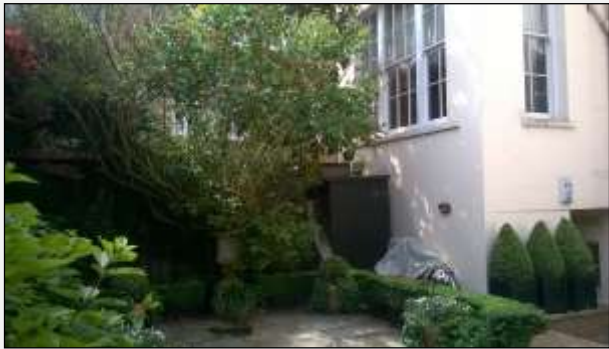
T12 Lilac

Tree No.	Species	DBH	No of Stems	Ht (m)	N	E	S	W	BS Cat	Age Class	Life Expect	Cr Ht (m)	Observation	Recommendations	RPA (m2)
T12	Lilac.	0.09	M/s	3.6	1	3	3	1	C1	Early-Mature	10_19	1	Poor form (Asymmetric canopy), shape and condition.	Fell to ground level.	3
T13	Japanese Maple.	0.04	1	3.4	0	1	1	0	C1	Young	10_19	0	Poor form (Asymmetric canopy), shape and condition. Young newly established tree.	Fell to ground level.	1
H1	Yew.	0.08	M/s	3.5	1	1	1	1	C2	Early-Mature	20_39	1	Average form, shape and condition. Maintained Hedgerow.	Remove section of hedge as indicated on TPP	2
