Landmark Trees

**ARBORICULTURAL IMPACT ASSESSMENT REPORT
& METHOD STATEMENT:**

Heath Park & Heath House
Hampstead
London
NW3 7ET

Ref: ADR/HP/AIM/01

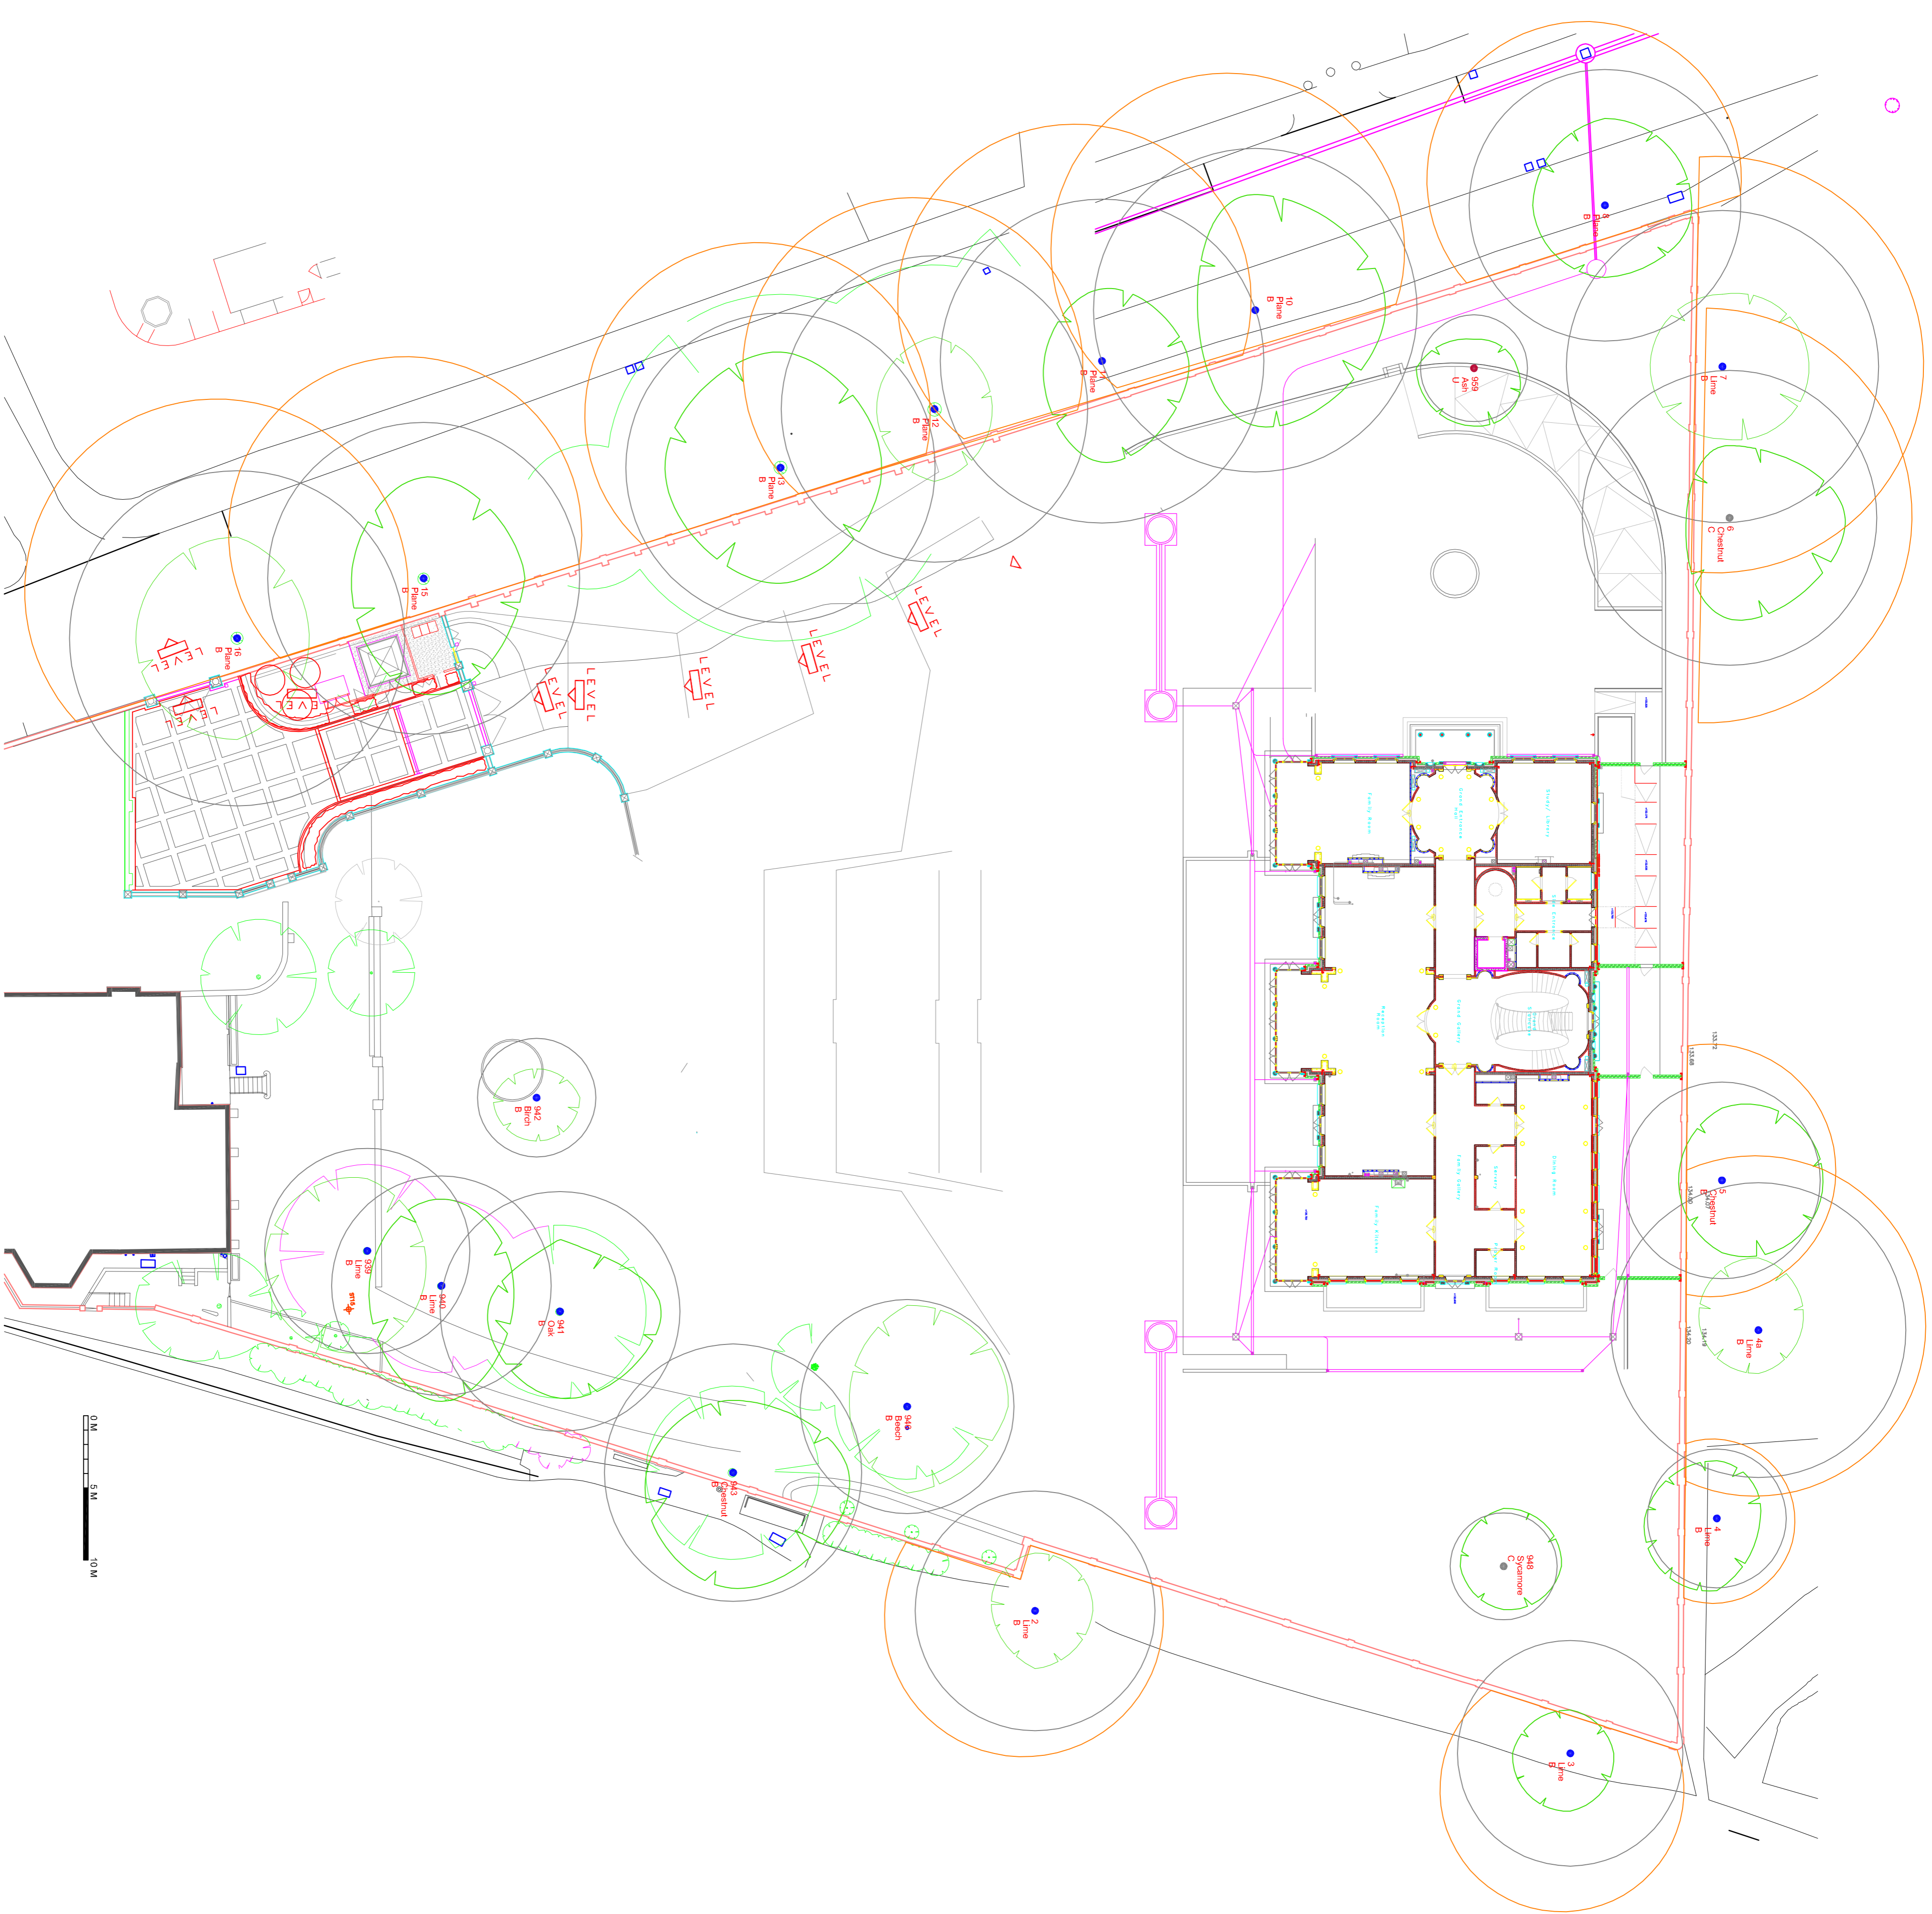
TREE CONSTRAINTS PLAN

- 1.3 The updated tree constraints have been plotted on the site plans, with the protection plans brought up to date, to allow the effective assessment of the potential impacts of the landscape proposals. The Arbtech report highlights the modified RPAs along the boundaries are based upon trial pit evidence. No roots were found as a consequence of the level changes either side of the boundary wall, and the unusual depth of the wall's foundations. It was accepted therefore, that the wall has acted as a permanent root barrier and no RPA should encroach on to the site from any tree outside of it.

- 1.4 During the survey, it was realised that the northernmost tree protected during the development proposals, and discussed at various site meetings, is in fact T948 that is to be retained in the absence of T947. It is clear that the works discussed since LT have been involved have yet to be undertaken; Appendix 2 of this AIM therefore recommends that the tree is pollarded to 7m as previously agreed with Camden Tree Officer, Alex Hutson, on site. The tree has declined further since the 2007 survey and subsequent LT visits in 2011; it is also acknowledged that significant landscape revisions have resulted to allow its retention, even though T947 was originally intended for retention (with T948 to be felled). The previously agreed pollarding will also reduce this tree's landscape contribution. Accordingly it is recommended that further investigations/discussions are undertaken to ensure that the tree is indeed worthy of retention in the longer term; these discussions will need to address the longer term landscape consequence of removal and replacement.

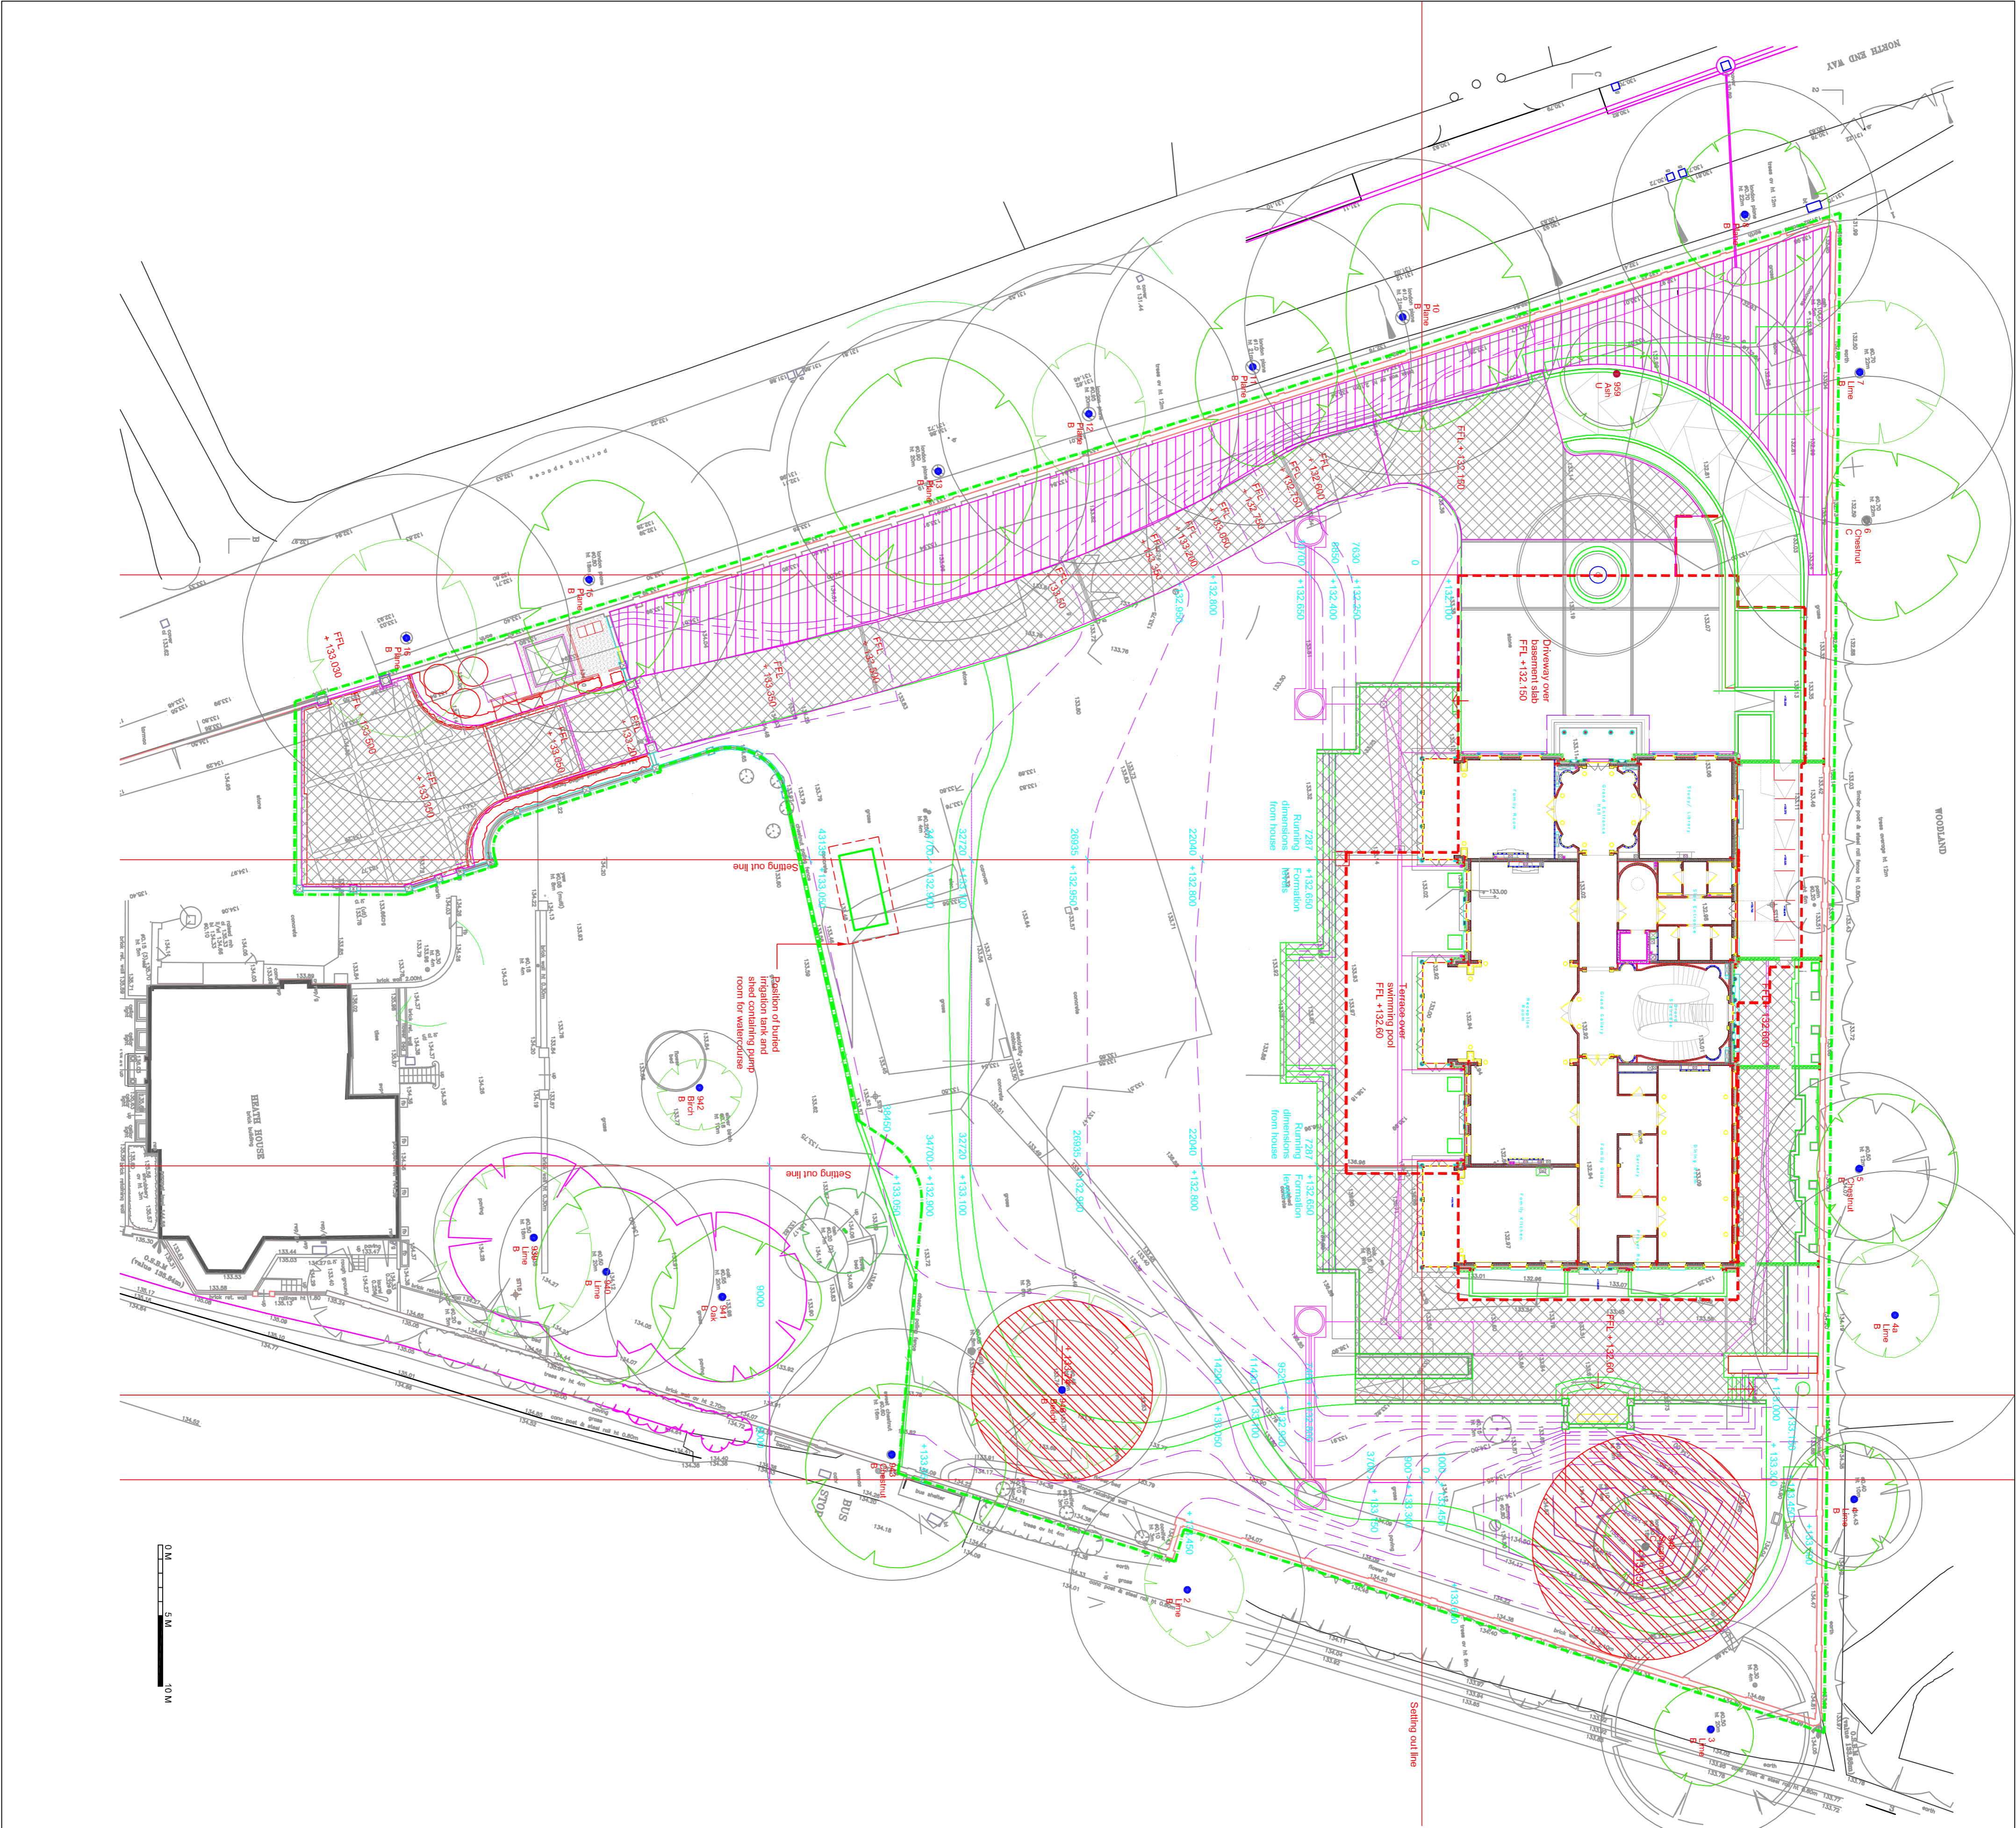
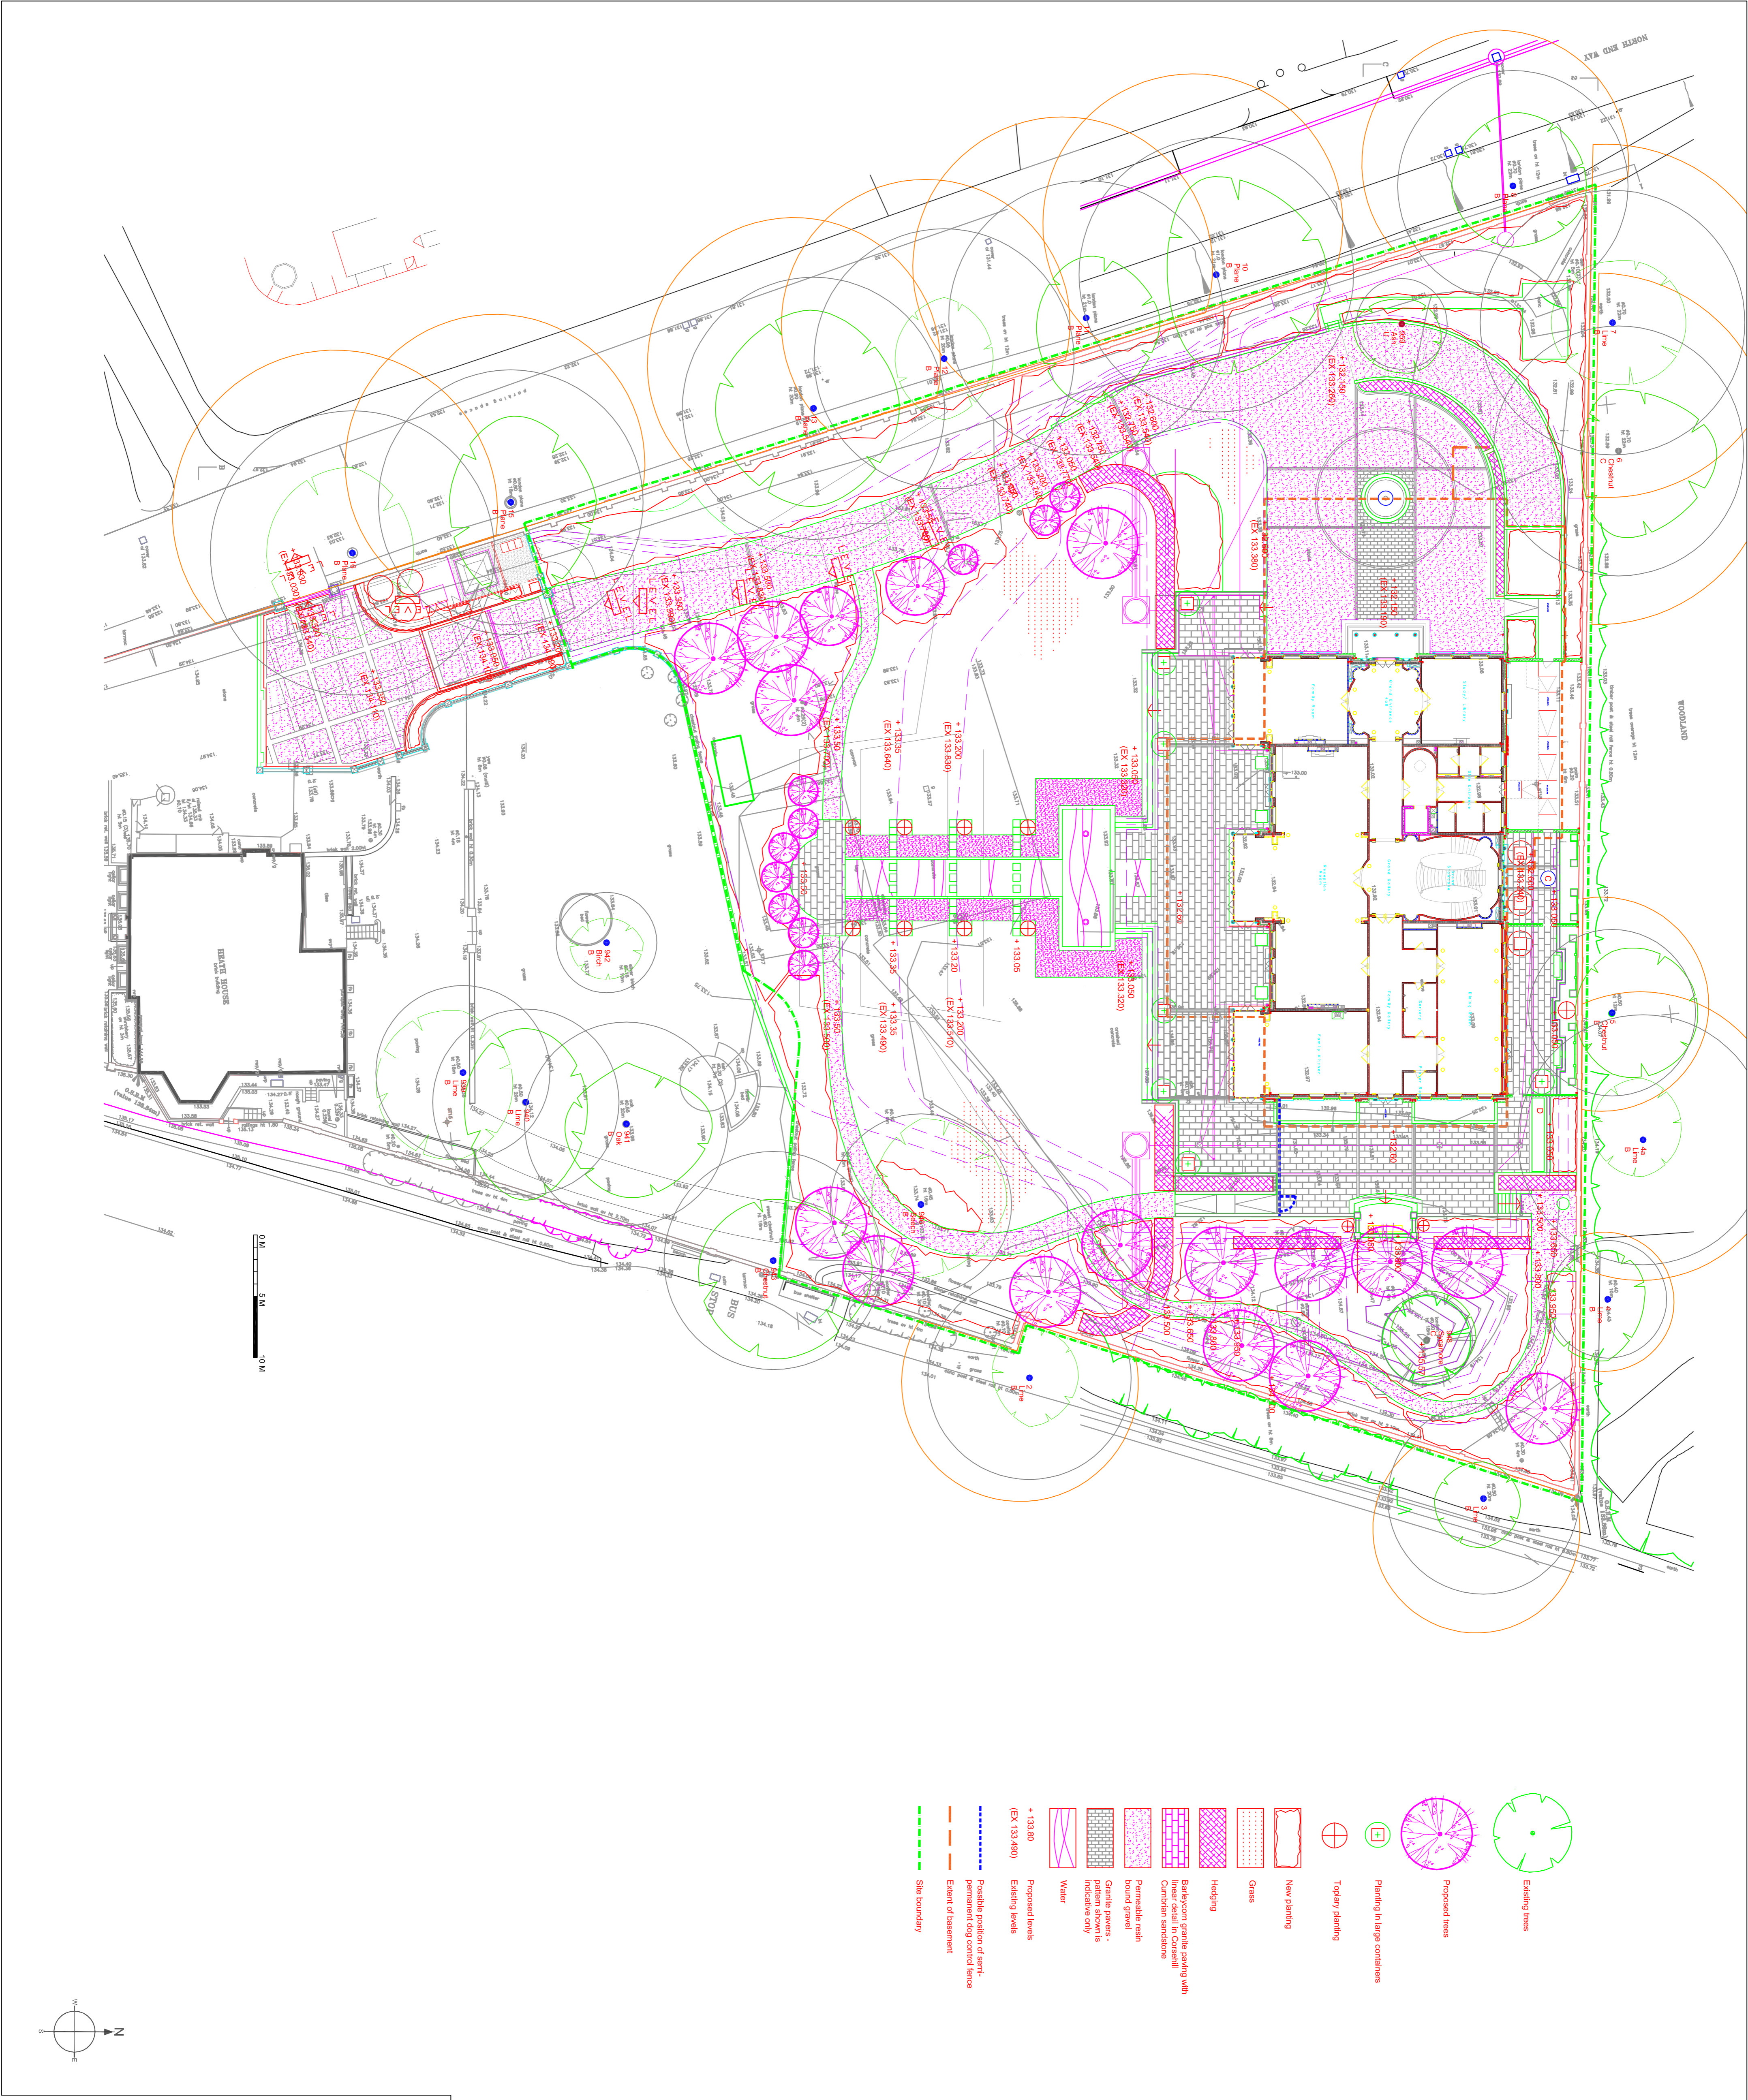
ARBORICULTURAL IMPACT ASSESSMENT PLANS

- 1.5 The Arbtech report clearly set out the arboricultural constraints on this site, which have been considered during the evolution of the landscape proposals. The AIA plan with the levels highlighted illustrates how the theoretical RPAs of the retained trees will be protected from any excavation works. Furthermore, it is clear that the RPA of T948 in addition to T946 (previously noted for felling) will be enhanced with the clearance of any debris/ removal of stones over 75mm in the soil.

- 1.6 The existing path within the RPA of T948 is to be removed manually, with the existing sub-base retained for the new permeable resin-bonded gravel surface. The existing paving within the RPA of T496 will also be removed manually, with the new porous resin-bonded path constructed on a no-dig basis.
