ARBORICULTURAL IMPACT ASSESSMENT REPORT & OUTLINE METHOD STATEMENT:

12 Park Village West
London
NW1 4AE

Ref: CZL/12PVW/AIM/02

Date: 8th December 2015

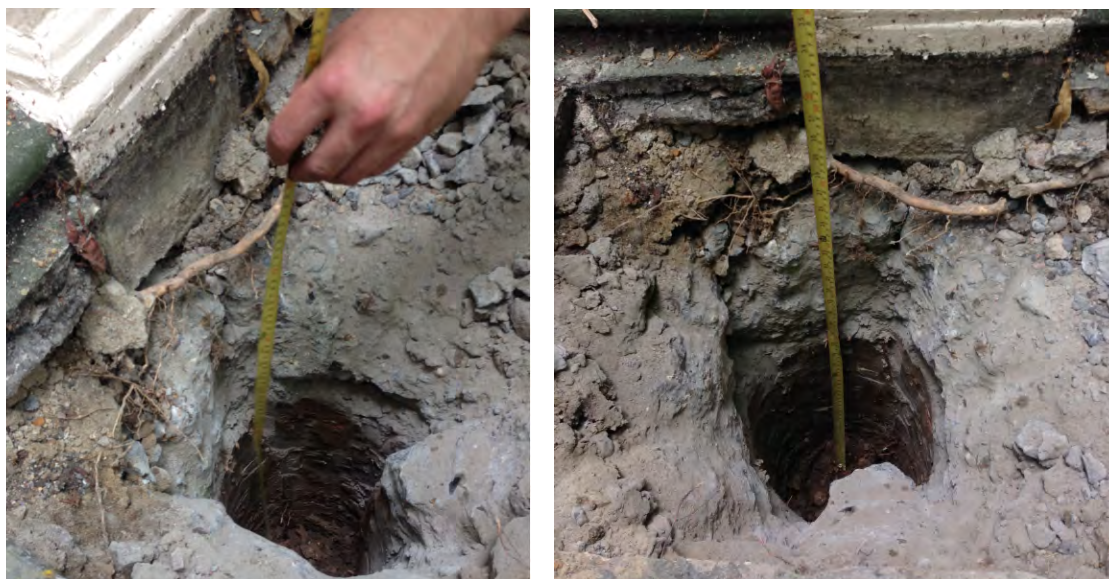
- 4.1.5 The most recent photographic trial pit evidence for trial pit 8 (see Appendix 5) has been viewed by the Tree Officer Nick Bell on the 12th August 2015. At the site meeting on the 5th of August 2015 and in a subsequent email, there is agreement between the parties that the excavations appear to be free of significant roots; the Tree Officer also noted that some of the excavations (TP8) would be best described as a holes as opposed to pits i.e. trenches. This was due to the existence of a 600mm concrete apron.

7 Southern wall of main house	Two tier with additional step up Top: 0.22m; Base: 0.5m and lateral projection 400mm Rootlets (fibrous roots) noted
8 Eastern wall of main house	Trench under concrete of approximately 0.6m depth – excavated below this to 0.82m No significant roots

Photographs A4.1 – A4.4: Results from Trial Pit 8 showing one root in the paving slabs only
