Simon Pryce Arboriculture

Report

Site: 17/19 Lyndhurst Terrace, Hampstead, London, NW3 5QA

Subject: Trees in the garden and the effects of proposed building work at no.15.

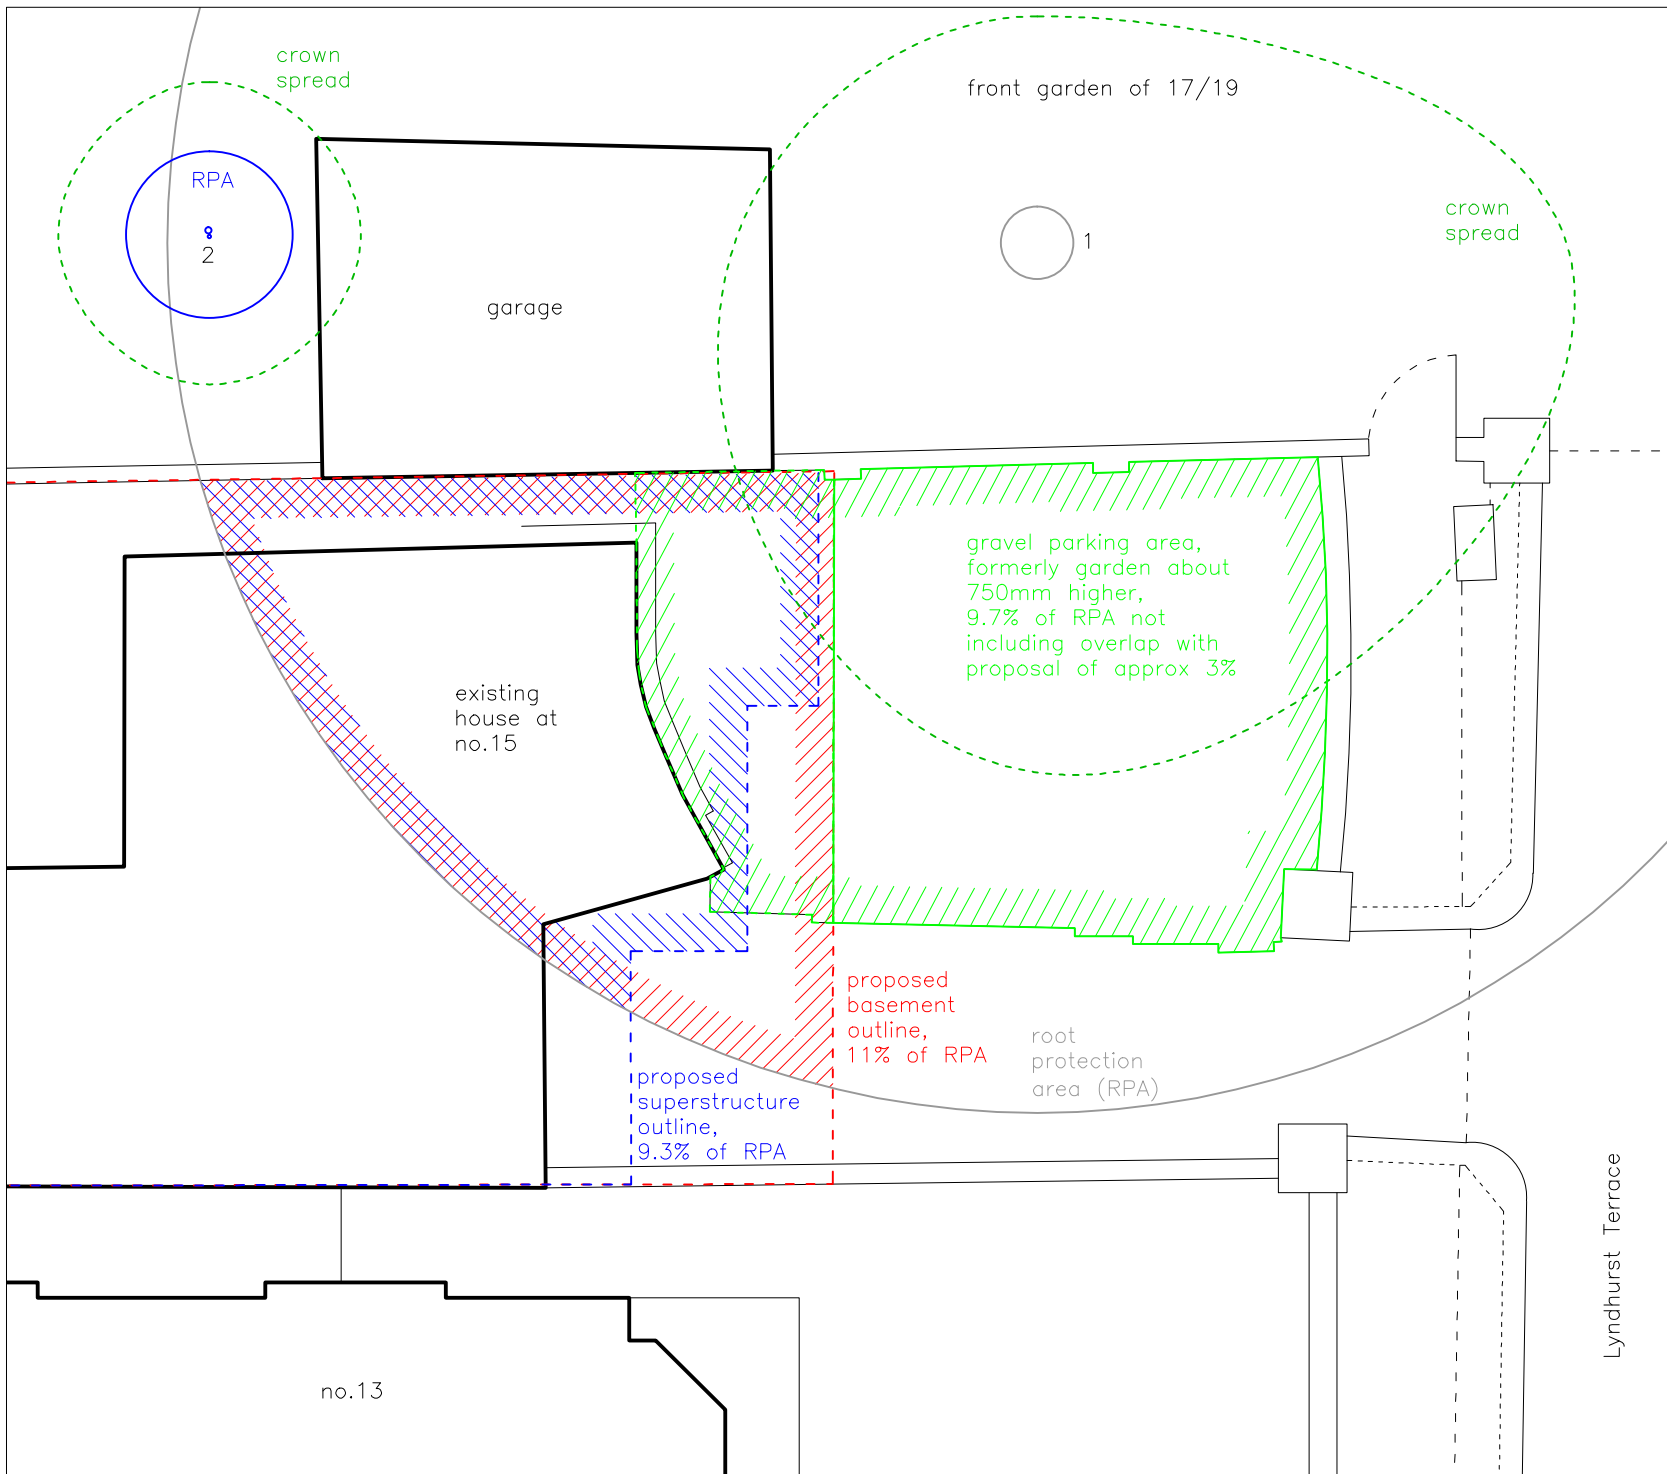
- 2.3 This is shown on the plans with the application on Camden Council's web site, their reference 2015/6278/NEW, and is to demolish the existing house and to build a new one that occupies the full width of the plot. The superstructure of the new house extends forward of the existing one, with a new basement forward of that. These are outlined in blue and red respectively on the attached plan, which is based on the one submitted with the application.

- 4.3 The size of the RPA is based on the size of the tree concerned. The starting point is that for a single trunked tree it has an area equivalent to a circle with a radius 12 times the trunk diameter measured at 1.5m above ground. With multiple trunked trees it is based on the diameter of a single trunk that would have the same cross sectional area. The shape can be modified if there is evidence that root spread might be uneven. There are building foundations and other features near the trees, although no.15 is apparently on a raft, which is not likely to impede root spread appreciably. The boundary wall and garage are unlikely to have foundations deep enough to be significant root barriers, the inspection pit will be deeper but its not likely to be a major obstacle. Therefore root spread might not be perfectly uniform but the circular RPAs, as shown on the plan, will be a sufficiently accurate reflection of root spread.

- 4.9 A substantial part of the tree's RPA is under the front garden of no.15 and the boundary wall is unlikely to be deep enough to be a barrier to root growth, so it will have been affected by recent changes there as well as the proposed works. The tree would have been present when the ground level in the front garden was raised by depositing the topsoil. During the 50 or so years that the soil was present roots will have grown into it and, as they need air as well as water, they are likely to have proliferated at the expense of the deeper roots. The area concerned is about 53m² or about 12.7% of the RPA although, as the area has been resurfaced, it is not possible to tell exactly what the effect on the roots was.

- 4.10 The tree was not in leaf when inspected but from the appearance of the twig growth it has tolerated the removal of the soil. However the basement footprint takes up about 11% of the RPA. There is some overlap with the former raised garden, so the overall incursion into the RPA is just over 20%. A younger healthier tree might tolerate that but, while this one is in reasonable physiological condition for its age, the cumulative effect of the recent and proposed ground work nearby would carry a high risk of harming it significantly. The loss of small feeding roots at the periphery of the root system would reduce its ability to absorb water and nutrients. Most of the main structural roots are within about 3x the trunk diameter, so with this tree these would be within no.17/19 and the work would be unlikely to affect the tree's stability directly. However damage to slightly roots could lead to the tree being colonised by honey fungus, which could kill it or decay the roots, leading to longer term stability problems. The fungus is present in the gardens and is a virulent form that has already accounted for several tree losses.

- 4.11 With a basement there is no possibility of using less damaging techniques, such as piled foundations. However much of the area affected is near the outer edge of the tree's RPA and a substantial part of the new house is outside it completely. Therefore a relatively small reduction in the extent of the nearer part of the new house, such as limiting the extent to the north to match the existing one, would reduce the risk to the tree significantly. However the detailed design of that is a matter for others.

- 4.12 The proposed work is a relatively large scale project for a site like this and will involve major excavation with heavy plant and vehicles to remove spoil. The boundary wall will provide some protection but the tree would be vulnerable to incidental harm from soil compaction or contamination. The applicants' tree report, rightly, refers to protective measures but does not go into any details. Therefore if consent is granted for any building work it should include a condition requiring a detailed tree protection plan and method statement to be submitted and approved before any work starts.
