# Basement Impact Assessment

**Site** | 76 Fleet Road  
London  
NW3 2QT

**Date** | January 2016

**Our Ref** | BIA/5839

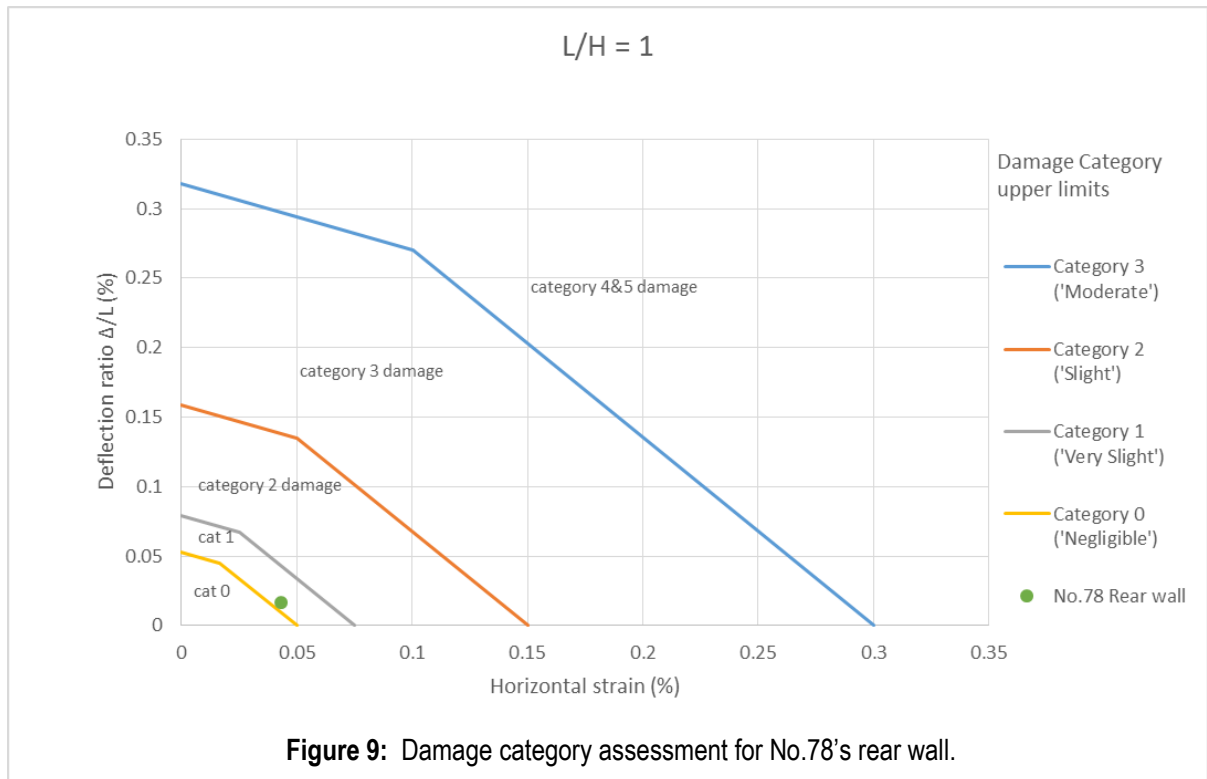
**Figure 9:** Damage category assessment for No.78's rear wall.

10.6.8 The maximum settlement predicted by the PDISP analysis beneath the 76/78 party wall, close to the rear wall, in Stage 4 was 1mm (0.5mm for the 76/74 party wall, though expected to be identical in practice). This must be added to the typical settlement caused by relaxation of the ground alongside the basement in response to excavation of the underpins, giving a maximum predicted settlement of the ground of approximately 6mm at the level of No.78's foundations. The settlement profile is expected to be convex, with a worst case (low stiffness) deflection,  $\Delta = 0.07\%$  of the excavation depth (based on Figure 2.11(b) in CIRIA Report C580), occurring at a distance greater than the depth of excavation from the excavation, so beyond the influence of the vertical stress changes modelled by PDISP. Hence,  $\Delta = 2.03\text{mm}$ , which represents a deflection ratio,  $\Delta/L = 1.72 \times 10^{-4}$  (0.017%). .

10.6.9 Using the graphs for  $L/H = 1.0$ , these deformations represent a damage category of 'very slight' (Burland Category 1,  $\epsilon_{lim} = 0.05-0.075\%$ ) as given in CIRIA SP200, Table 3.1, and illustrated in Figure 9 below.

10.6.10 Use of best practice construction methods, as outlined in Section 10.4 above, will be essential in order to ensure that the ground movements are kept in line with the above predictions.

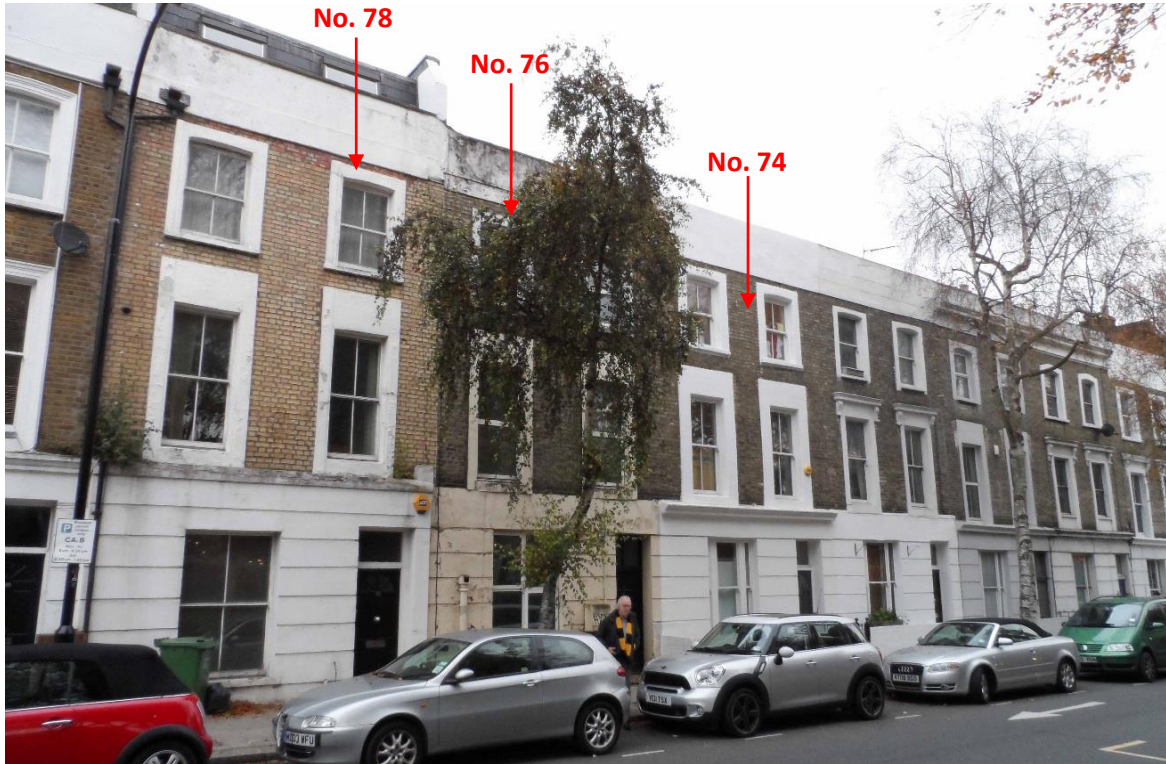
**Photo 1:** Front elevation (street scene) looking north-east. No.76 Fleet Road is a 3-storey, mid terrace house, situated on the north side of Fleet Road, between No's 78 and 74.

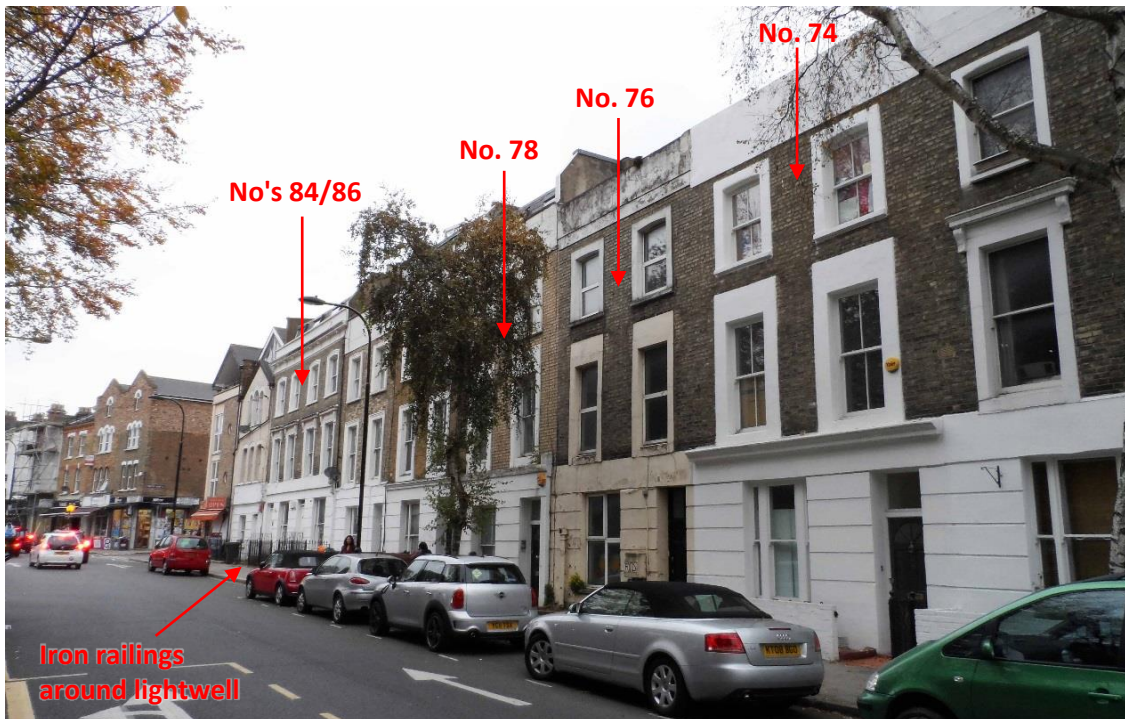
**Photo 2:** Front elevation (street scene) looking north-west. To the west of No.76, No's 84/86 Fleet Road have basements, with iron-railings around the front lightwells.

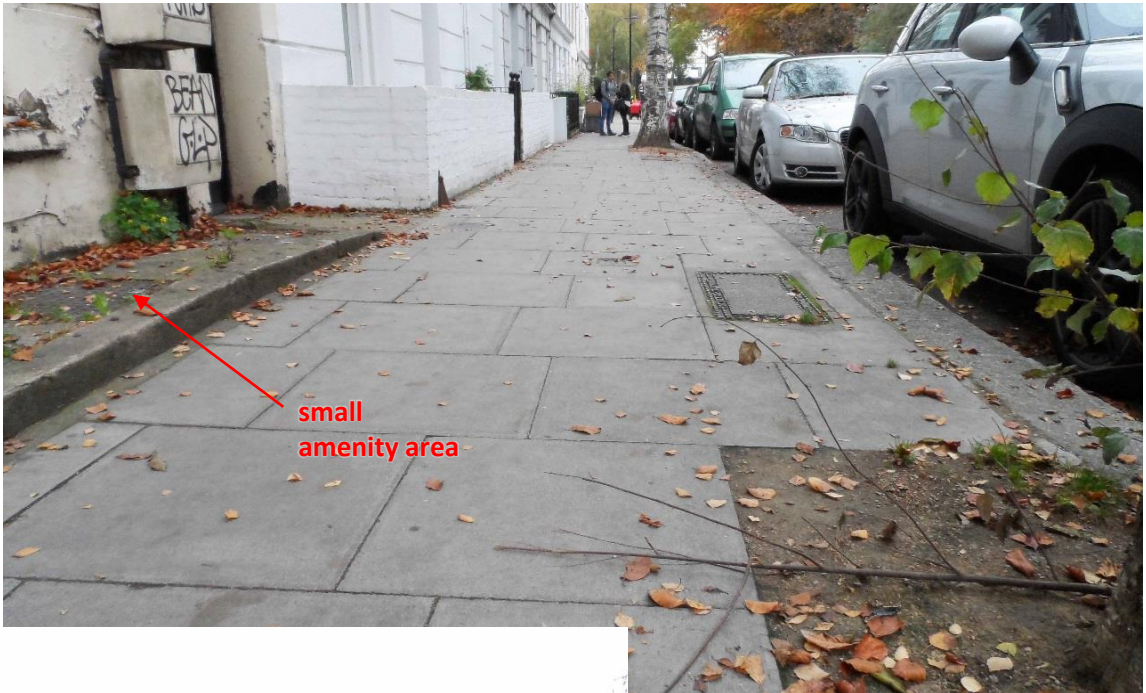
- 5.2 The gentle fall of the footway away from the front of the property (Photo 3), together with the slightly raised amenity area and the south-eastwards fall of Fleet Road, are likely to ensure that most surface (rain)water drains away from the property under normal conditions. The small amenity area at the front of the property is surfaced with concrete and bounded by kerb stones (Photo 3), thus its surface water catchment will be limited to direct rainfall only, and there will be no infiltration. The high brick boundary walls which form the site's northern and eastern boundaries, between the Camden Ambulance Station and No.78 Fleet Road respectively, will prevent surface water run-off from or to these areas (Photos 5 & 6). Between No's 76 and 74 Fleet Road however, the low brick boundary wall which adjoins the perimeter raised flower bed is in poor condition, with large sections missing altogether (Photo 5), therefore the surface water catchment for the rear garden is expected to be restricted to the site itself, plus any surplus overland run-off water seeping from the adjoining No.74's back garden. Most of the rear garden is surfaced with paving slabs or concrete, so infiltration will be limited or nil in

**Photo 3 (above):** The footway in front of No.76 falls gently towards the Fleet Road carriageway, away from the property. Note the small amenity area which extends across the full width of the property.

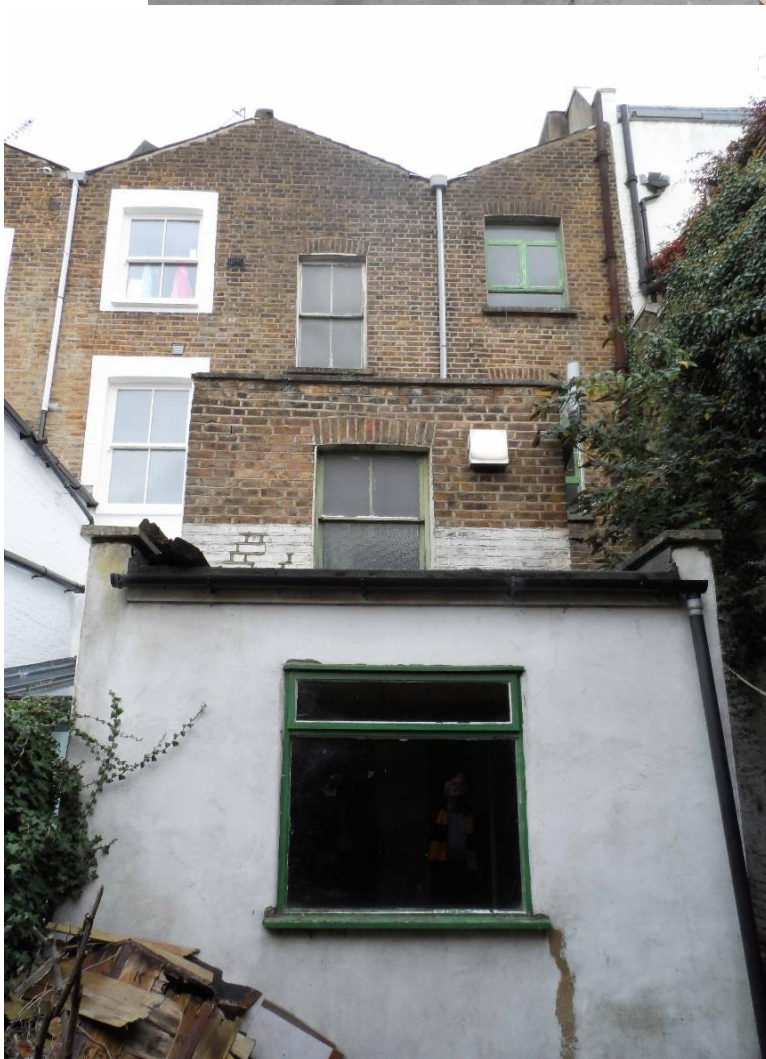
**Photo 4 (left):** To the rear of the house there is an original two storey rear projection, and a single storey rear extension which is a later addition to the property.

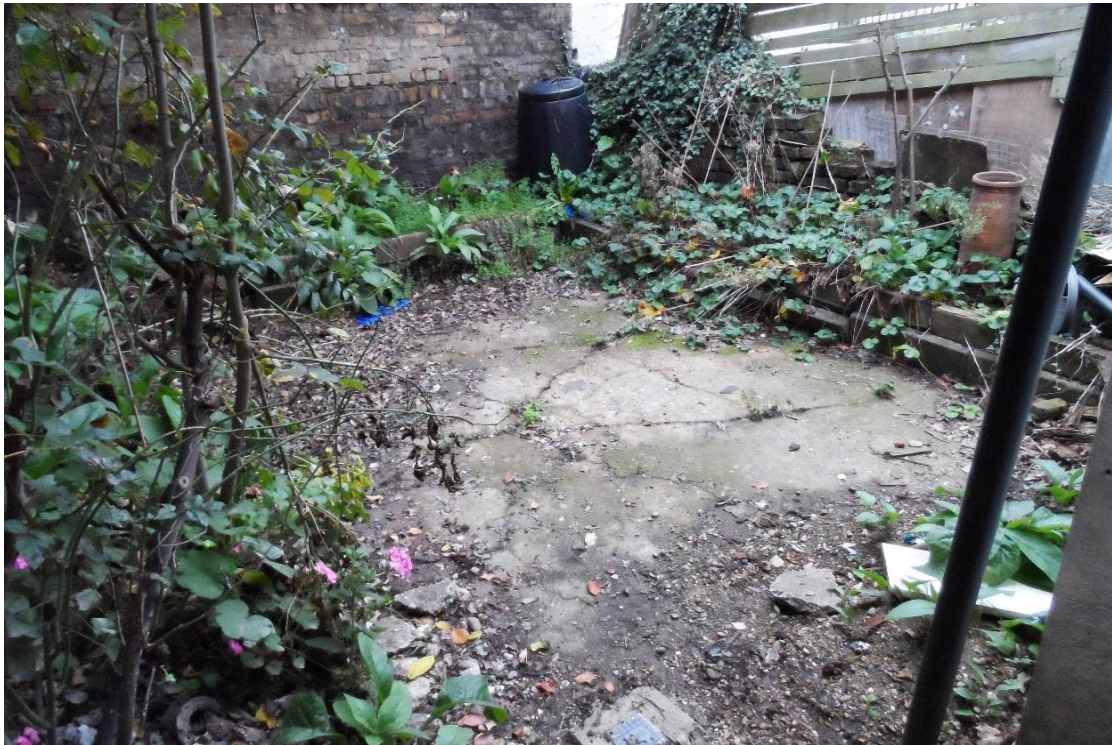
**Photo 5:** The rear garden is surfaced with paving slabs alongside the rear projection, and concrete beyond it, with a perimeter raised flower bed formed from 'railway sleepers' surrounding the rear part of the garden. The brick boundary wall between No's 74 & 76 is in poor condition.

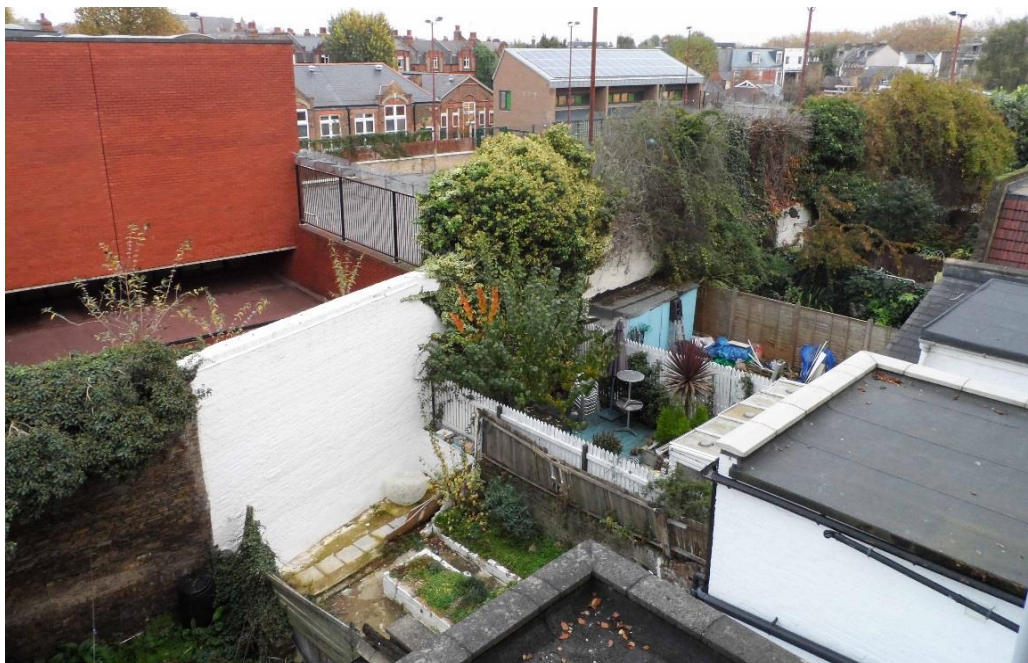
vehicular access into the building - Photo 6). This area extends southwards into the rear gardens to No's 74 and 76 Fleet Road; however, due to the high brick boundary wall which separates these properties from the Camden Ambulance Station, this must be either coincidental or incorrect (the height of the boundary wall made it impossible to assess the relative ground levels on either side of the wall).

**Photo 6:** High brick walls form the northern and western boundaries to the site, between the Camden Ambulance Station and No.78 Fleet Road respectively. Note the irregular nature of the northern boundary, which is believed to follow the former course of the River Fleet.
