# **HERITAGE DESIGN AND ACCESS STATEMENT**

Readymoney Fountain The Royal Parks Project: Ref/File No: HK 2139/3.1

Title: Heritage Design and Access Statement

Date: 17 November 2015

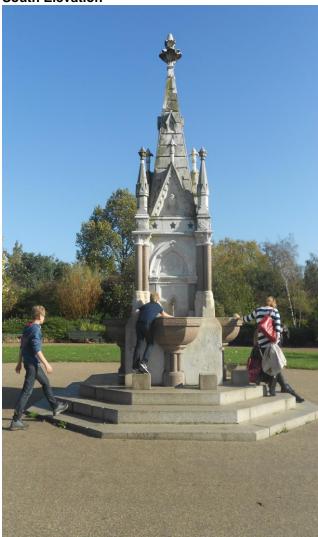
Uncontrolled overflow from fountain ponding on masonry

Difficult access for children

Water from spout lodging on basin shelf.

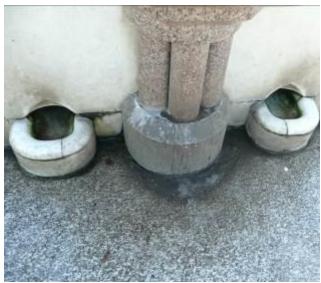
Leaks though masonry joints on north side.

Active leaks though masonry on west side.

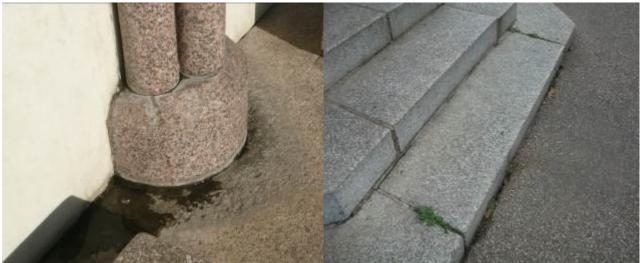
Active leaks though masonry on south side.

Weed growths on failing masonry joints
