ARBORICULTURAL IMPACT ASSESSMENT REPORT:

3 Belsize Place
London
NW3 5AL

Ref: GCM/BLS/AIA/02

Date: 26th January 2016

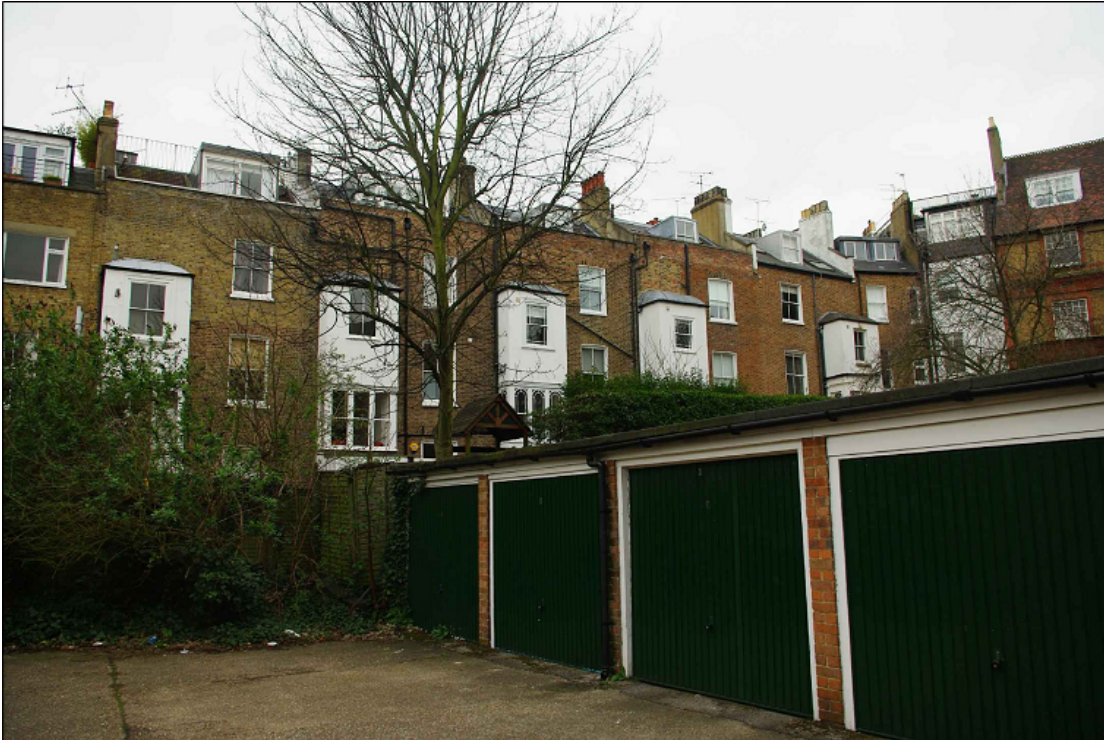
Photograph 1: View of existing garage block with T2 in background at 3 Belsize Place, London NW3 5AL

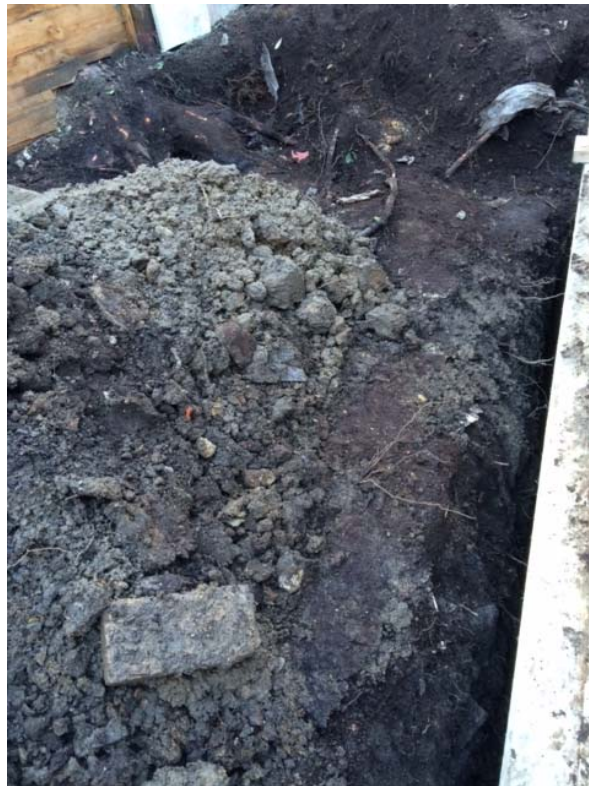
- 6.1.1 The primary impact of development is the location of the new garage block within the theoretical RPA of the sycamore tree, T2. Following consultation with the applicant, the footprint of the garage has been pulled back to 2m from the boundary fence leaving a theoretical encroachment of 5m² (12.3%). Two trial pits have established that there are few significant roots penetrating more than 1m into the site, and none at 2m distance. The single large buttress root entering the site was observed in TP2 to change direction approximately 1m into the site, growing straight down into the soil, with only fibrous roots found in TP1 located 2m in from the site boundary (see photographs 2 and 3 below).

- 6.1.2 Having established that no significant roots are present within the likely footprint of the redeveloped garage block (to the depth of its 600mm excavation), the founding of this structure can be supported, in the knowledge that will be no significant impact to the low quality tree or its roots. The impact of the proposal is therefore rated as low.

Photograph 2: Trial Pit 1 (trench 2m long and 700mm deep) only fibrous roots discovered

6.3.2 The limits of excavation within RPAs will be undertaken manually; any roots encountered will be cleanly pruned back to an appropriate junction with a sharp pruning saw or secateurs. Roots larger than 25mm diameter may only be cut in consultation with an arboriculturalist.

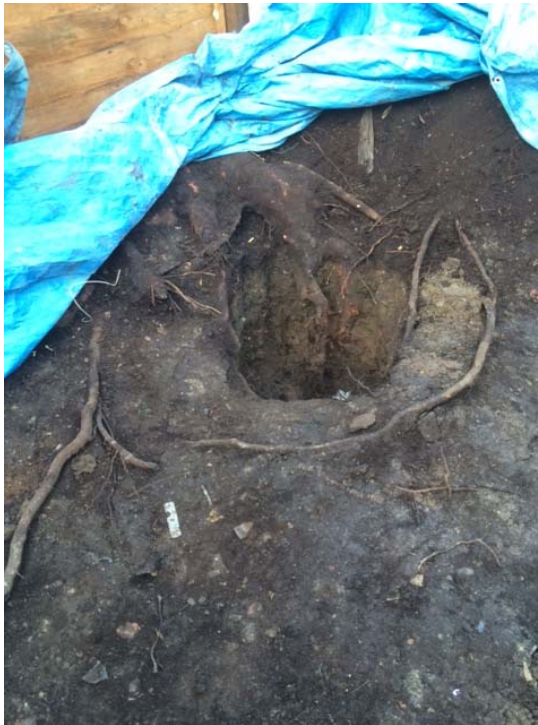
Photograph 3: Trial Pit 2 (300mm deep) showing surface buttress root growing straight down at this point

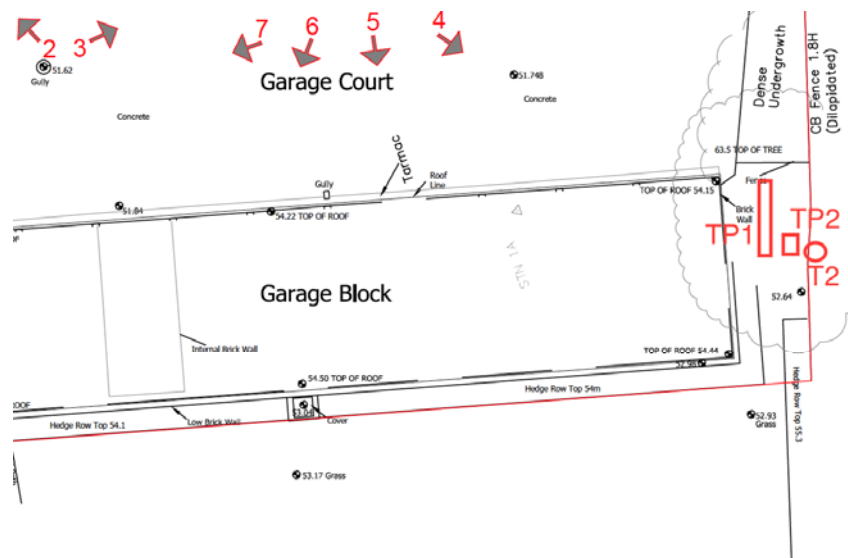
Plan Extract 1: Location of Trial Pits (sycamore referred to as T2)

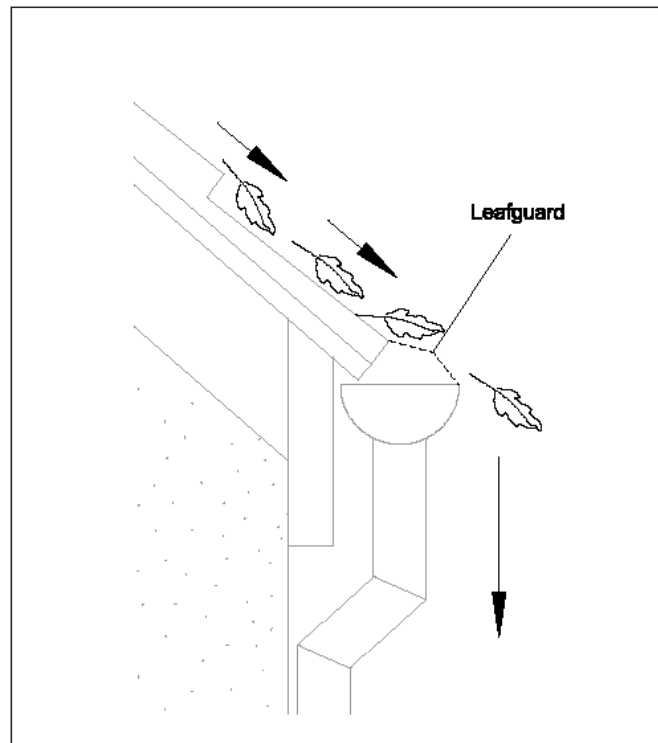
6.3.3 Nuisance deposition can be further mitigated with routine maintenance, light pruning / deadwooding and the fitting of filtration traps on guttering (see Figure 5 below).

Figure 5: Filtration traps, as shown above, could be fitted on the gutters which can easily be maintained at 2-3m above ground.
