### **Arboricultural Survey (BS5837:2012) & Impact Assessment Report**

Junior Branch  
University College School  
11 Holly Hill  
London  
NW3 6QN

1st February 2016

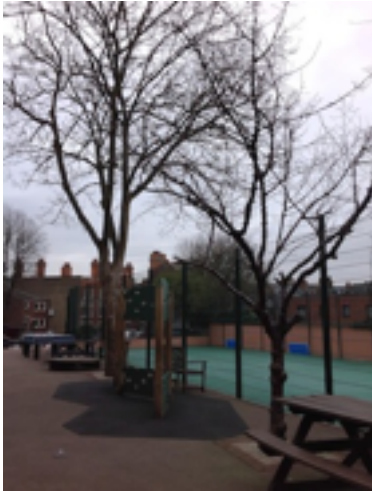
C.1 Photograph of trees T1 and T2, Junior Branch, University College School, 11 Holly Hill, London, NW3 as viewed in an easterly direction

4.10 Tree T1 is a mature ornamental Tibetan Cherry (*Prunus serrula*) located within the strip of land between the main school building and the playground area. The tree is sited at the western end of the area adjacent to the Science Block and Cloister where alterations and development works are proposed. The tree is generally structurally sound and offers good ornamental value but limited amenity value due to its limited growth habit and likely compacted ground and growing conditions.

4.10 Tree T2 is a mature Sycamore (*Acer pseudoplatanus*) located similarly to tree T1, between the main school building and the playground area. Located within a planting pit which has likely been constructed surrounding the tree a significant period after the actual establishment of the tree, the tree shows some signs of declining vigour in the upper crown.

4.11 The well balanced specimen is generally structurally sound and the deadwood within the crown is minor only. With a relatively light pruning history the tree has a balanced mid and upper canopy lightly encroaching towards the school building and also over the playground area. The tree is rated as a 'C.1' category tree (BS5837: 2012) offering reasonable amenity value and is therefore proposed for retention.

4.11 The tree is proposed for removal as its location is within the footprint of the development. The tree's loss will not affect the overall landscape of the school playground in this area and it is recommended that a tree of similar species is re-planted within the grounds to provide continued ornamental value for the long term.

4.13 As a solution to tree protection it is recommended that basal shuttering, as shown in *Appendix B.4.1*, is installed surrounding the main stem of tree

*Fell to ground level and grind out stump*

*Remove deadwood*

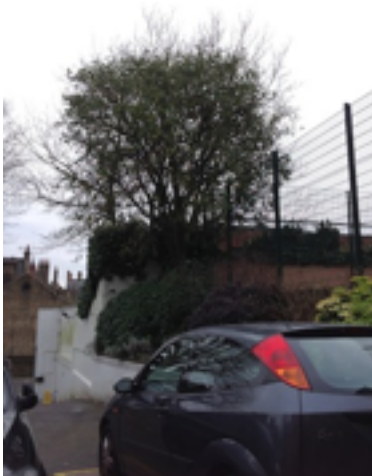
C.2 Photograph of tree T3, Junior Branch, University College School, 11 Holly Hill, London, NW3 as viewed in a southerly direction

4.14 Tree T3 is a mature Alder tree (*Alnus spp*) which is located on the southern boundary in the raised planter area / mid wall area directly adjacent to the access driveway. The tree provides good ornamental value with some amenity value to this area and is generally structurally sound. The tree is rated as 'C.1' (BS5837:2012) taking into account the above factors and limited visibility within the overall streetscape.

4.15 This tree is sited within close proximity of the proposed works which are minor and incorporate alterations to the mid wall only. The soft landscape area will remain in situ and therefore protection measures are not required for this tree. The recommended root protection distance is 4.3m (BS5837:2012) for this tree, and the boundary wall to the east where alterations will be taking place is 1.6m distance from the tree. However the retained tree roots within this raised area will remain unaffected. In addition the tree's main stem and canopy will not be affected by the development process and therefore protection measures are not proposed.

*Crown reduce to previous reduction points leaving some soft furnishing growth*

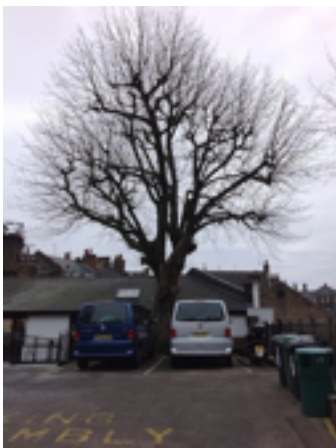
C.3 Photograph of tree T4, Junior Branch, University College School, 11 Holly Hill, London, NW3 as viewed in a southerly direction

4.16 Tree T4 is a mature Horse Chestnut tree (*Aesculus hippocastanum*) which is located on the southern boundary adjacent to the Art Building. This is a large tree which is located within very close proximity of the adjacent building (0.5m at the closest point) and associated retaining walls. However, the relationship between tree and building is clearly long standing and relatively harmonious. The tree shows overall good form with good vigour shown in the growth since previous reduction works 4-5 years ago. There is some seepage of liquid from the main stem along with large pruning wounds which have occluded well and the tree is surrounded by hard landscaping. However the tree is generally structurally sound and cyclical crown reduction works have been recommended to be carried out taking account of the tree's urban location within a busy school playground area.

4.17 The tree is rated as 'B.1' (BS5837:2012) taking into account the prominent location and high amenity value provided. This tree is at its closest point is sited in excess of 21.0 metres from the proposed development - East Balcony Deck - and taking into account its recommended root protection distance of 13.0m, its comprehensive protection is fully achievable. It is recommended that the tree protection fencing is installed as recommended in *Appendix B.4.2* to provide protection mainly from any associated construction site activities which could overspill from the development site.

4.18 The tree protection fencing is recommended 7.0 metres from the main stem of tree T4 to allow for protection of the tree to the north within the playground area. Obviously to the south, east and west, this tree will remain fully protected by virtue of its location adjacent to the Art Building. To the north the encroachment of the fencing within the recommended 13.0m root protection radius (BS5837:2012) is possible due to the existing hard landscape which will remain in situ during the construction works. The fencing will allow for protection of the canopy, main stem and initial northern root plate whilst also providing sufficient space for construction site activities within the relatively limited space of this site.

*Crown reduce to previous reduction points leaving some soft furnishing growth*

*Remove any remaining deadwood*

*Crown thin 15%*

*Crown lift to 5m*

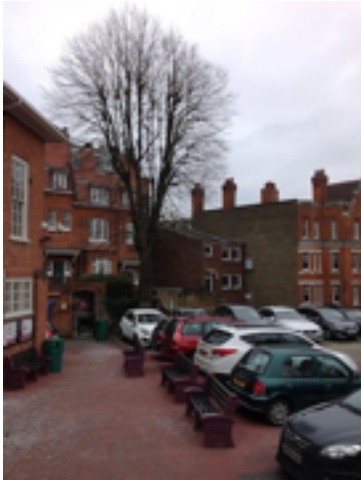
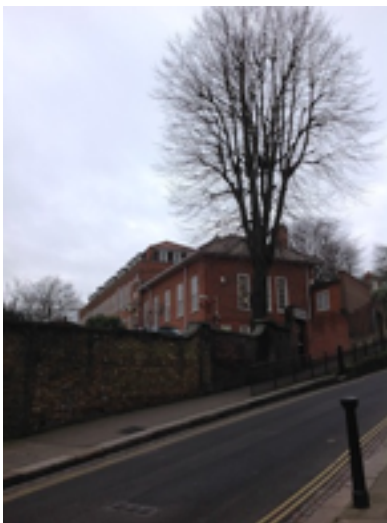
C.4 Photograph of tree T5, Junior Branch, University College School, 11 Holly Hill, London, NW3 as viewed in an easterly direction

4.19 Tree T5 is a mature Lime tree (*Tilia spp*) which is located on the eastern boundary adjacent to the boundary wall with Holly Hill. The tree is currently growing with a slight lean at the base to the east, sited 0.1m from the boundary wall at this point and growing directly against the wall at 1.6m height. After this point, the tree straightens to provide a balanced crown which is cyclically crown reduced to provide a compact and balanced tree; crown reduction works were last carried out approximately 4-5 years ago and these works have been recommended within this report. The tree is generally structurally sound and offers excellent amenity value being rated as a category 'B.1' (BS5837:2012) specimen.

4.20 The root protection area recommended for tree T5 is 8.2 metres and the development encroaches within the area. The closest point of ground works is proposed 5.2m from the main stem of tree T5 and this is the installation of a single steel post which will support the composite timber decking and painted steel structural framework above. This is the only significant excavation required within the protected root plate area of the tree and therefore this will require a careful hand dug approach as outlined within the *Tree Protection Specifications* below. This is particularly important due to the urban nature of this tree's location and the likely adventitious root system that has developed.

4.21 The re-landscaping works will allow for an extension of the soft landscape area by up to 1.1m to the south and west in a curved and informal planting border. This will in the long term benefit the tree as it will provide further permeable ground for water to access the root system. In order to provide protective fencing it is recommended that the tree protection fencing is installed on this proposed line as shown in *Appendix B.4.1*, to provide protection to both the main stem and the initial root plate during the construction process. This will allow for sufficient space for the implementation of the raised decking area whilst protecting the exposed ground surrounding the tree and main stem also. The remainder of the ground within the root protection area should remain as hard standing with the root plate protected beneath, with the exception of excavations for the supporting steel foundation where strict adherence to the tree protection guidelines as below should be applied. With additional hard landscape works within the root protection area of this tree (8.2m from the main stem) close adherence to the *Hard Landscaping Removal* guidelines below should be applied.

*Crown reduce to previous reduction points leaving some soft furnishing growth*

*Remove any remaining deadwood*

*Crown thin 15%*

*Crown lift to 5m including removal of all epicormic growth to this point*
