CLIVE FOWLER ASSOCIATES
Tree Consultancy

29th January 2016

**Methodology - Trees in Relation to the Relocation of the Driveway at
16 Millfield Lane, Highgate, London.**

Clive Fowler Associates: Tree Survey at 16 Millfield Lane, Highgate, London.

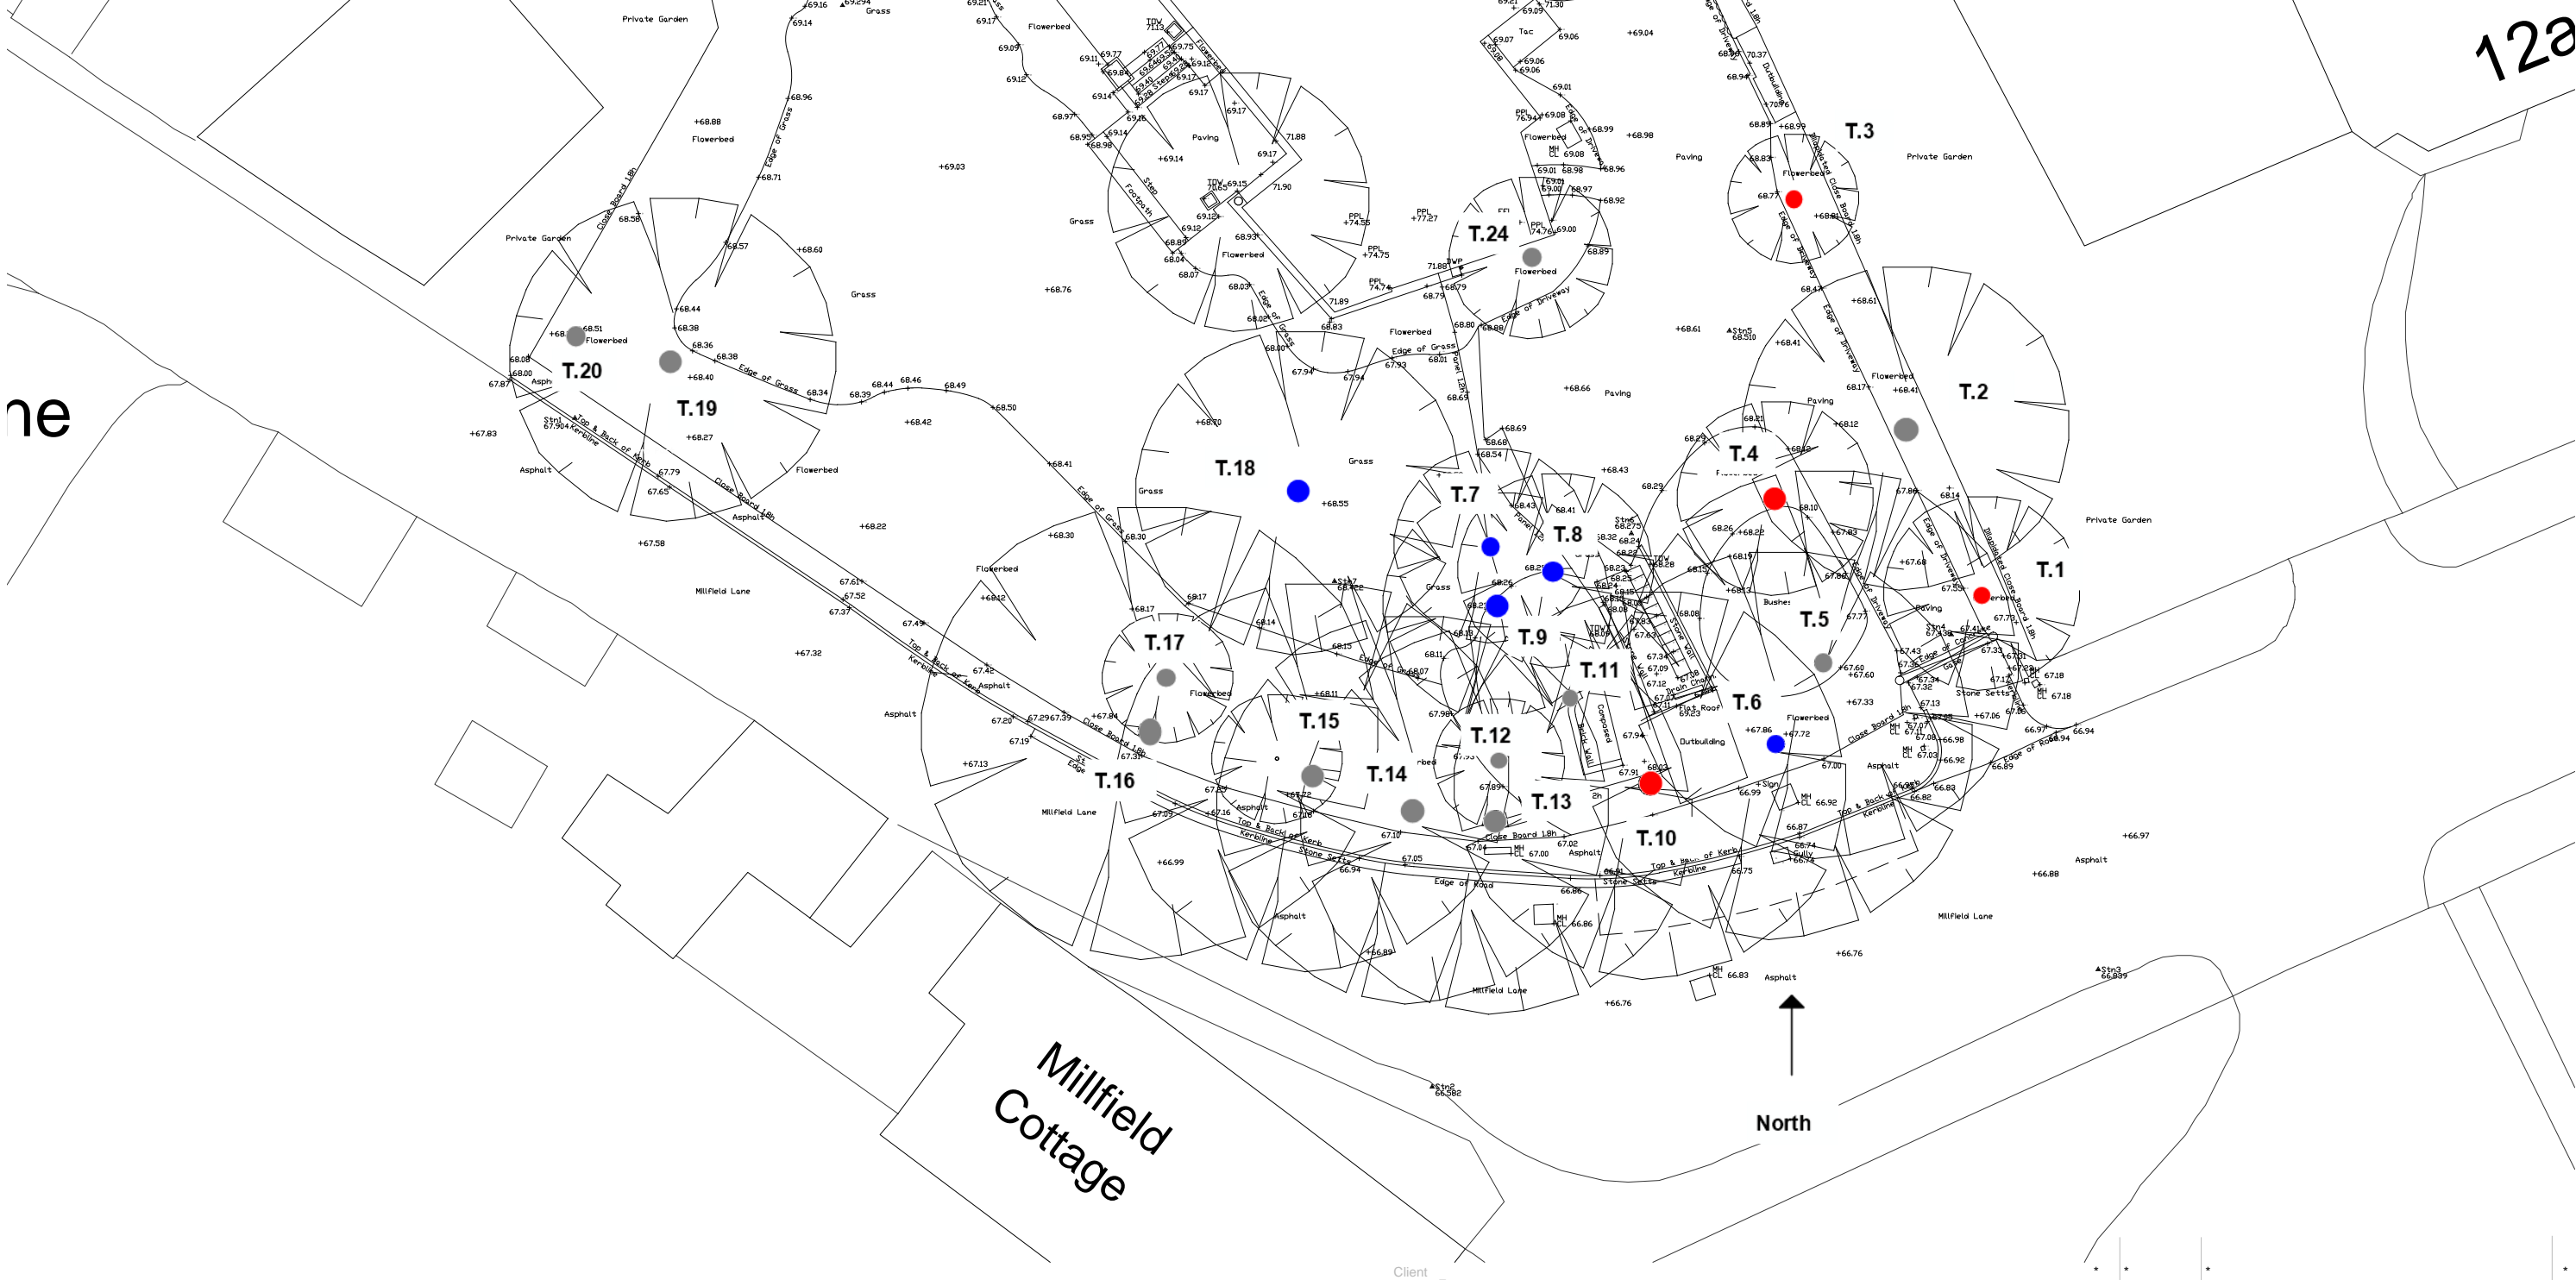
Tree Location Plan.
(January 2016).
Originally produced in colour.

2. As the poplars have been pollarded since my original visit, thus reducing their aesthetic / amenity value, they have been regraded in some cases (in accordance with BS5837: 2012) and I have subsequently updated the attached Tree Survey Schedule (appendix 'a') and Tree Location Plan (appendix 'b') to take this into account.

to Design, Demolition and Construction - Recommendations'. I have also categorised each tree in accordance with the above Standard and they are colour coded on the attached drawing (appendix 'b') to aid their recognition.

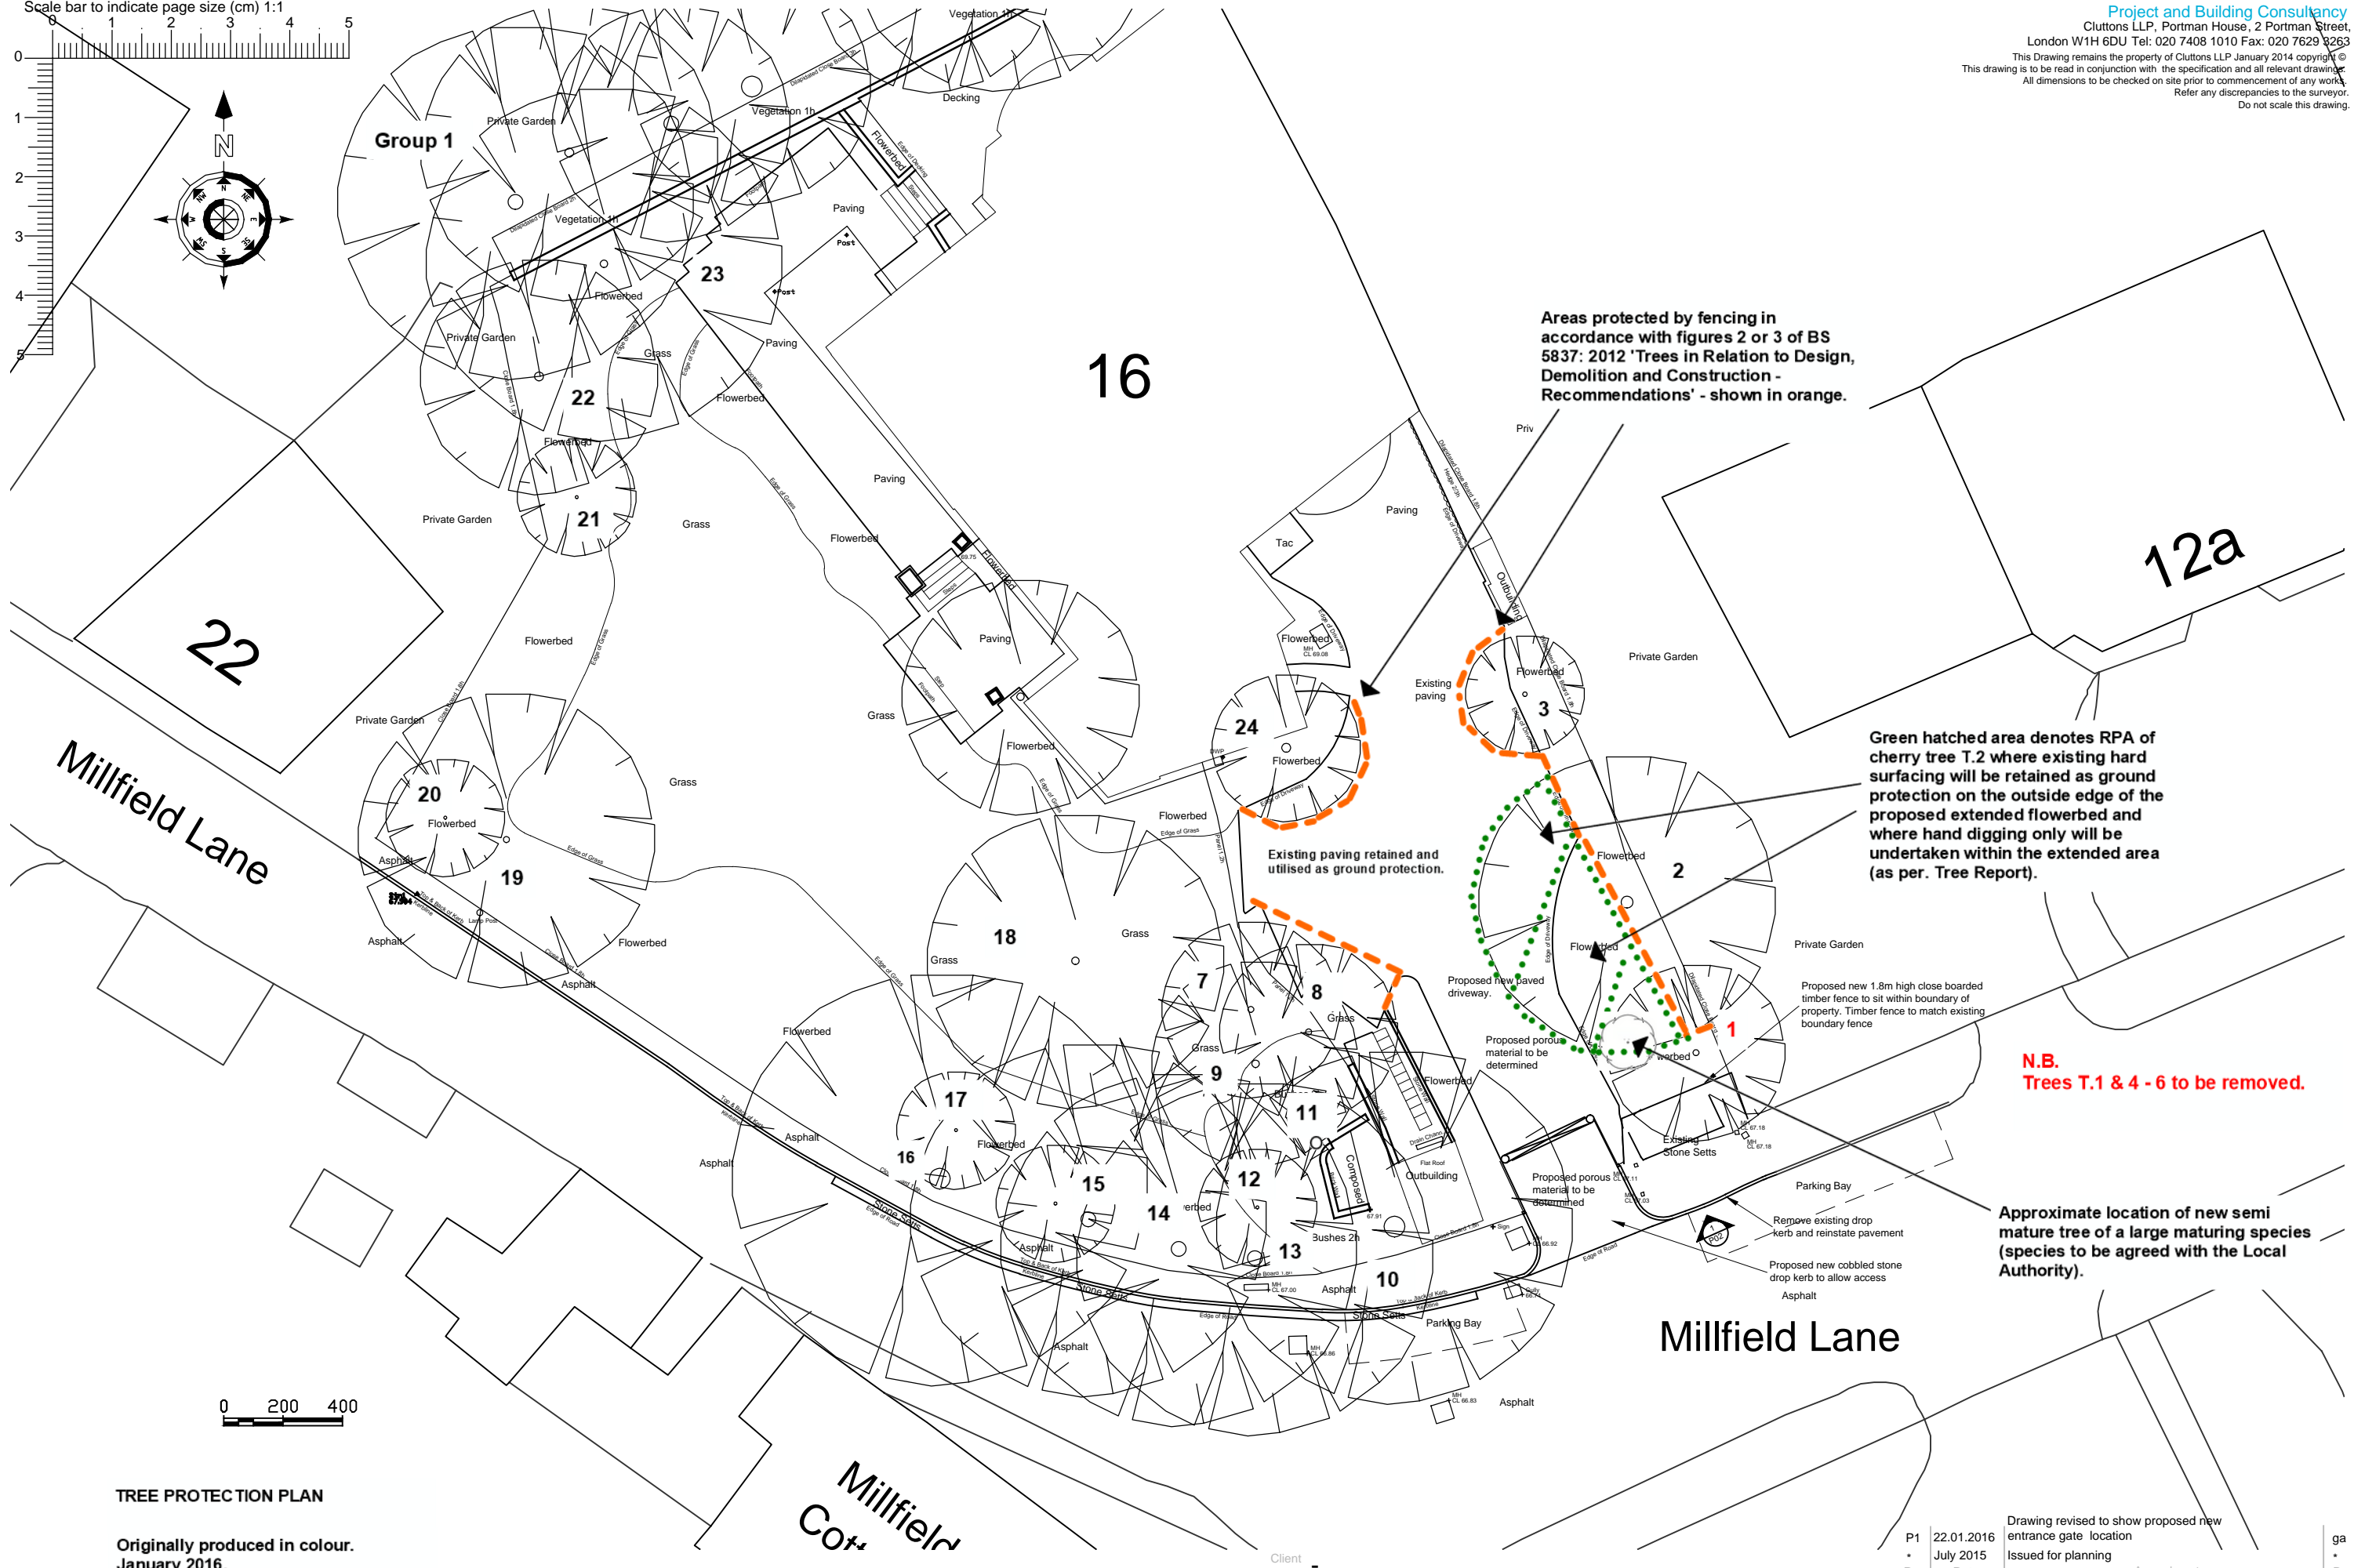
TREE PROTECTION PLAN

17. Following the removal of the existing hard surfacing, the new edging (as shown on the Tree Protection Plan at appendix 'e') will be placed upon the existing sub-base (ensuring that no excavations are required below such level) and all such works will be undertaken in accordance with Section 7.2 of BS5837: 2012 as detailed below;
