Which? HQ 2 Marylebone Road London, NW1 4DF

Part 1 Tree Survey Report

October 2015

Client: Which? Landscape Consultant: Charles Funke Associates

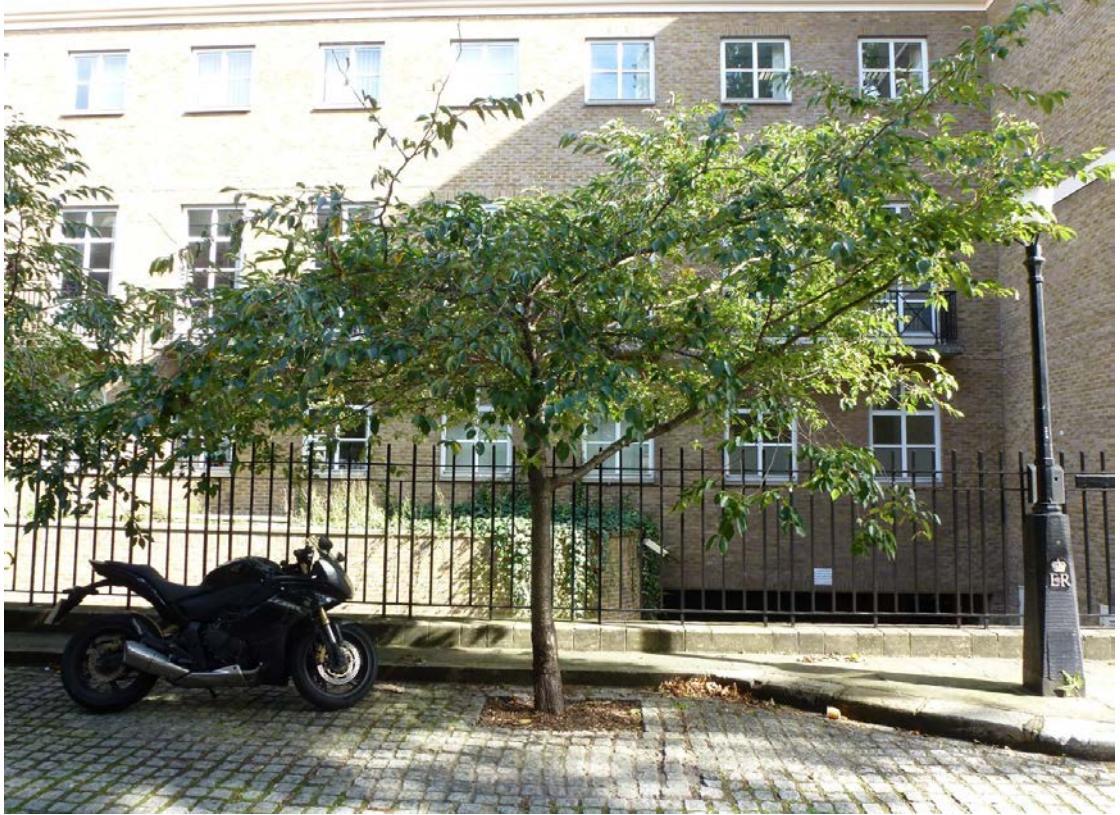
Image 01 Showing T1

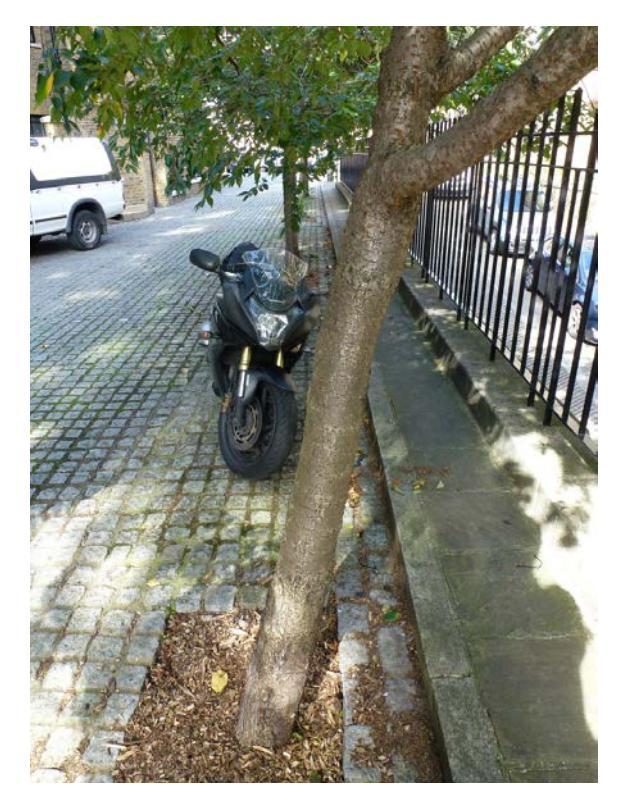
Image 02 Image showing T1 trunk leaning East.

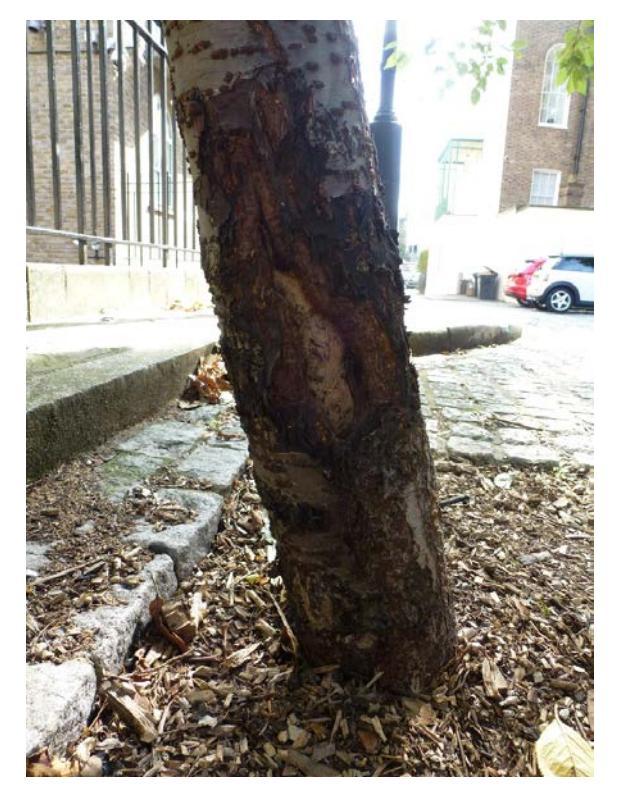
Image 03 Image showing T1 trunk damage.

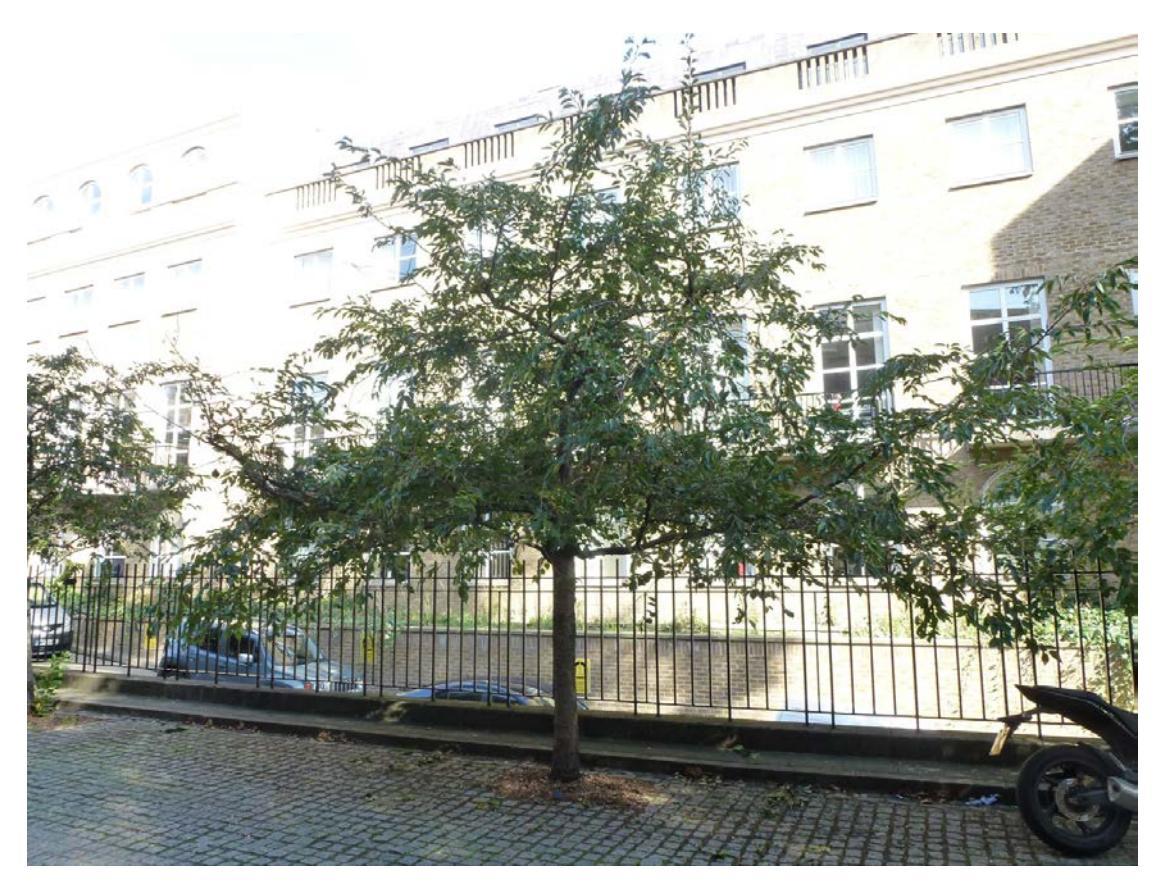
Image 04 Showing T2

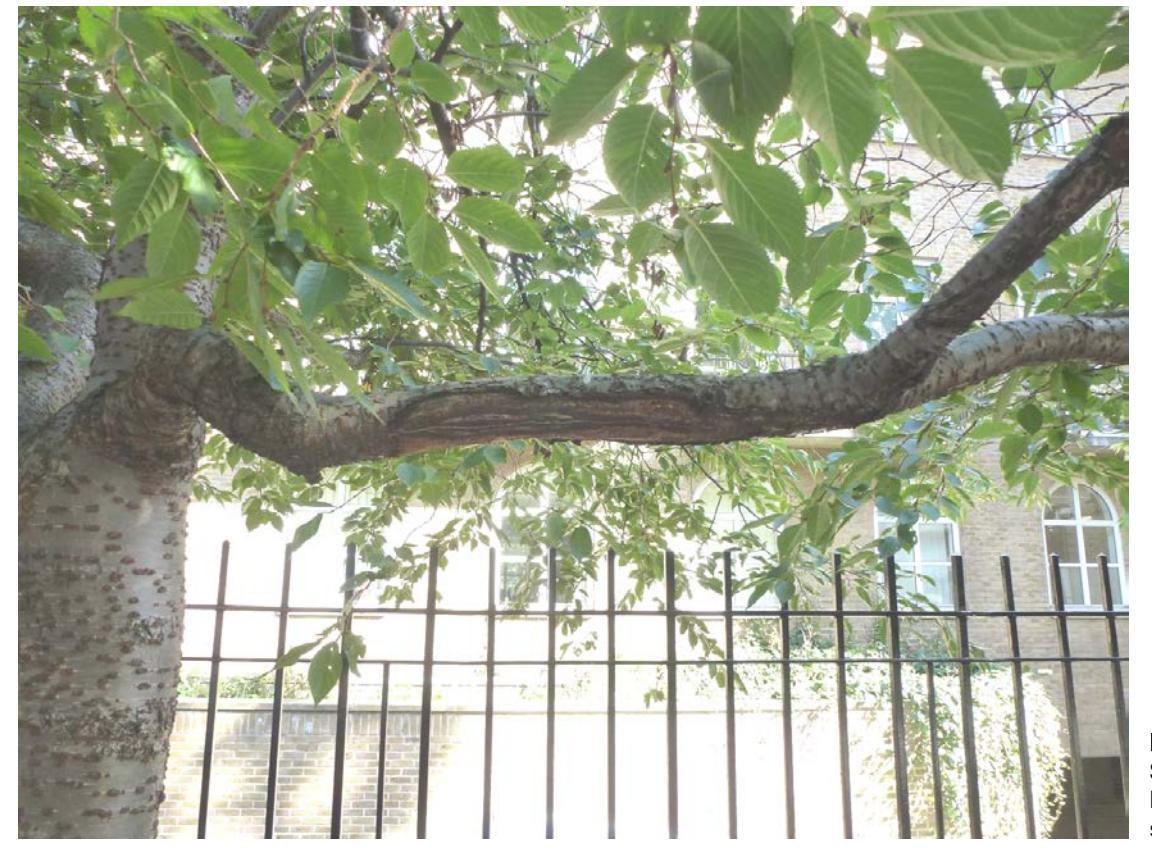
Image 05 Showing T2. Damage to first significant branch.

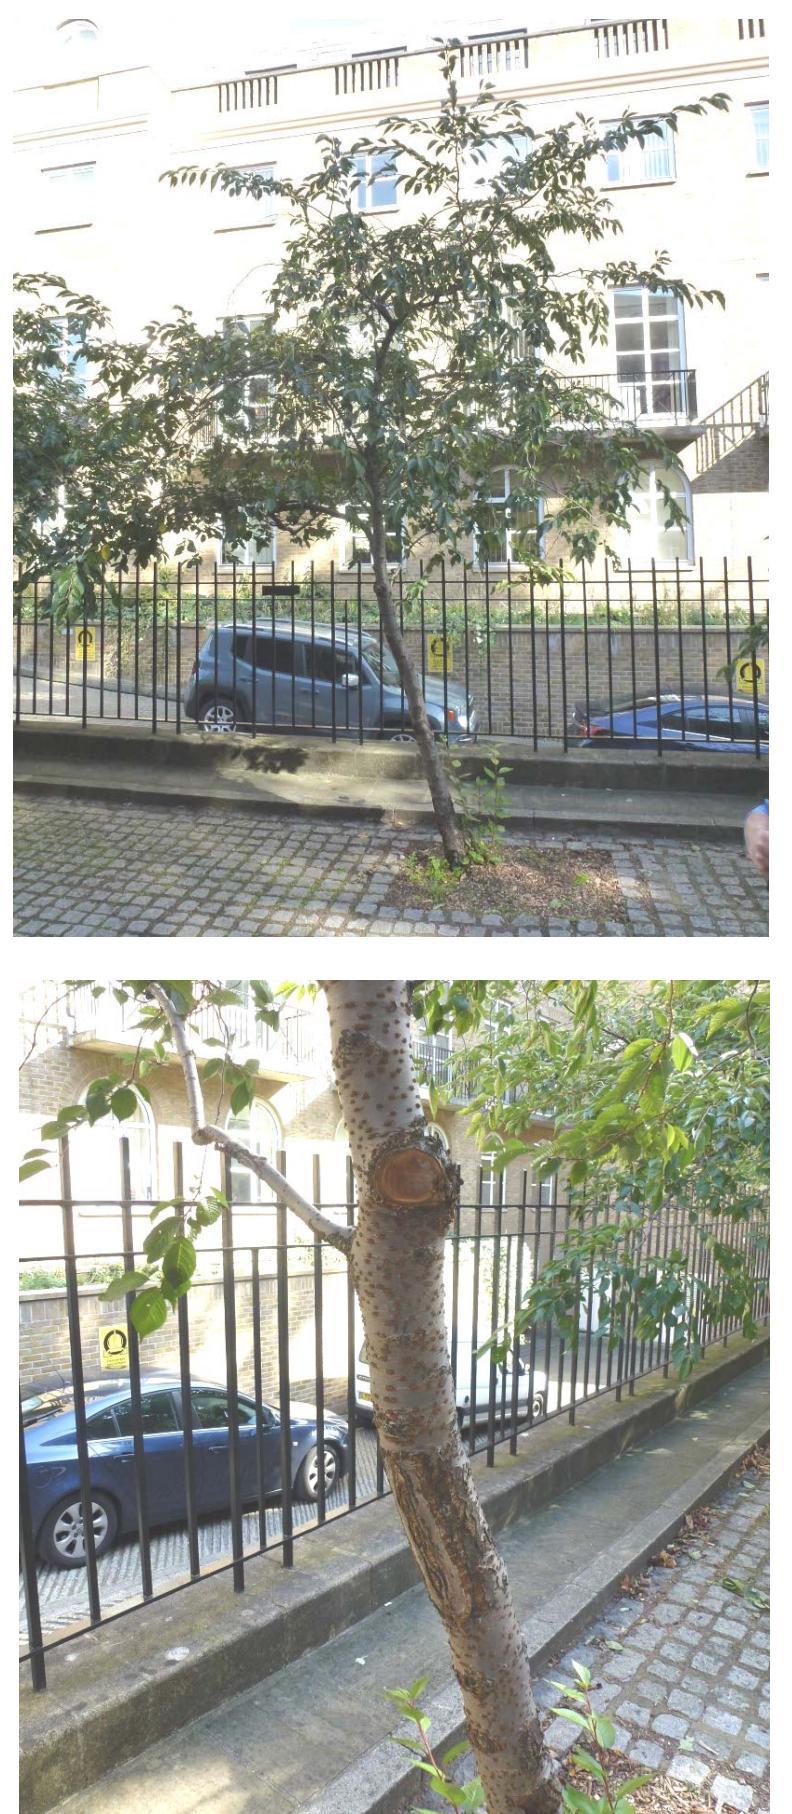
Image 06 Showing T3.

Image 07 Damage to T3 trunk and branch removal. Tree is leaning North and showing signs of stress due to epicormic growth et base of tree at base of tree.

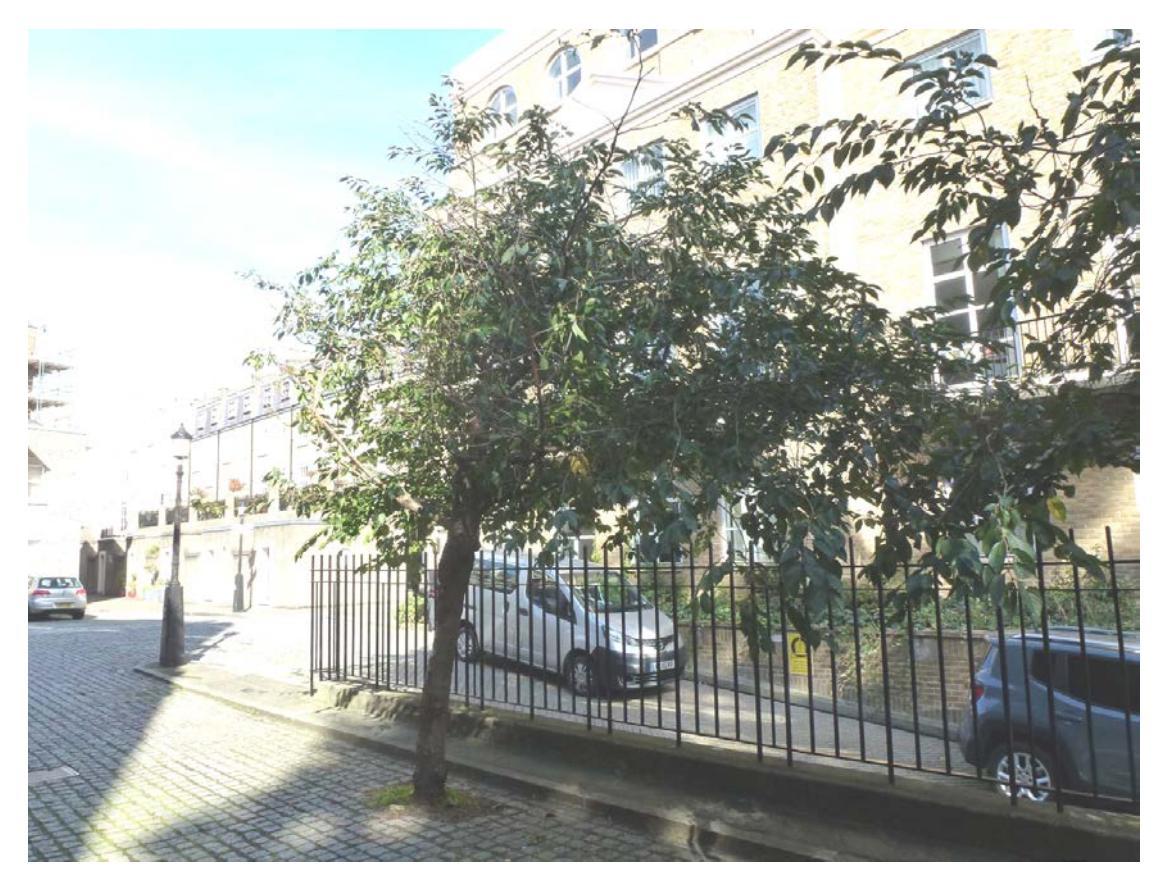
Image 08 Showing T4.

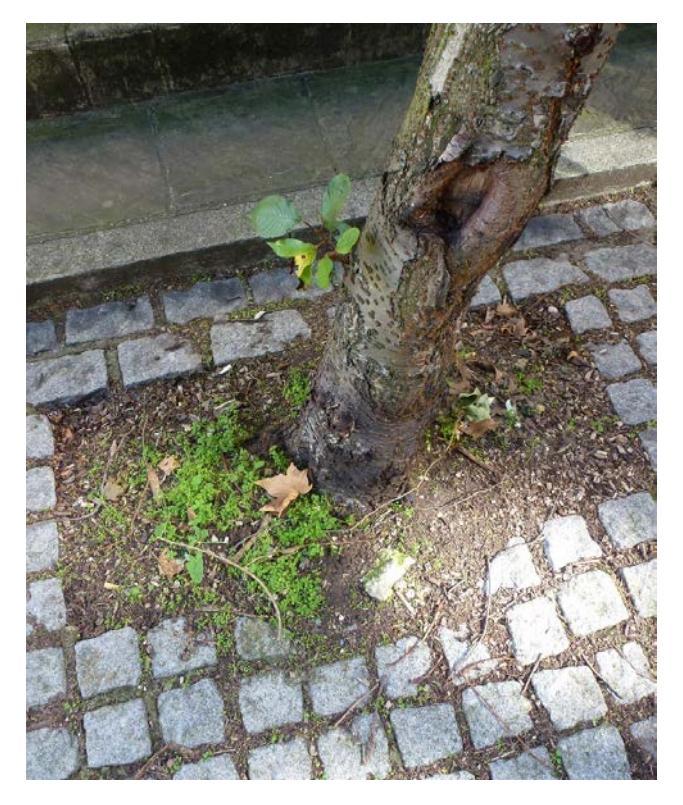
Image 09 Image showing T4 base. T4 leans to the South.

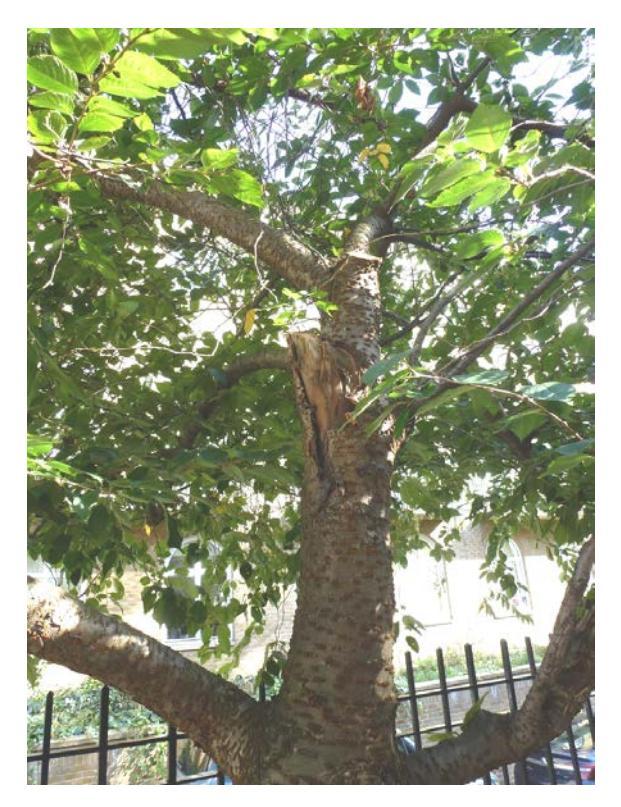
T4 Canopy. There is substantial damage to the crown. Branches have been removed and / or damaged.. There is also significant crown die-back on the West face (see Image 11).

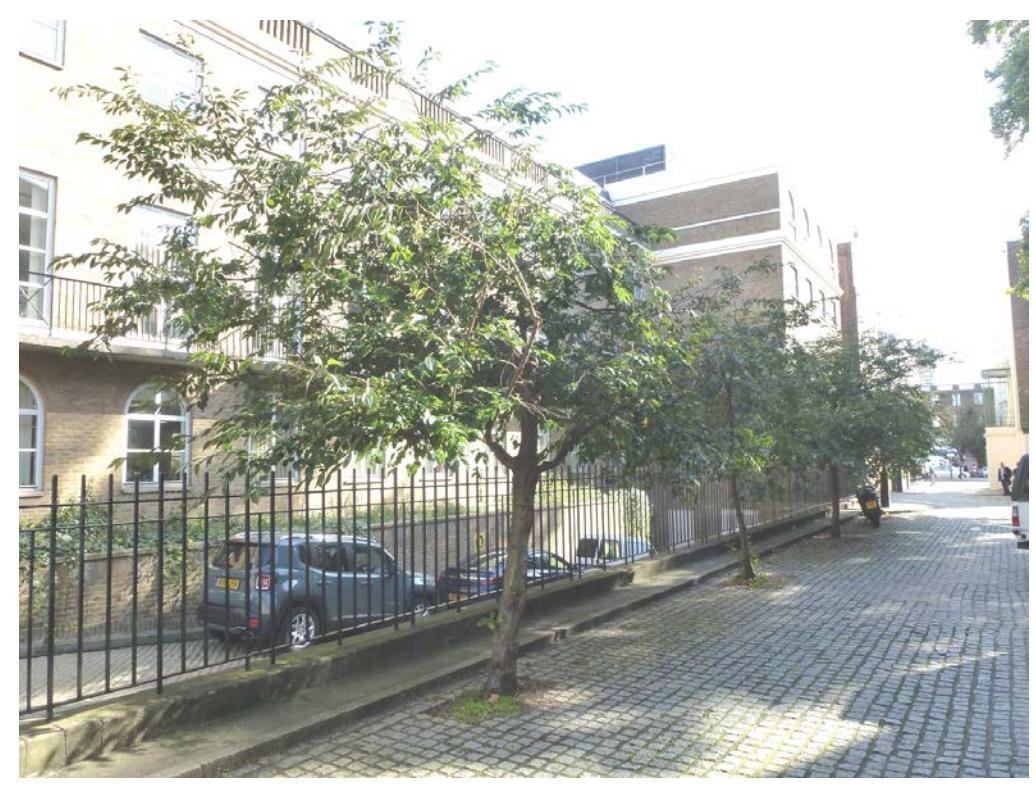
#### Image 11

Image of T1 – T4 looking South East. T4 is in foreground with retaining wall to vehicle ramp behind.

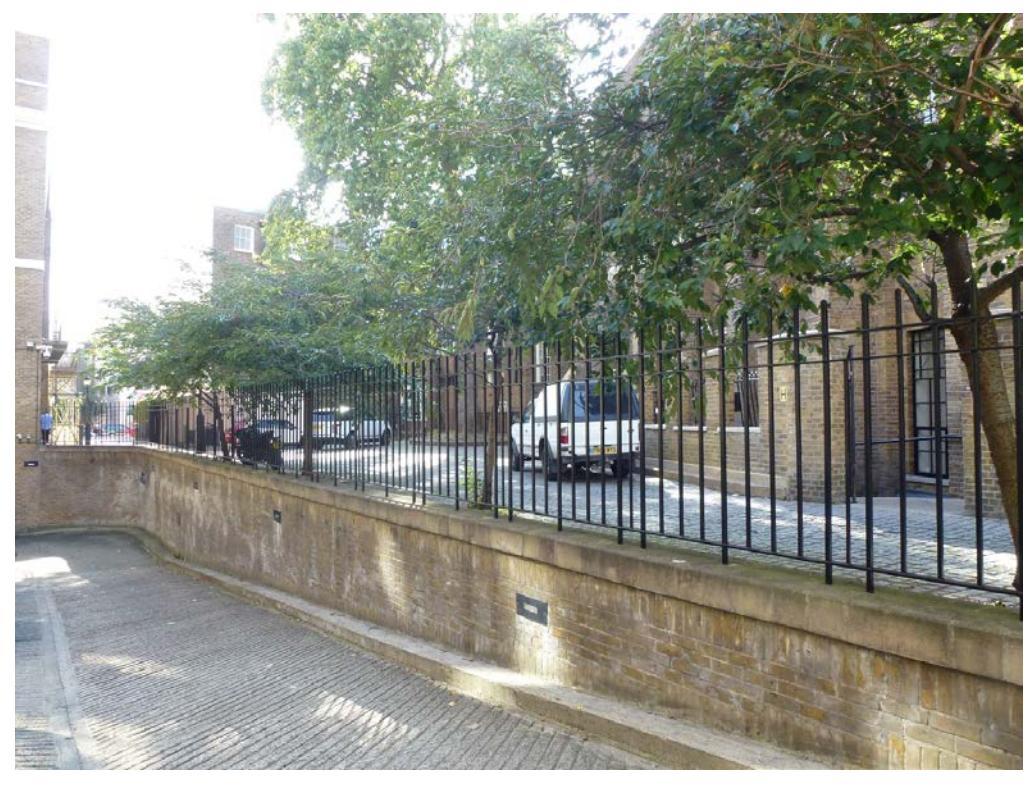
#### Image 12

Image of T1 – T4 looking South West with Basement carpark ramp retaining wall in foreground.
