13 Kemplay Road, Hampstead

Tree Survey Report

1st March 2016

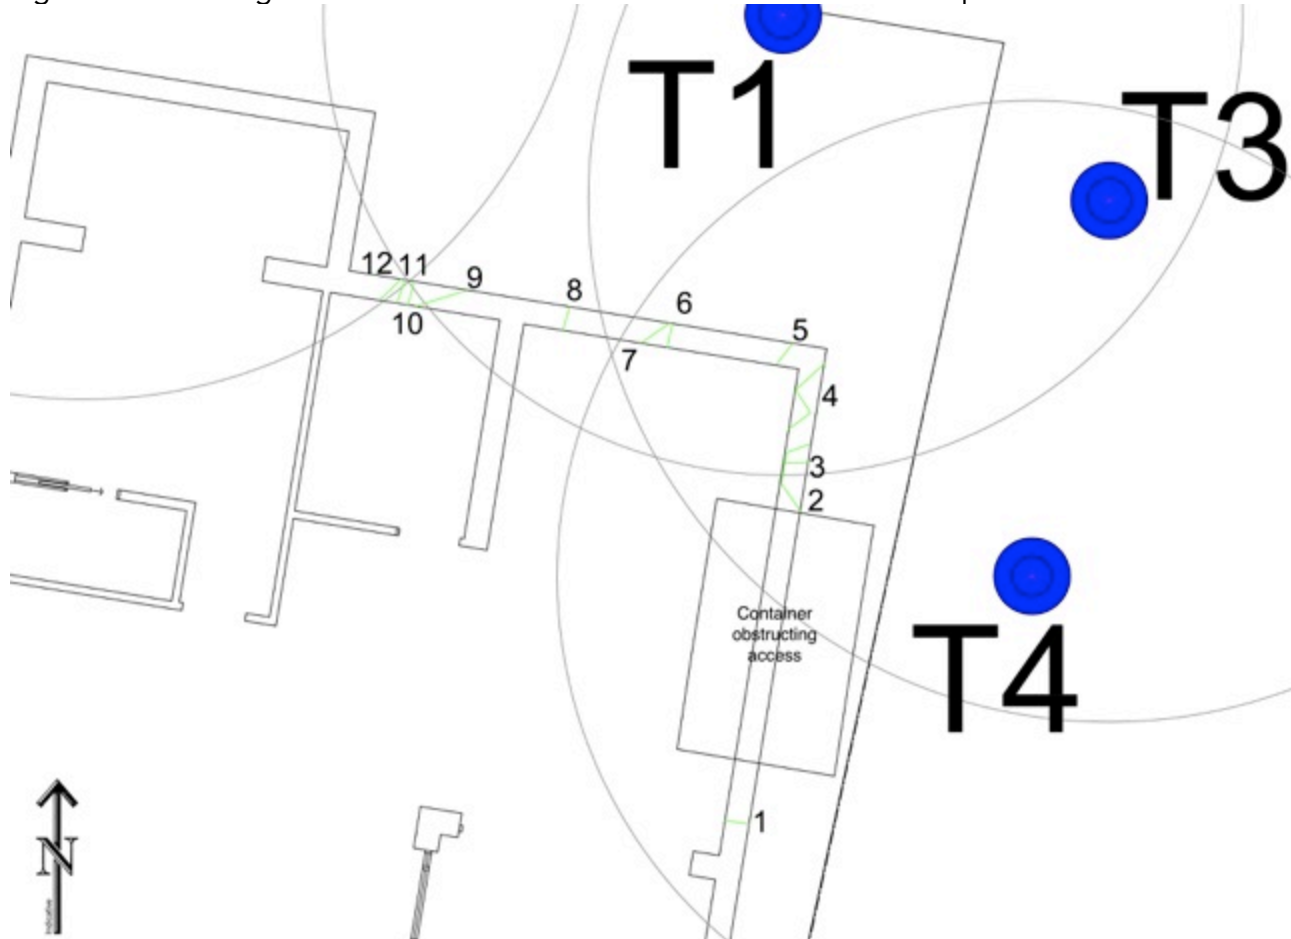
Figure 2: Illustrating the location of roots recorded within the basement perimeter/RPAs

In relation to T1 and T3-4 and the exploratory root investigations, of the twelve roots identified in Section 3, the majority (10) have a diameter of 25mm or below and two roots have a diameter 35mm.

The majority of the roots found are 25mm or below which indicates they can be pruned if necessary in accordance with the BS. However, two of the roots found on the northern flank of the proposed basement line are above 25mm in diameter and considering the limited rooting space of T1, these roots are considered to be significant and should therefore be retained as detailed in a subsequent section.

To minimise the impact of the proposed works on the trees, it is recommended that the excavation line of the northern flank is moved one metre south from the current position, which will ensure that a total of 5.5m² of available rooting space can be retained. The wall of the ground floor can continue along the line of the existing dwelling as the foundation can be cantilevered from the basement wall.

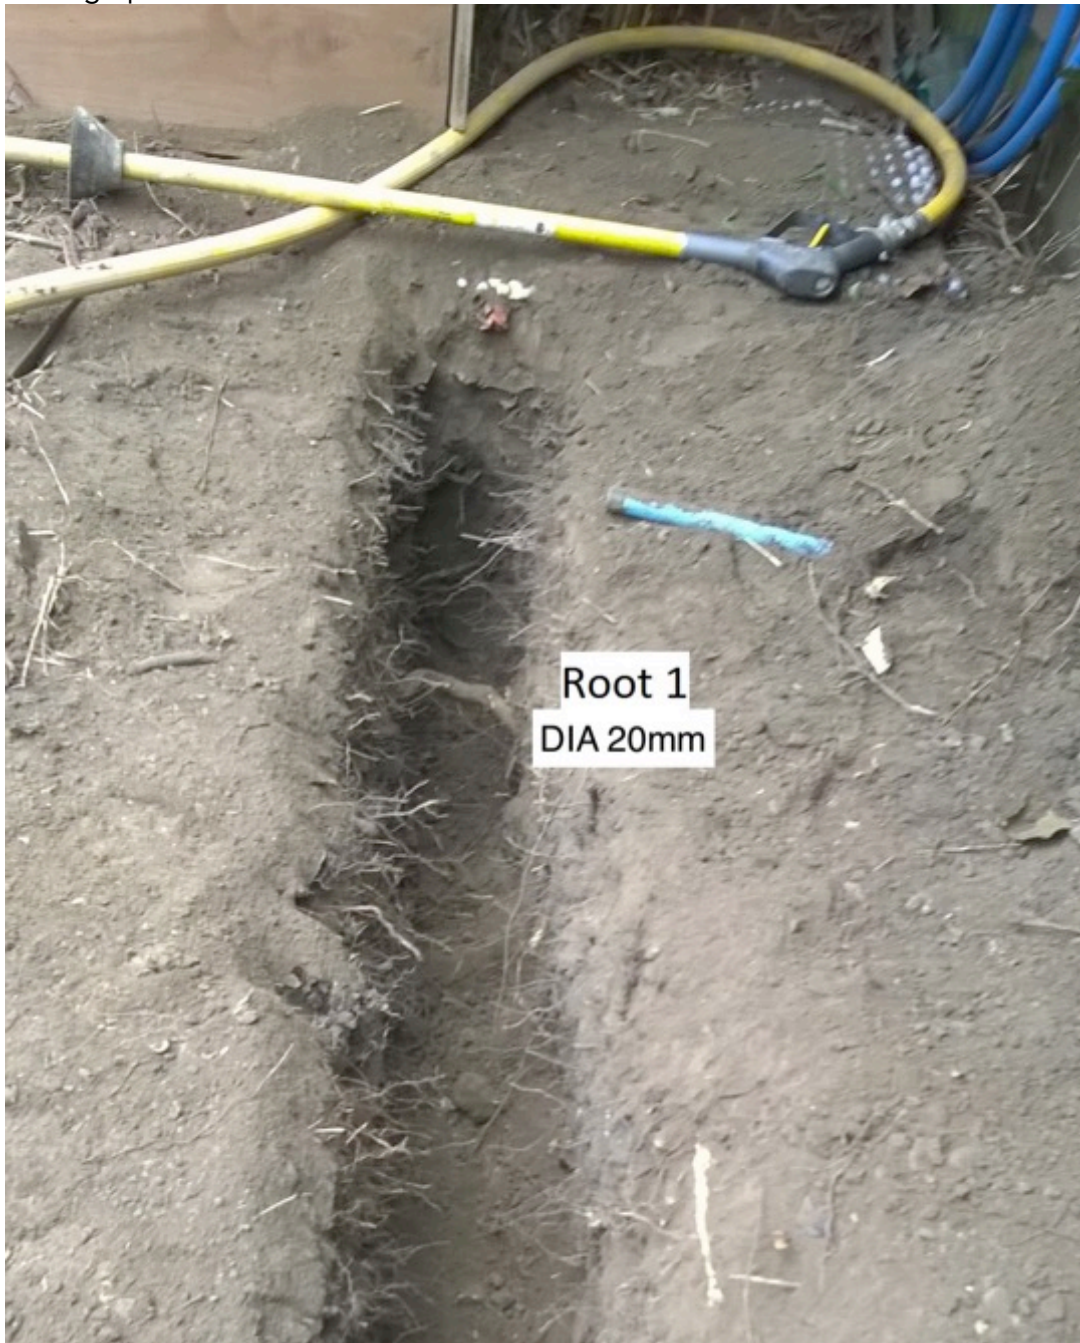
Photograph 1: Root 1

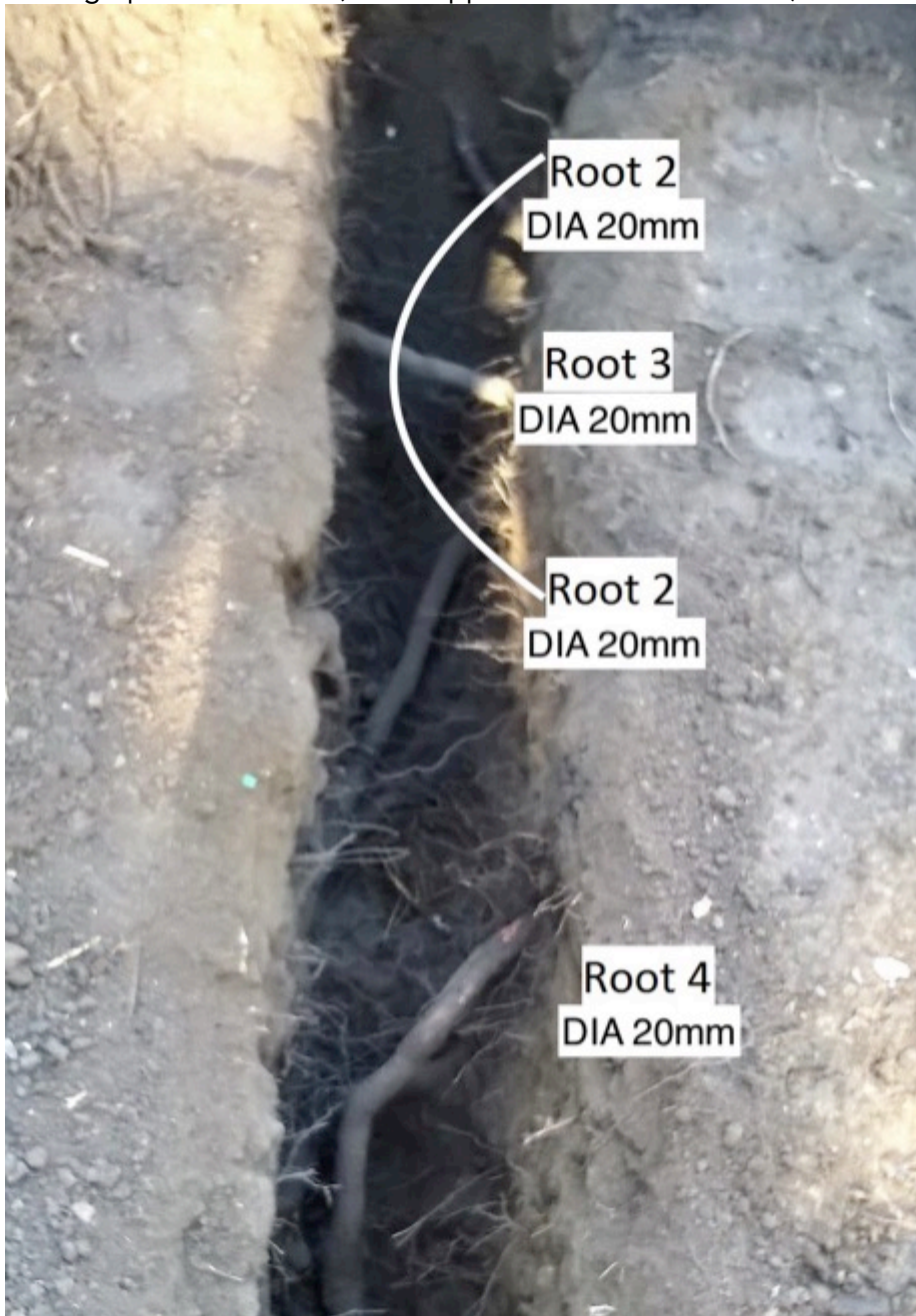
Photograph 2: Roots 2-4 (root 2 appears twice in the trench)

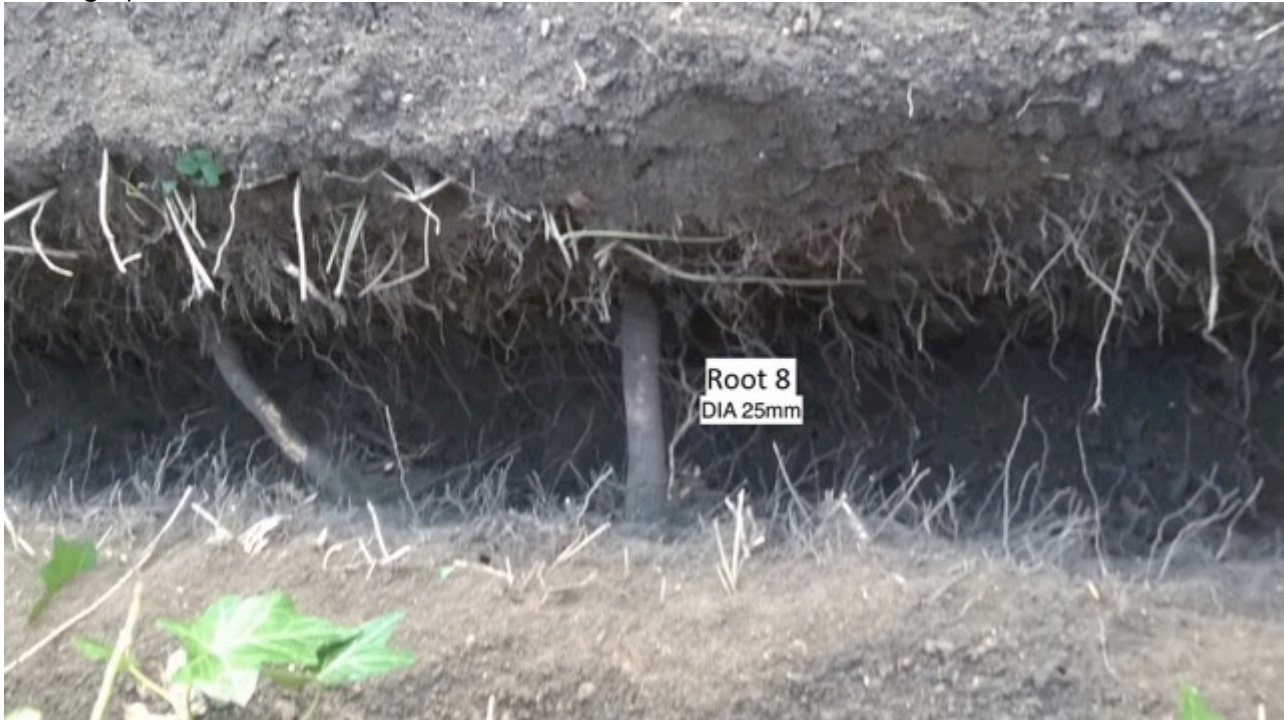
Photograph 5: Root 8

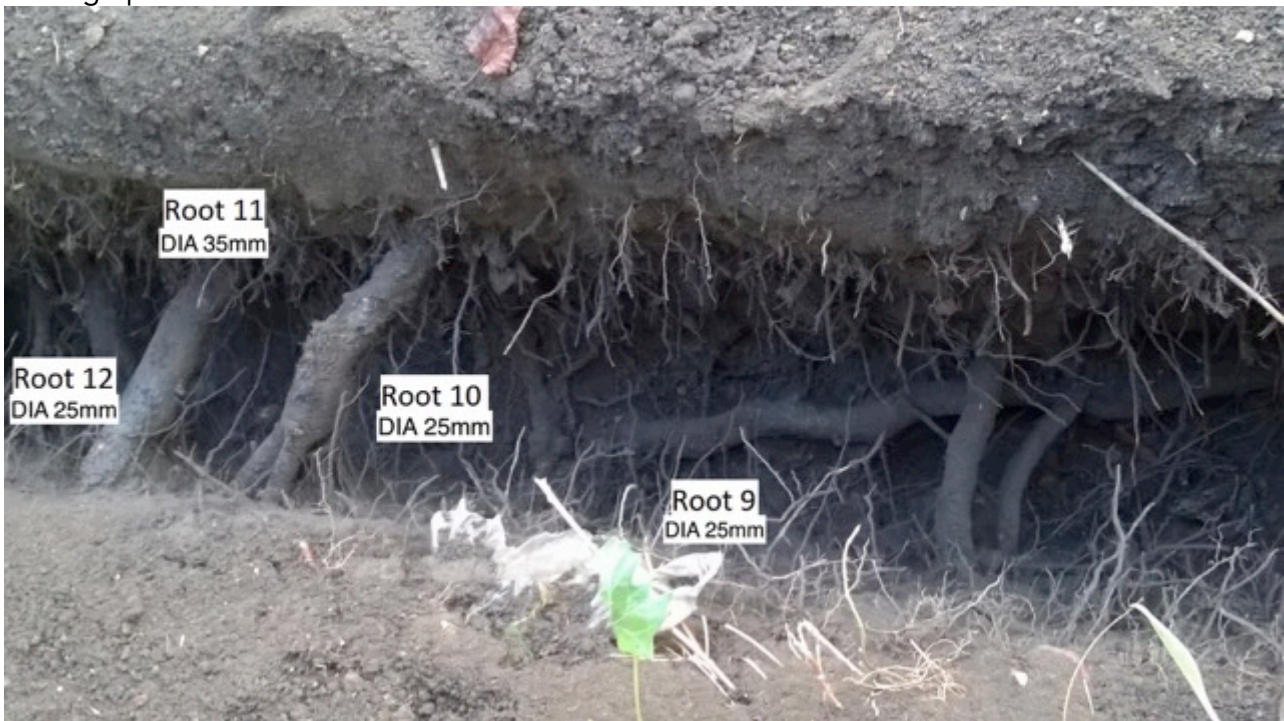
Photograph 6: Roots 9-12
