**Chestnut Cottage, Vale-of-  
Health, London**

Arboricultural Impact  
Assessment

Arboricultural Method  
Statement

March 2016

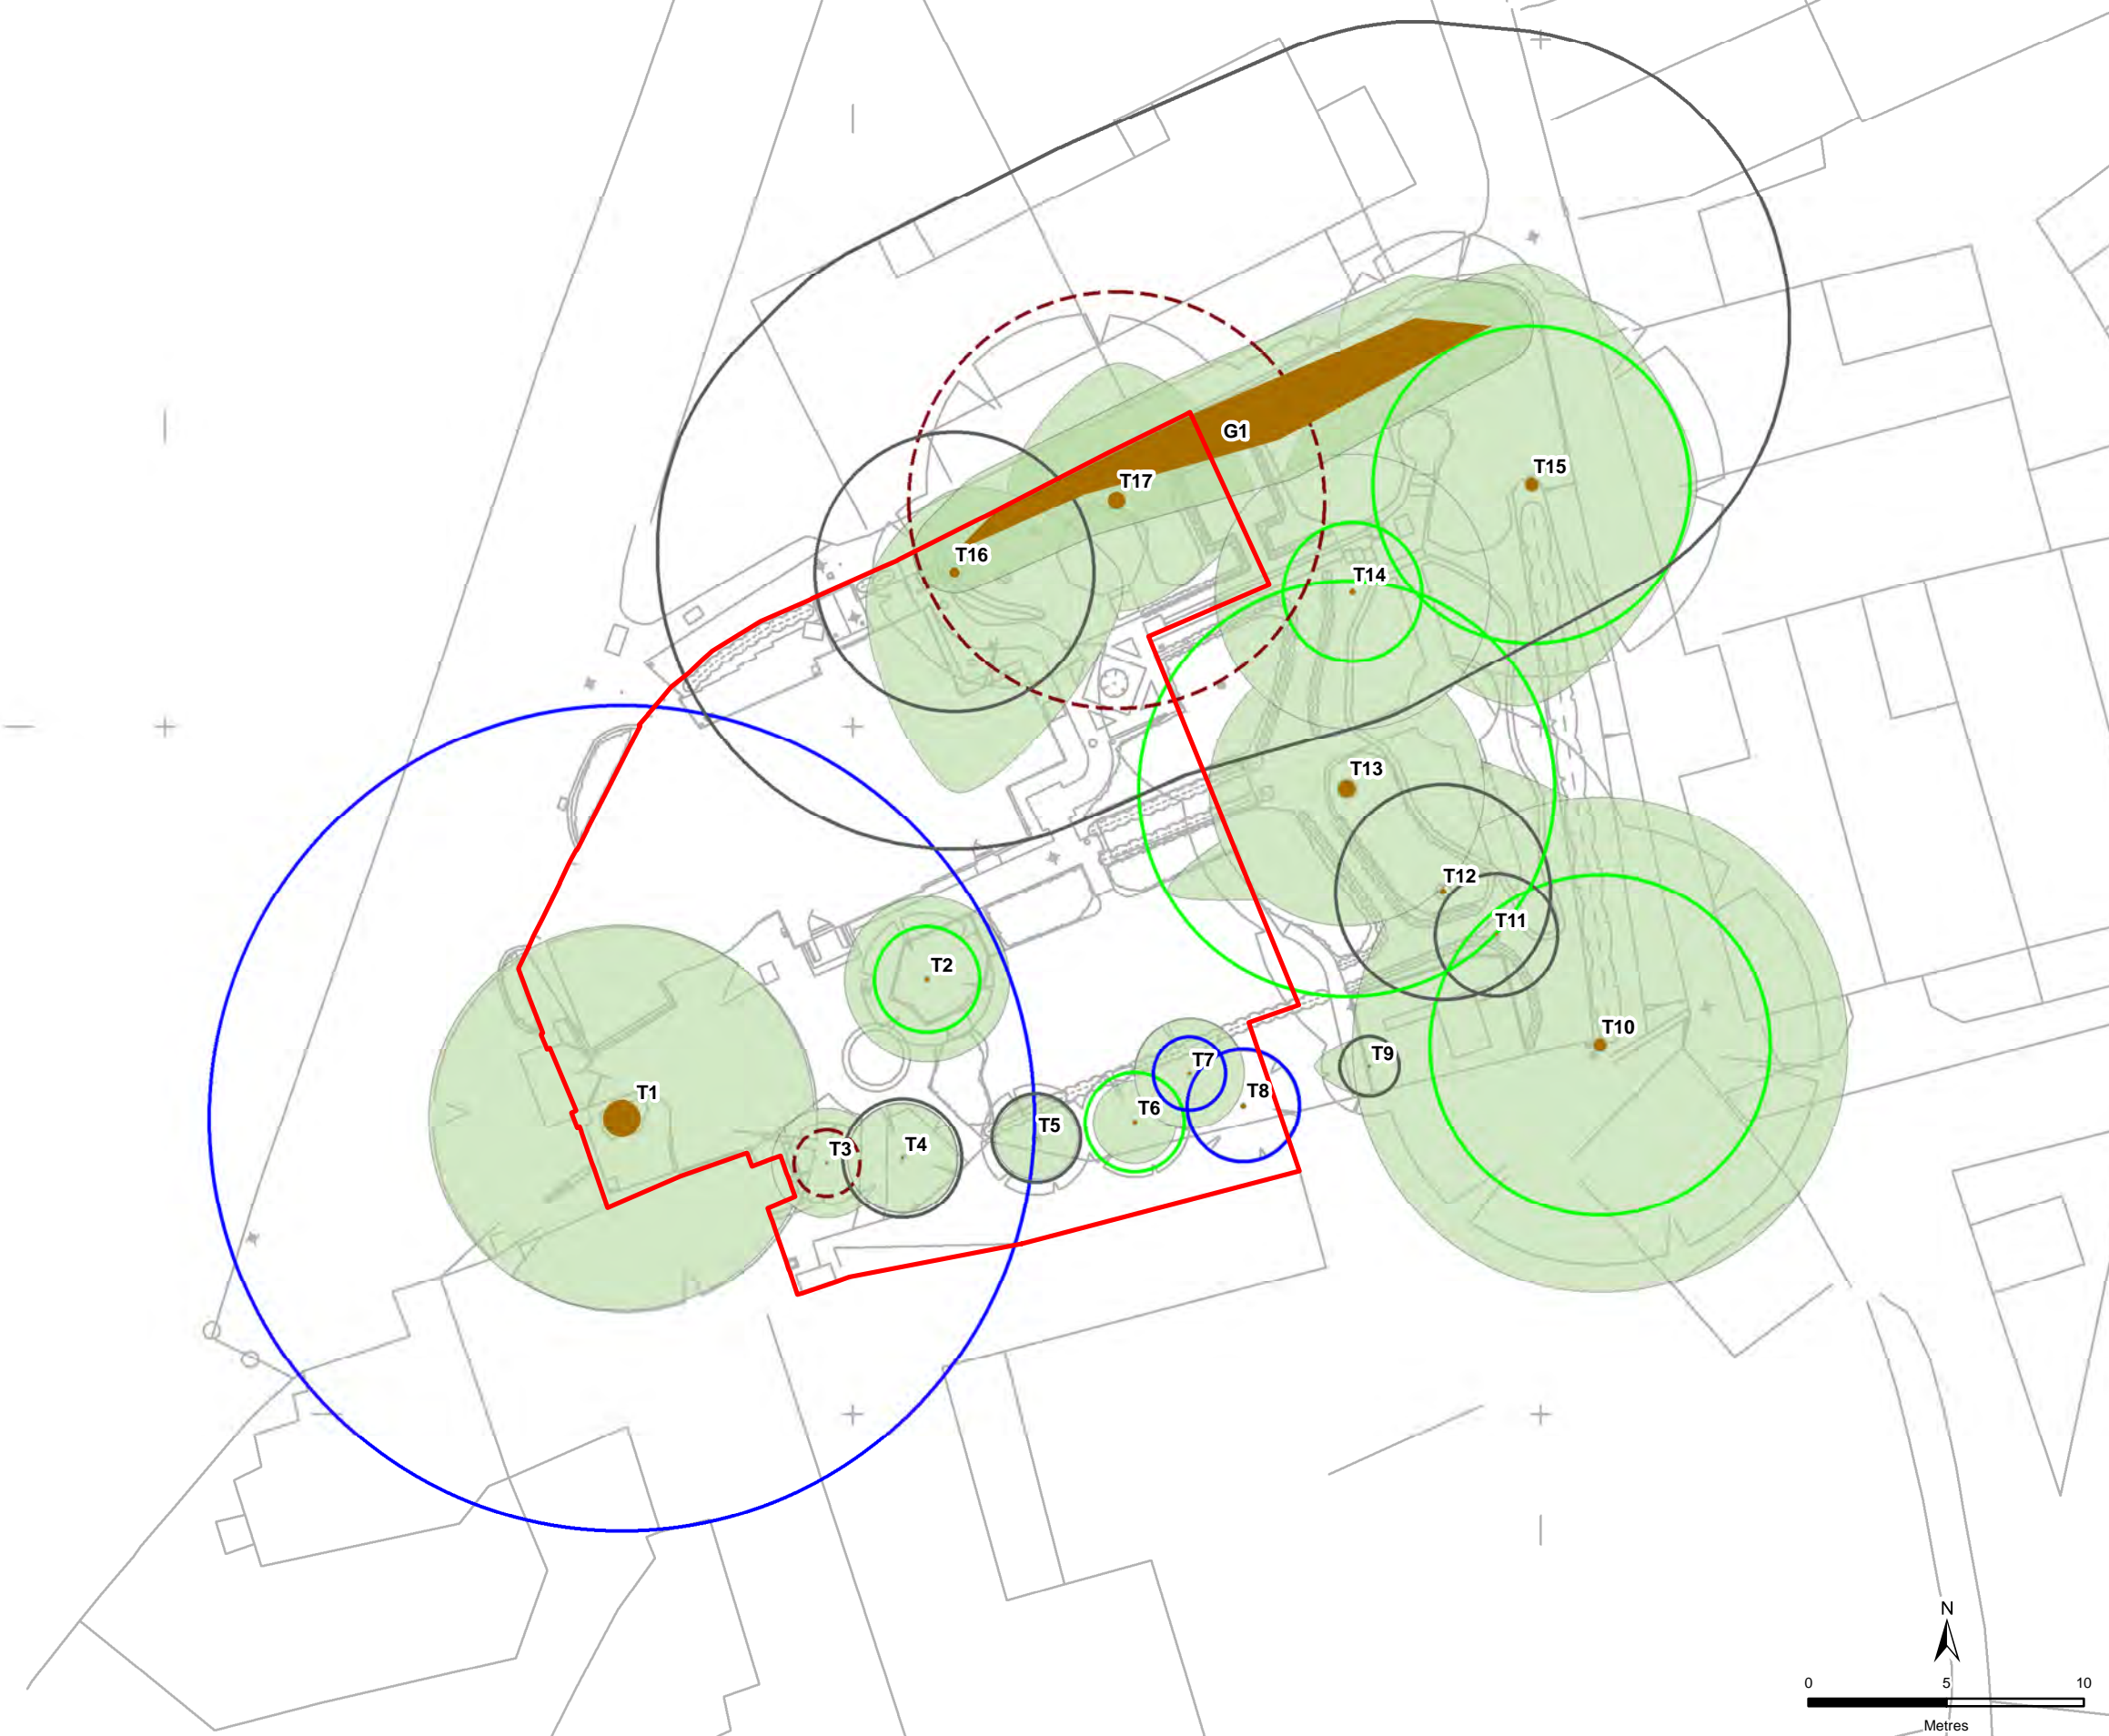
Drawing Ref		MFEA101/20030/1	
Scale at A3		1:250	
Drawn	AS	Checked	NS
Date	17/11/2015	Date	17/11/2015
Client Tate Harmer LLP			
Figure Number		2	
Figure Title Tree Constraints Plan (TCP01)

- 1.1.6** Two Category U trees, T3 and T17, are to be removed due to their poor structural condition and for sound arboricultural reasons (see Figure 2). Furthermore, one Category C tree, T16, is to be removed to facilitate the proposed development.

4.2.3 The RPAs for the trees and groups surveyed can be seen in Figure 2. The actual RPAs, in m<sup>2</sup>, for the individual trees surveyed are shown in Appendix 1.
