Analysis

3.1.1 Entrance Hall (Lobby & Reception)

3.2 Existing Lower Ground Floor

3.3 Existing Guest Lifts

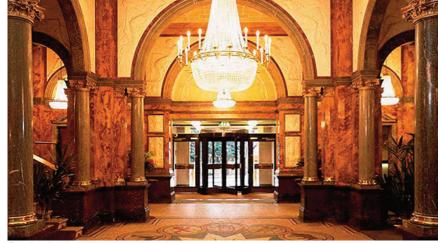
Existing Lobby - view towards main entrance door

The reception desk and front of house office areas currently locate either side of the main entrance, under the new mezzanine, and further obscure visibility from the street and general public.

Operationally it is an inefficient space with poor circulation and the lobby does not provide a sense of arrival or guest experience suited to a high quality four star hotel.

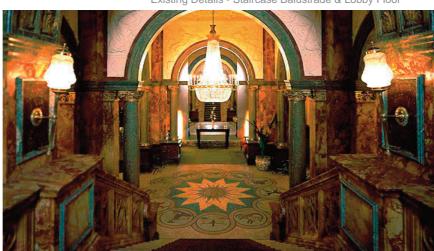
Existing Lobby - view from feature staircase landing

The extravagant grand entrance hall displays walls and columns clad in pink & red Italian marble, with plaster friezes and spandrels featuring extravagant plastermoulded female figures. On the floor is a broken mosaic featuring zodiac symbols surrounding a 'winking' sun. And a grand feature staircase extends from the lobby up through the core of the building.

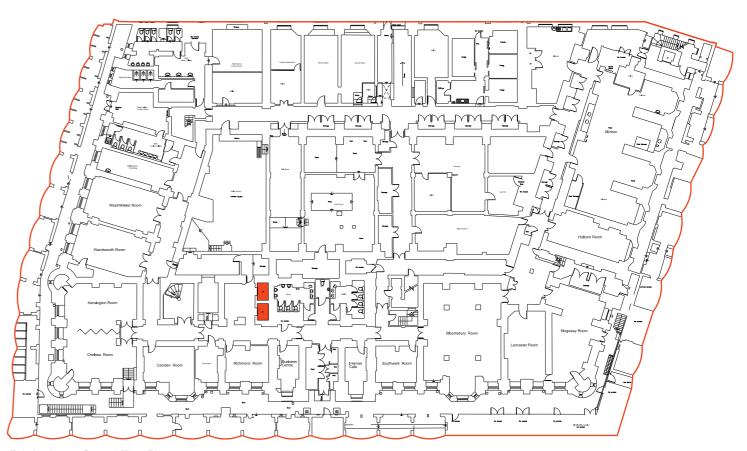
Existing Lower Ground Floor Plan (with existing guest lifts highlighted in red)

The existing lower ground floor has been substantially reconfigured over the years and little remains that is considered of historical significance.

Public access from the Ground Floor is by means of the two small guest lifts and a modern intervention in the form of a spiral staircase. Public areas incorporate 11 no. meeting rooms and their ancillary facilities, and the interior fit-out is generally considered to be out-dated and in need of refurbishment. The remaining area is all Back of House space, including the main kitchen, staff areas, plant and stores.

No lifts currently extend as far as the 8th Floor and only the two small lifts service the lower ground, meaning that there is no accessible provision to the meeting rooms.
