Bat Survey Letter of report: Garden House, Vale of Health, Hampstead, NW3 1AN

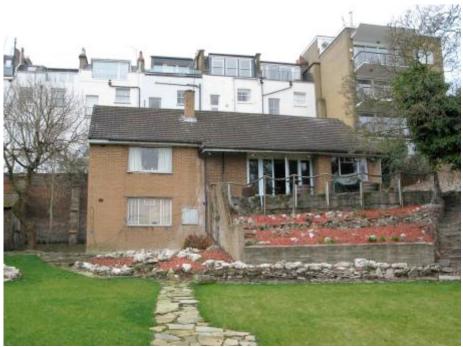
The buildings proposed for development include a two storey detached dwelling and a small outhouse. The dwelling was comprised of red brick with a concrete tiled roof (Photo 1). Wooden soffits were observed at each gable end. Roosting opportunities were found to be very limited as soffits and tiles were all tightly fitting. Internally the loft space was inspected. The void was cluttered, full of cobwebs and no evidence of roosting bats was observed (Photo 2). Numerous rat droppings were however recorded.

Photo 1 - Garden House, Vale of Health

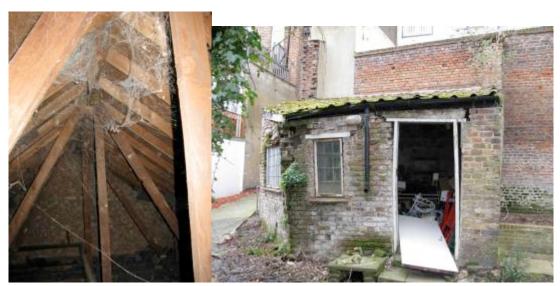
Photo 2 – Void of dwelling.
