ARBORICULTURAL IMPACT ASSESSMENT REPORT:

73-75 Avenue Road
London
NW8 6JD

Ref: BWR/75AVR/AIA/01b

Date: 22nd March 2016

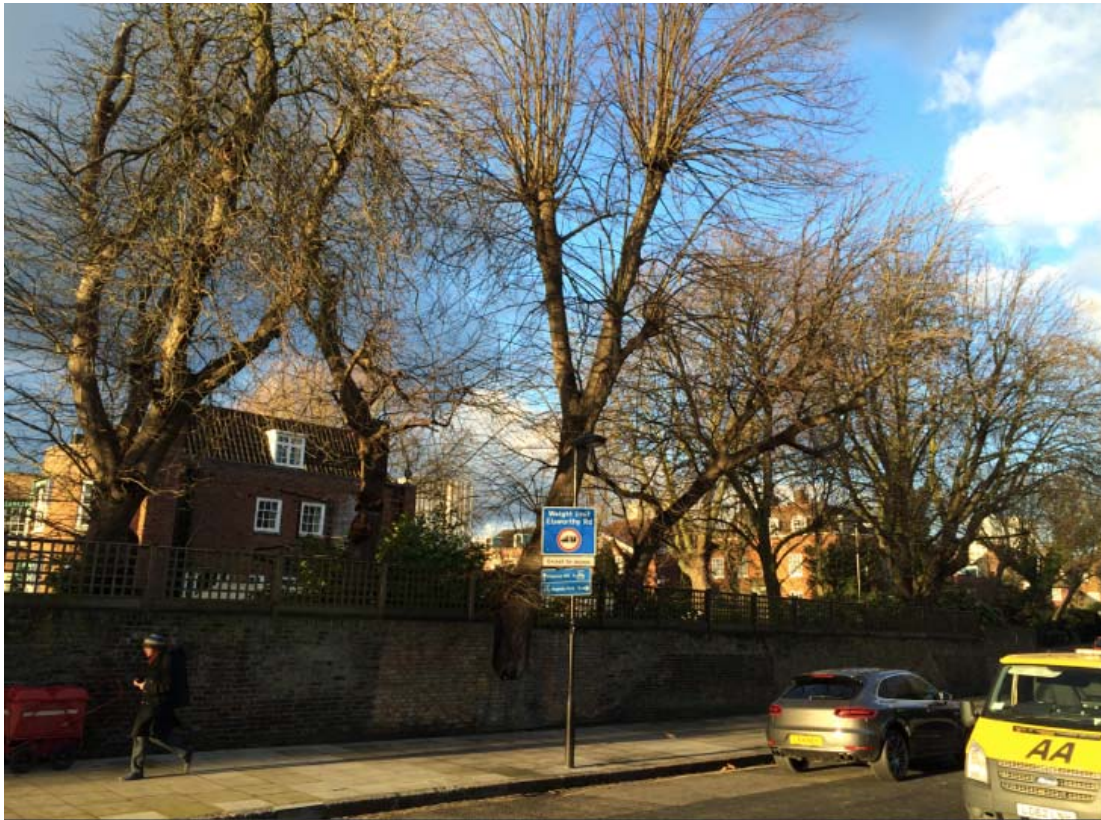
Photograph 2: Trees T18 – T24 along south eastern boundary

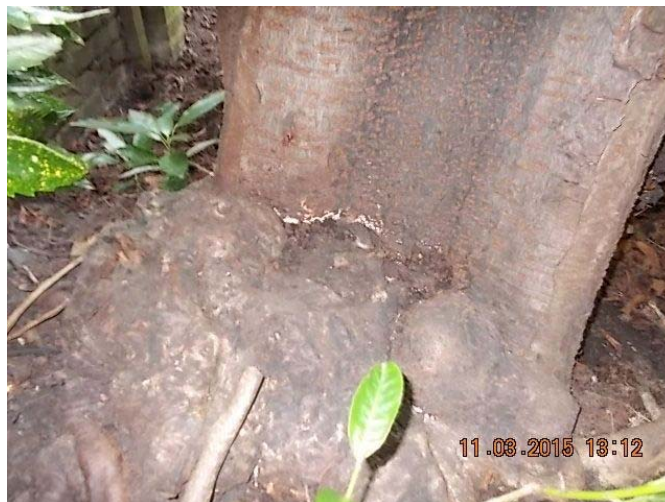
Comments			
Further investigation of decay in T19 recommended urgently – tree may well require felling. Other recommended works identified for 8 trees (see Appendix 2).			
Recommendations			
1	Proposal will mean the loss of important trees (TPO/CA)		N
2	Proposal has sufficient amelioration for tree loss		Y
3	Proposals provide adequate tree protection measures		Y
4	Proposal will mean retained trees are too close to buildings		N
5	Specialist demolition / construction techniques required		Y
6	The Proposal will result in significant root damage to retained trees		Y
7	Further investigation of tree condition recommended		Y

3.2.5 There are recommended works for 9 trees, including the urgent investigation of the decay on the category U tree T19 (see photograph 3 below). These works are listed in Appendix 2.

Photograph 3: Decay on T19

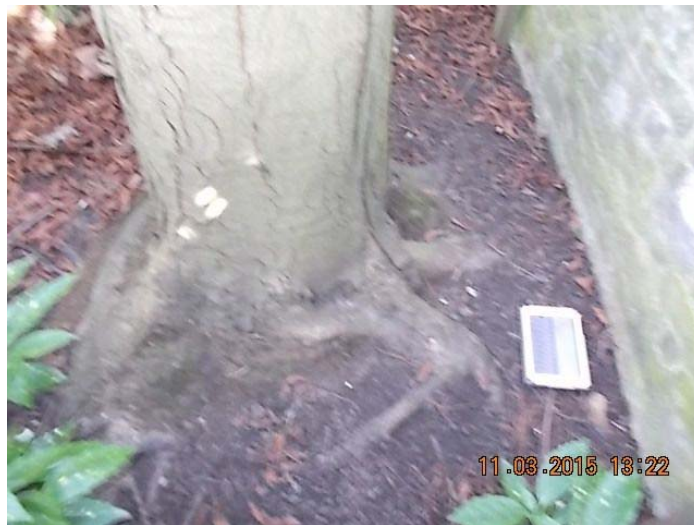
Photograph 4: Stem of T22 illustrating pattern of buttressing

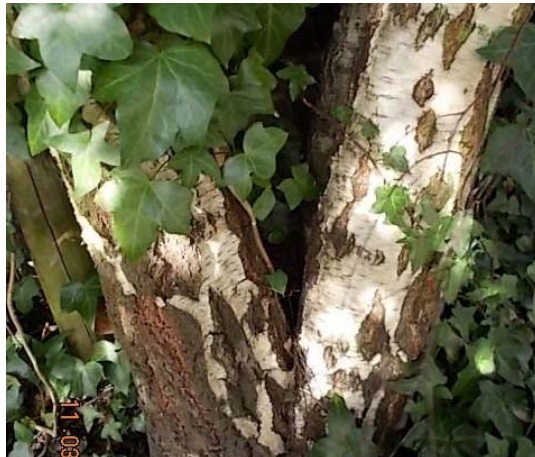
Photograph 5: Co-dominant stems of T2

- 7.3 The tree that is recommended for felling has co-dominant stems and is of little individual significance, such that its loss will not affect the visual character of the area. The loss will be mitigated within the proposed landscaping scheme by Boyles and Wyre.

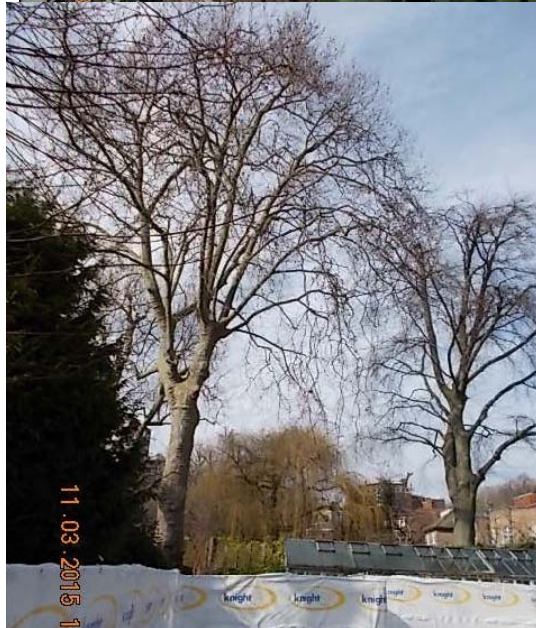
Photograph 6: Current overhanging branches of T8

- 6.3.5 The immediate canopy encroachment can be avoided with minor tree works (See Appendix 3). Nuisance deposition can be mitigated with regular crown cleaning and filtration traps on the guttering (see Figure 5 below). Alternatively, elements of green roof construction might be considered, where applicable.

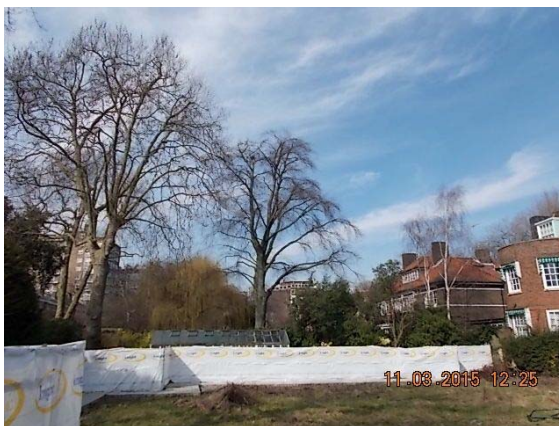
Photograph 7: Current overhanging branches of T8

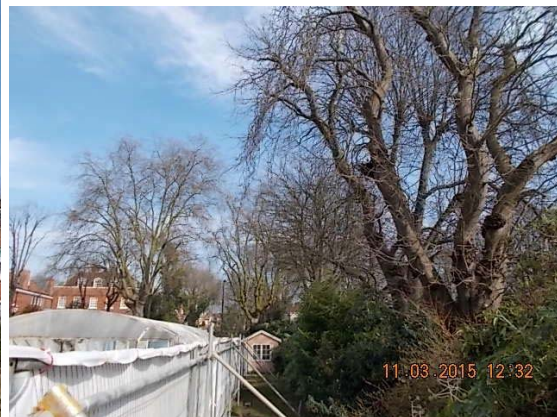
Photograph 8: Current overhanging branches of T22

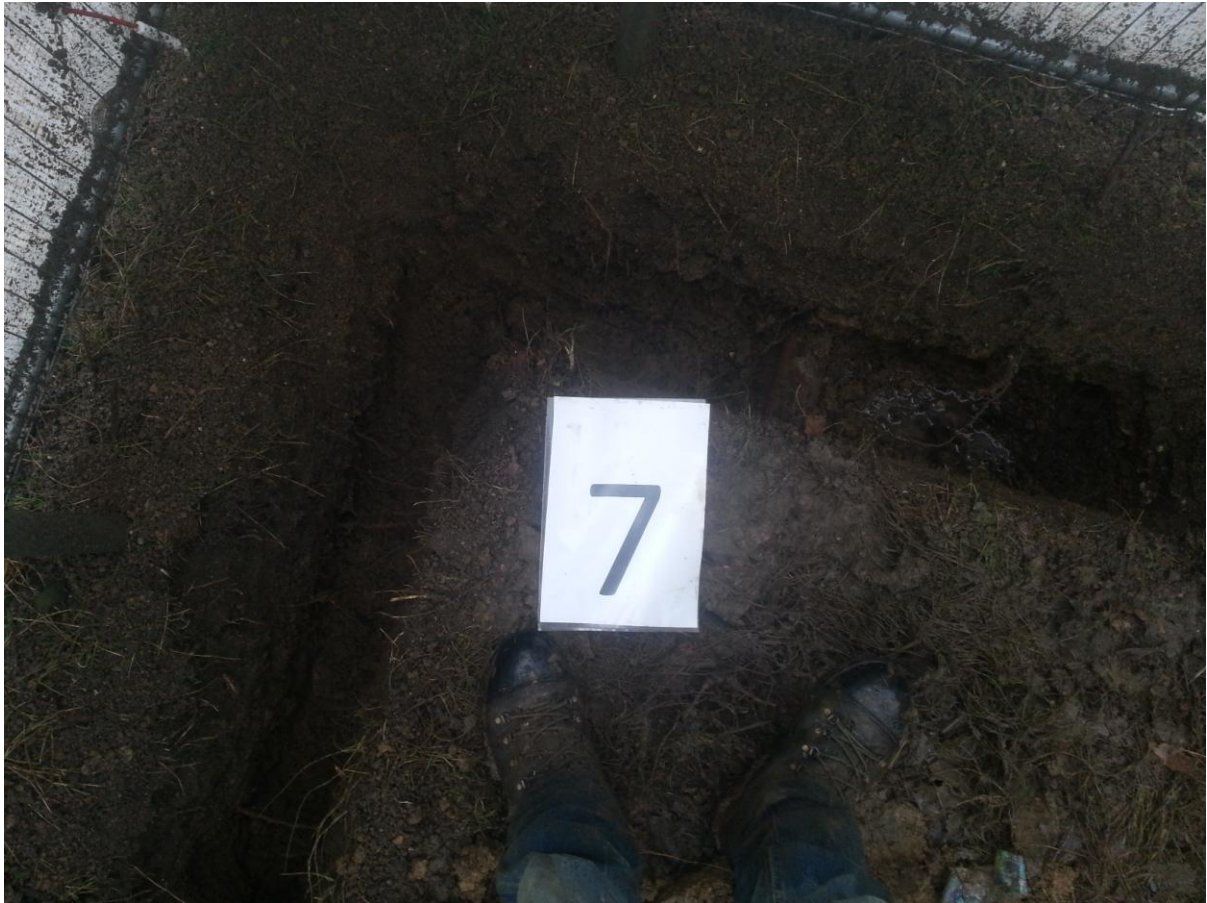
- 4.1.4 Similarly, the trial pit 7 on the tree side of the existing TPB was inspected by both parties and agreed to contain no roots. The tree T8 has been left with a conventional RPA, since it would appear either that it is freely rooting below boundary walls (quite conceivable for the species) or its boundary hugging RPA is too eccentric to plot.

Trial Pit 1	1.5m Long, 40cm Wide, 12cm Deep. 1x60mm root Number of fibrous roots
Trial Pit 2	1.5m Long, 40cm wide 18cm Deep. 1x 50mm Root
Trial Pit 3	1.5m long, 35cm wide, 13cm Deep 1x45mm root 1x50mm root
Trial Pit 4	90cm long, 40cm wide, 12cm deep 2x30mm roots 1x25mm root
Trial Pit 5	1.5m long plot containing 2x 40mm roots, Chased this back into the lawn to determine point that roots reduce <25mm. 2.5m out from initial plot (11m from boundary wall) roots are still 30mm in diameter.
Trial Pit 6	1.5m long, 40cm wide, 20cm deep 1x45mm root 1x30mm root
Trial Pit 7	1.5m longx1.5m long "L", 40cm wide, 70cm deep No Roots
