OPTIONS REVIEW AT EXTERNAL OPENING WITH LGAZED FEATURES WITHIN 1800mm of potential escapees using basement external fire escape stairs

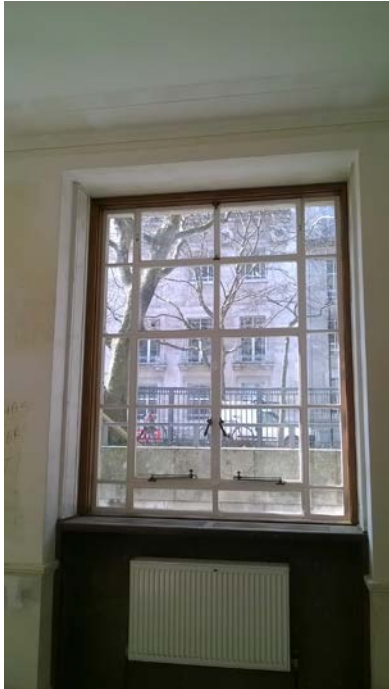
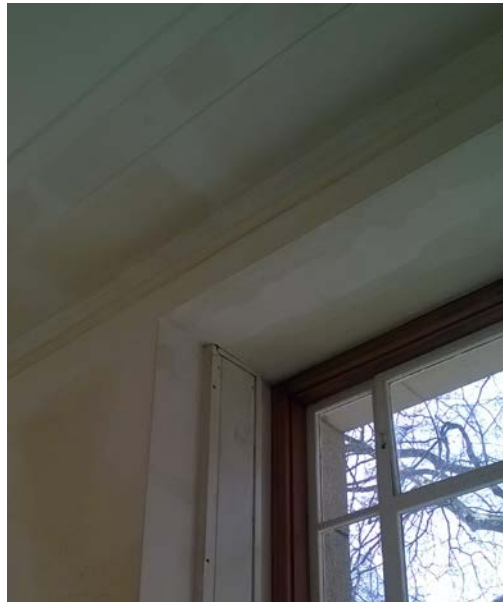
**Window at location (1)**

Cornice, high level picture rail affected by shutter box  
Dado, skirtings affected by guide rails.  
Maintaining fire rating integrity will require these all to be cut.

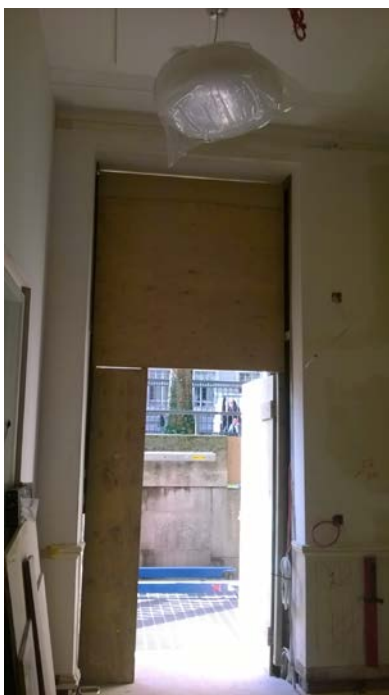
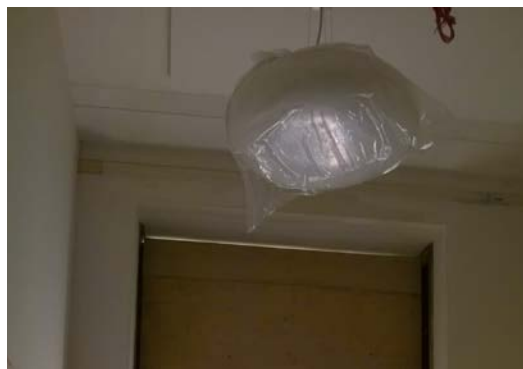
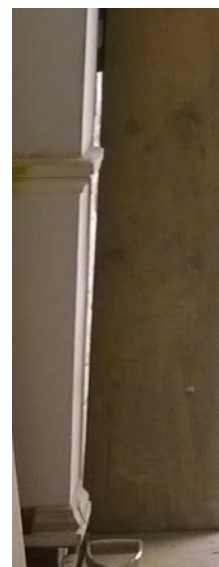
**External door at location (A)**  
Impact as above if shutter (opt 2)

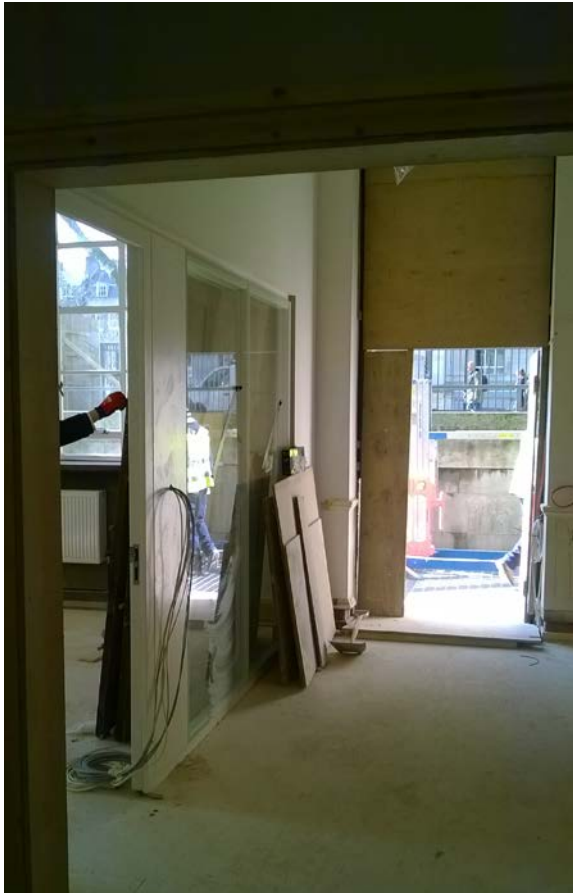
**New glass screen between escape route (G.47) and seminar (G.06)**

Client is prepared to omit as room well daylight on two sides.

Door opening at location of photo taken from to be widened. Option 1 would see screen omitted, single door glazed ( extent limited by acceptable FR and 30 minutes integrity so TBC) , plus new wide door, probably 1200 leaf in original but enlarged opening.

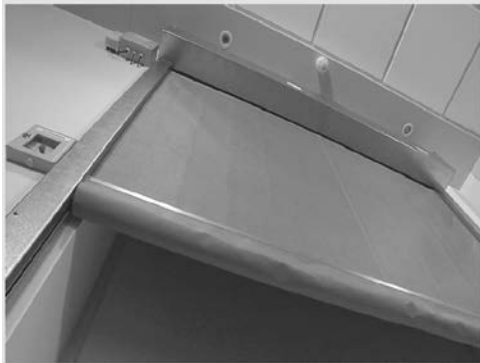
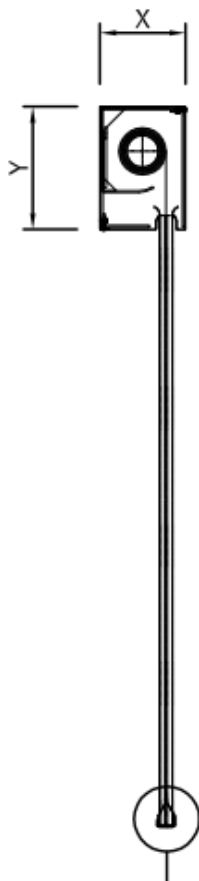
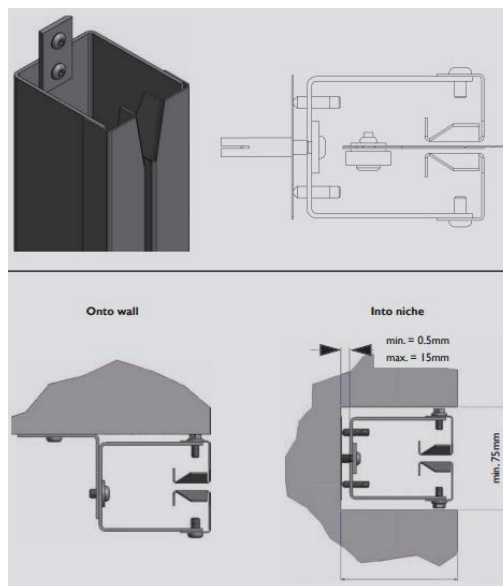
**Typical fire shutter details**

Components can be powder coated. It may be possible to conceal both head box and guide rails by plasterboard cladding, they will additionally project into the room geometry.

Control panel and fire alarm interfaces ( assume 200 x 200) need to be with close proximity of the shutter.
