**13 Kemplay Road, Hampstead**

**Decay Assessment Report**

**7<sup>th</sup> May 2016**

| <b>File reference</b> | 16_1206_ReportX02_NT |

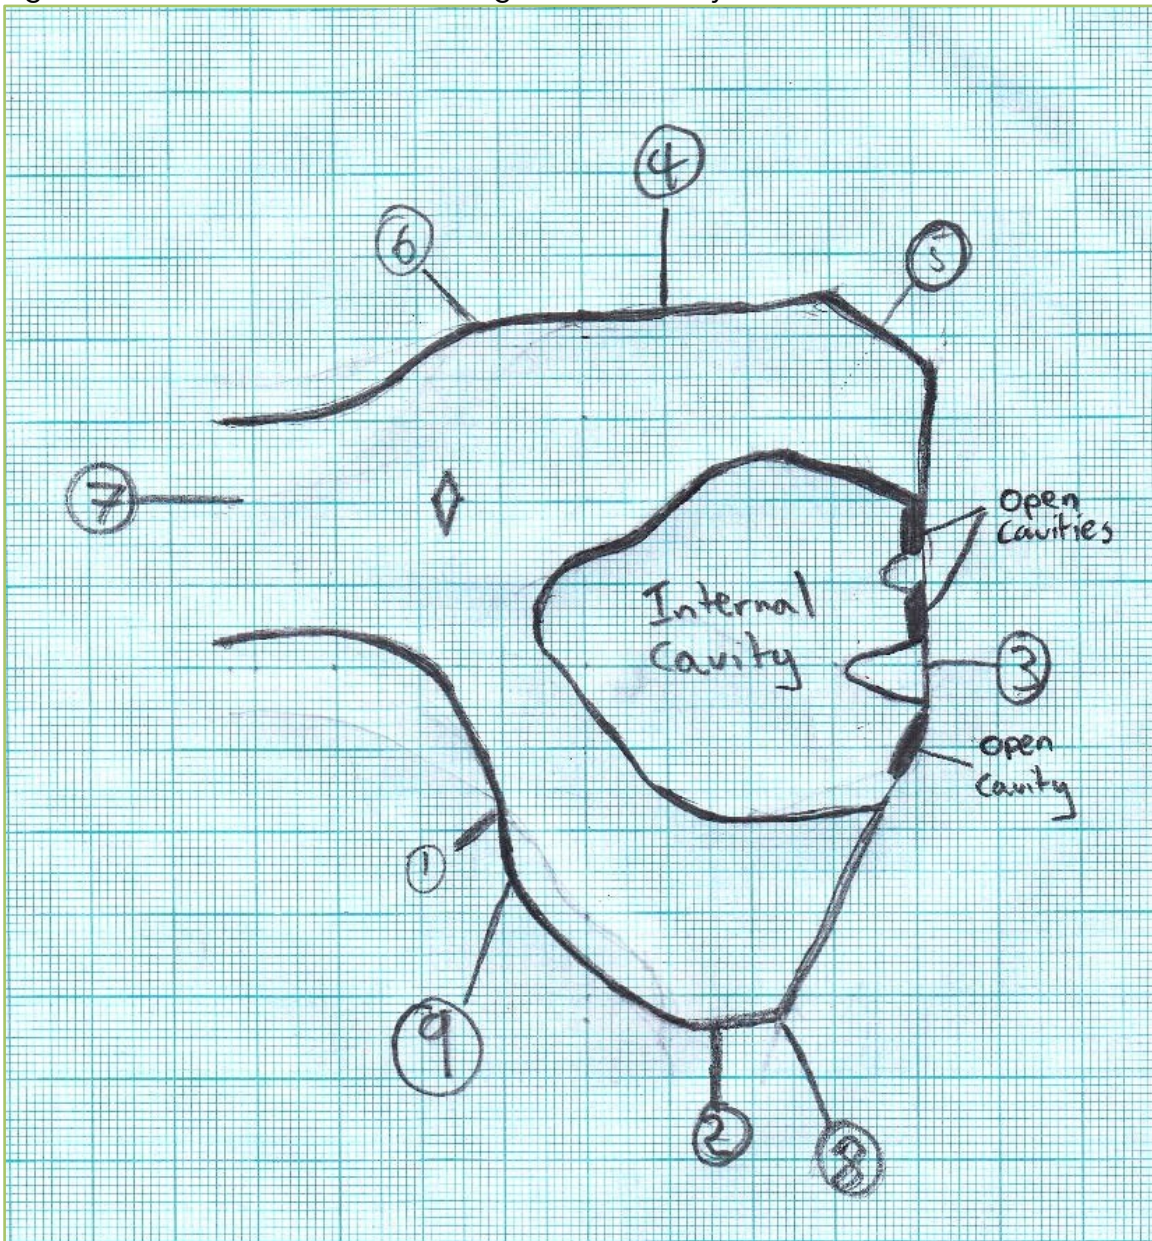
The numbered points represent each resistograph test, the output of which can be seen in Appendix 1. Eight of the nine tests completed showed areas of no resistance which signifies an internal cavity. The results enabled a sketch of the cavity to be drawn onto the cross section to give a visual representation of the resistograph readings.

Figure 1: Cross section sketch showing extent of decay

No fungal fruiting bodies or rhizomorphs were found. Three open cavities at the base of the tree on the eastern side were recorded and are illustrated in Figure 1 above.

The results of the resistograph tests show that the tree has significant internal decay that is likely to compromise its structural integrity, although the extent of the decay is not considered sufficient to require its immediate removal. However, the current height of the tree means there is a high lever arm effect imposed on the weak point at the base. A reduction in height of five metres would significantly reduce the lever arm effect but would result in the majority of the canopy being lost, reducing the tree's ability to photosynthesise and therefore resist the fungal pathogen attacking the base of the tree. Furthermore, a significant reduction of the tree will detract from its amenity value within the context of the street scene.

Therefore, it is recommended that the subject tree should be removed. The stump should be ground out and the area replanted with a more suitable species such as silver birch.

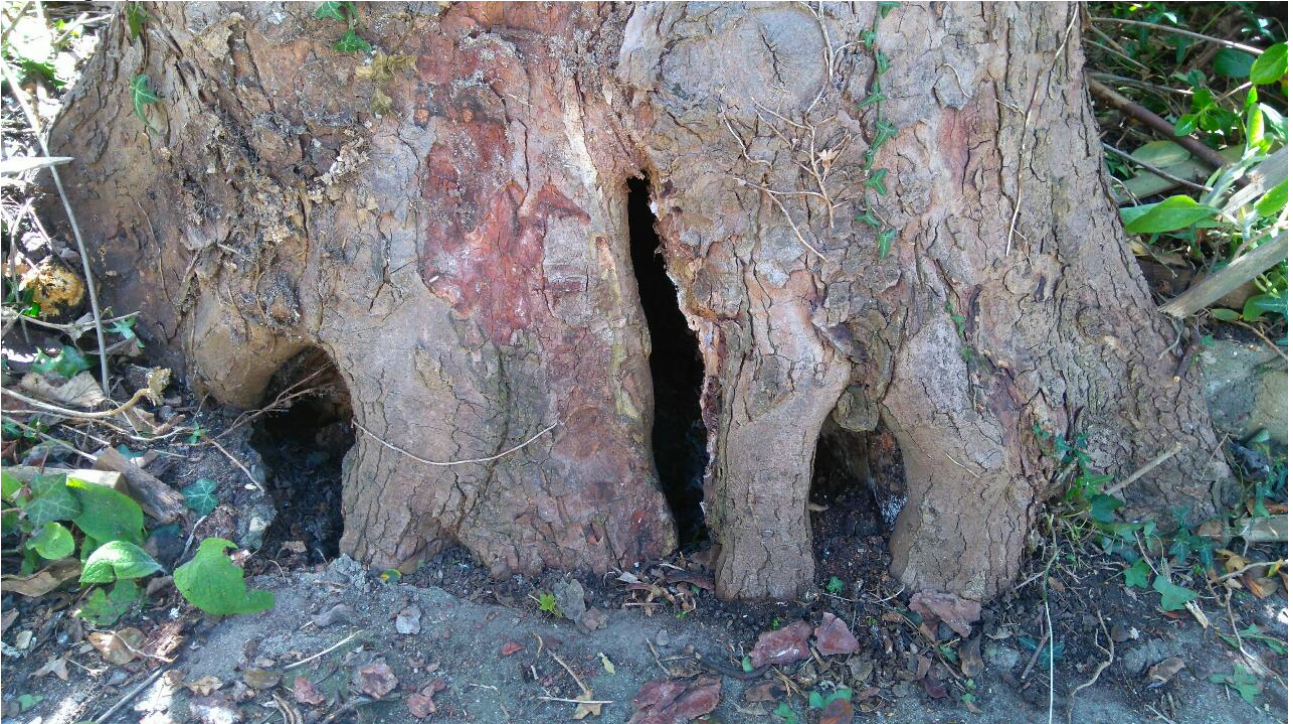
Photograph 1: View of the base from the east
