# Arboricultural Survey

45 Broadhurst Gardens London NW6 3QT

27<sup>th</sup> October 2015

PJC ref: 3836B/15-01

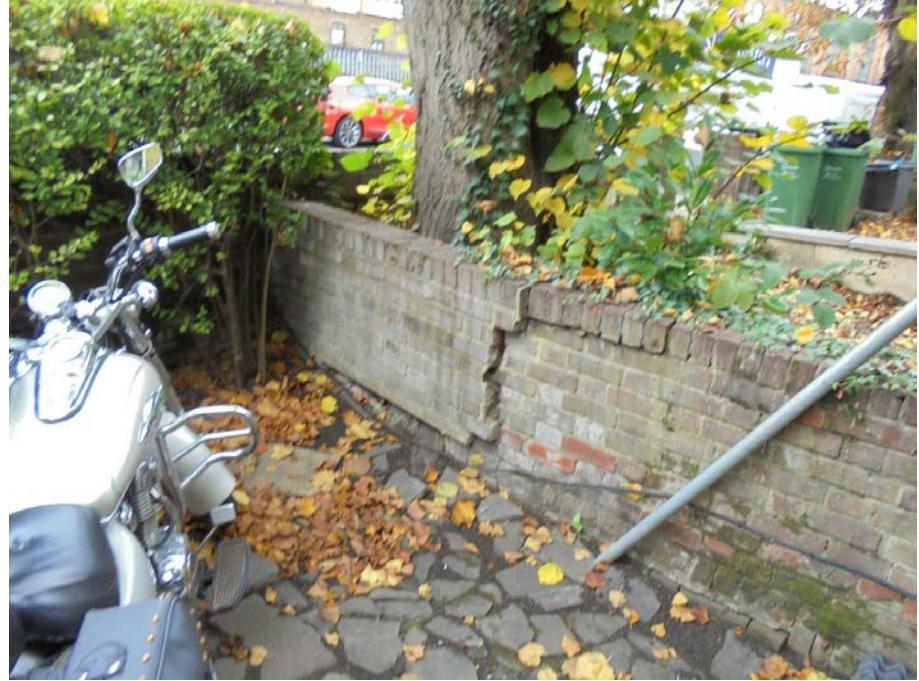
3.4 The buttress of T1 abuts against the low brick wall that separates the gardens of numbers 45 and 47. As a result, the wall has partially collapsed, as has the section of wall on the road frontage directly north of the buttress. A large buttress root from T1 extends above ground level, through the wall directly west of the tree. It will not be feasible to repair the wall adjacent to T1 in its existing location whilst the tree is still present. The majority of the dividing wall can be repaired, however the section immediately adjacent to the buttress would either have to remain as existing or be removed. If this section of the wall is removed, it is recommended that the footings be left in situ below ground level to avoid unnecessary disturbance to the buttress roots,

Photograph 1 – Damage to dividing wall from T1

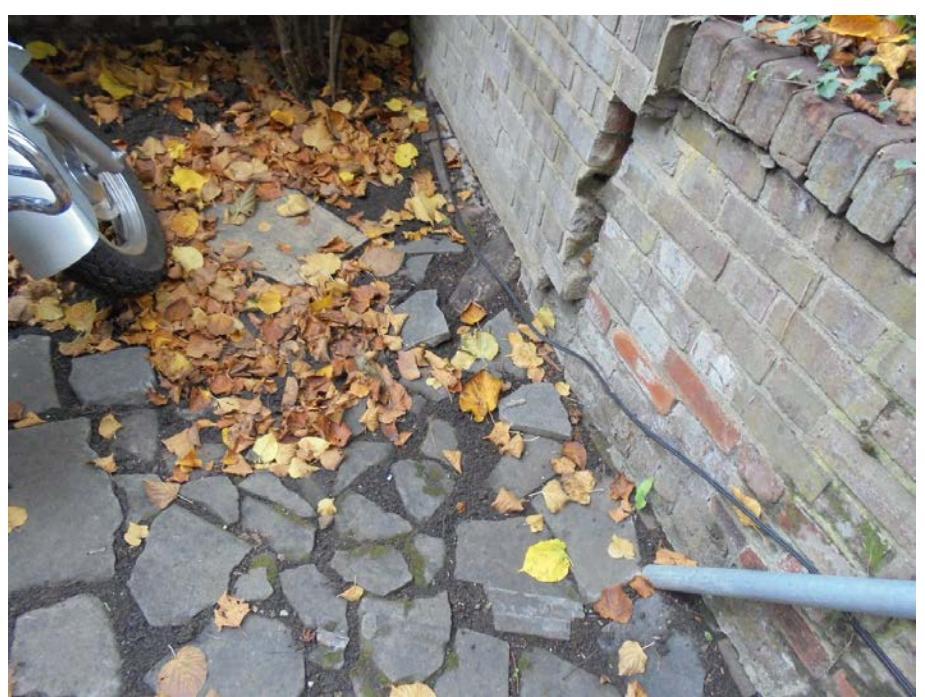
Photograph 2 – Buttress root from T1 through boundary wall

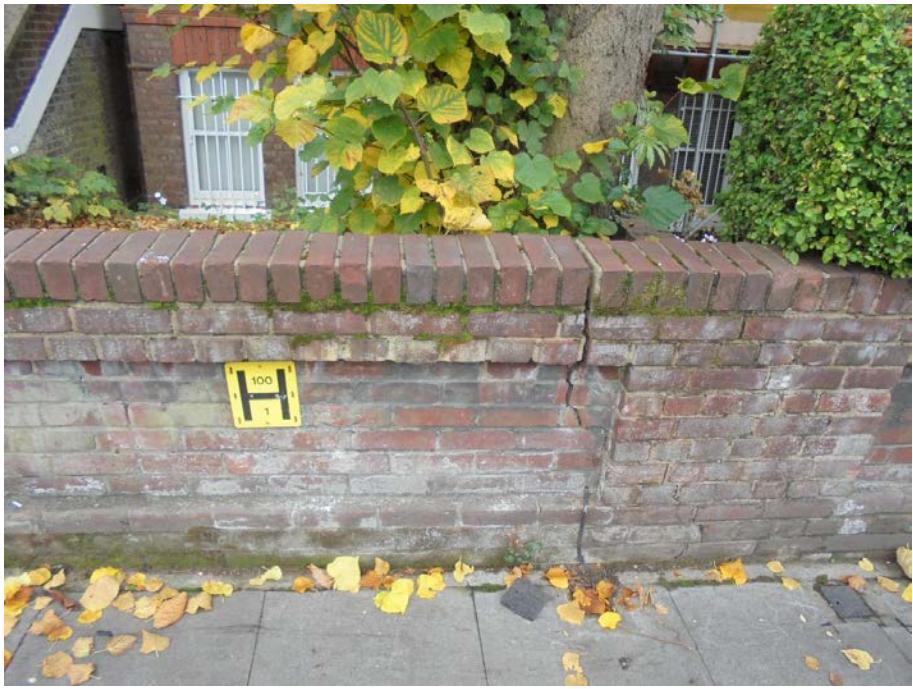
Photograph 3 – Damage to boundary wall from T1

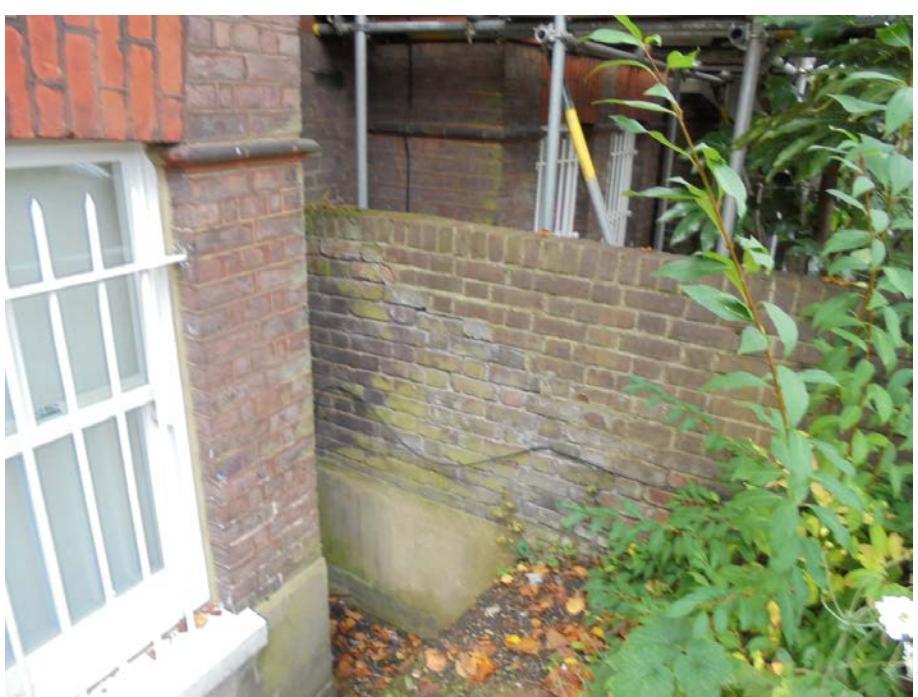
3.7 A diagonal crack is present in the dividing wall, to the south of the retaining wall at the southern end of the garden of number 45. The form of the crack suggests it may have resulted from the partial collapse of the wall adjacent to the buttress of T1.

Photograph 4 - Crack in dividing wall potentially attributed to T1

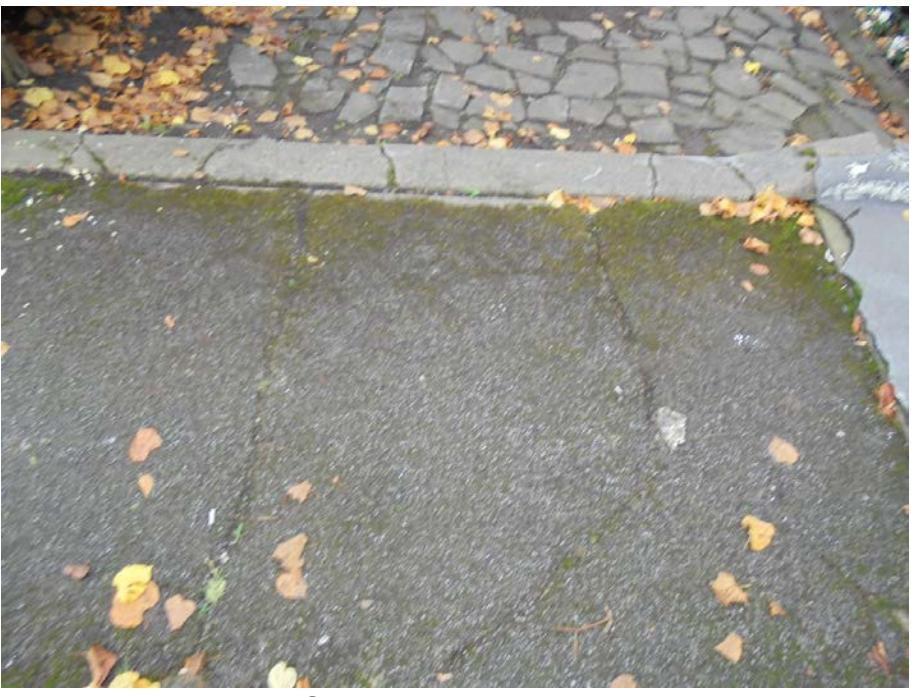
3.6 Root growth from T1 also appears to have had an impact on areas of surfacing within the front garden of 47 Broadhurst Gardens. There are two main areas of paving within the garden of number 47. The eastern section of the garden comprises irregular paving slabs that appear to have been slightly lifted in places, potentially by tree roots. The western half of the garden comprises tarmac with cracks extending in an east/west orientation, which is along the root radii of T1 so root growth may again potentially be the cause. Given the size and proximity of T1, and the presence of the large buttress root extending through the dividing wall, it should be assumed that roots from T1 will be located beneath all areas of paving in the front garden of number 47. However, whether incremental root growth is the cause of the damage to the surfaces cannot be absolutely confirmed without ground investigation.

Photograph 5 – Cracks in tarmac surface of number 47

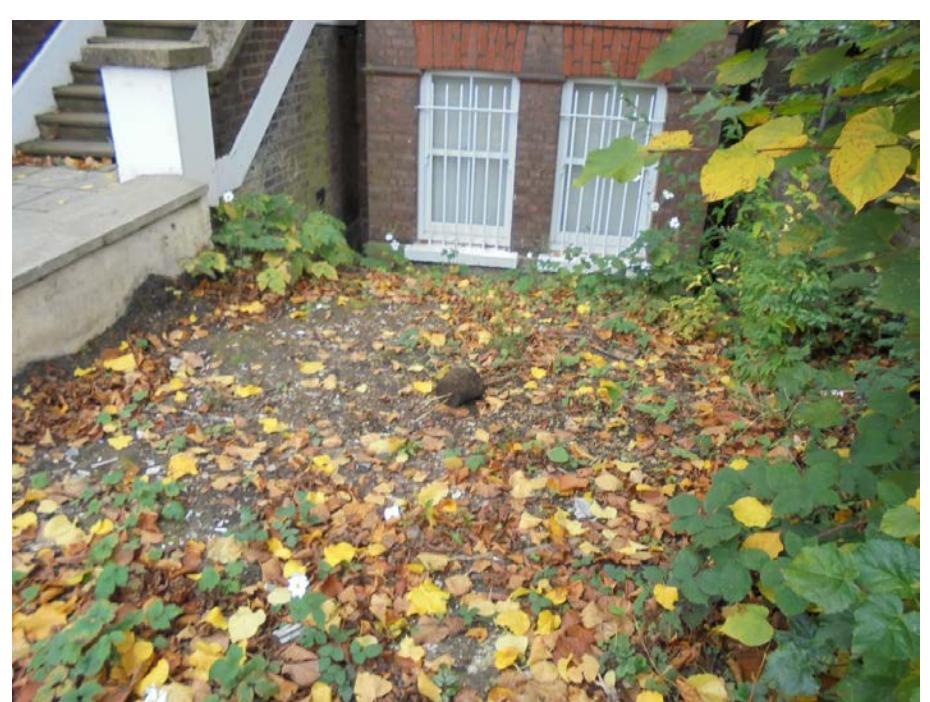
Photograph 6 – Bare ground in garden of number 45

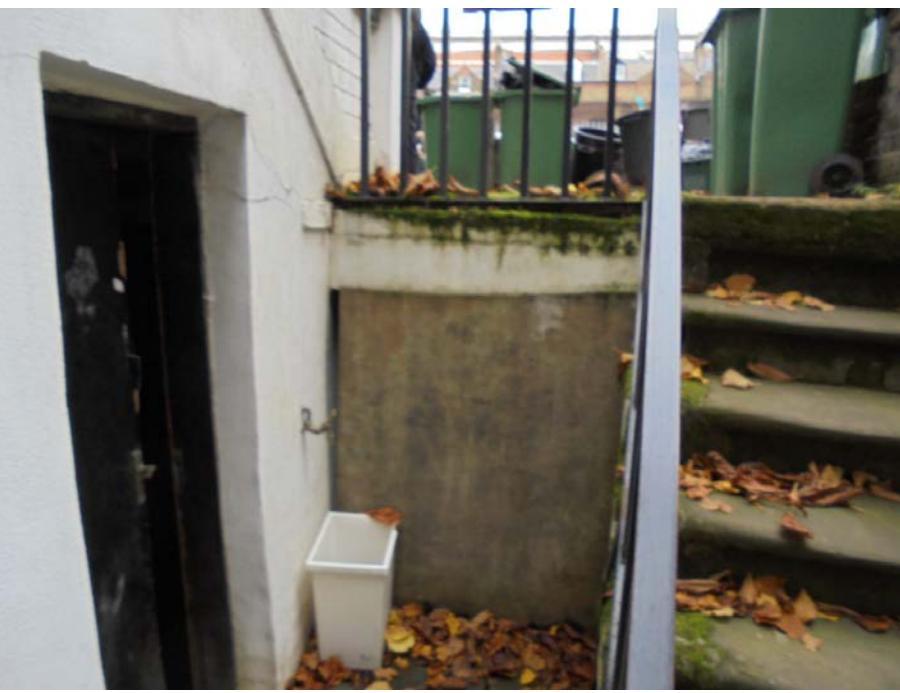
Photograph 7 – Hollow space beneath steps at number 45

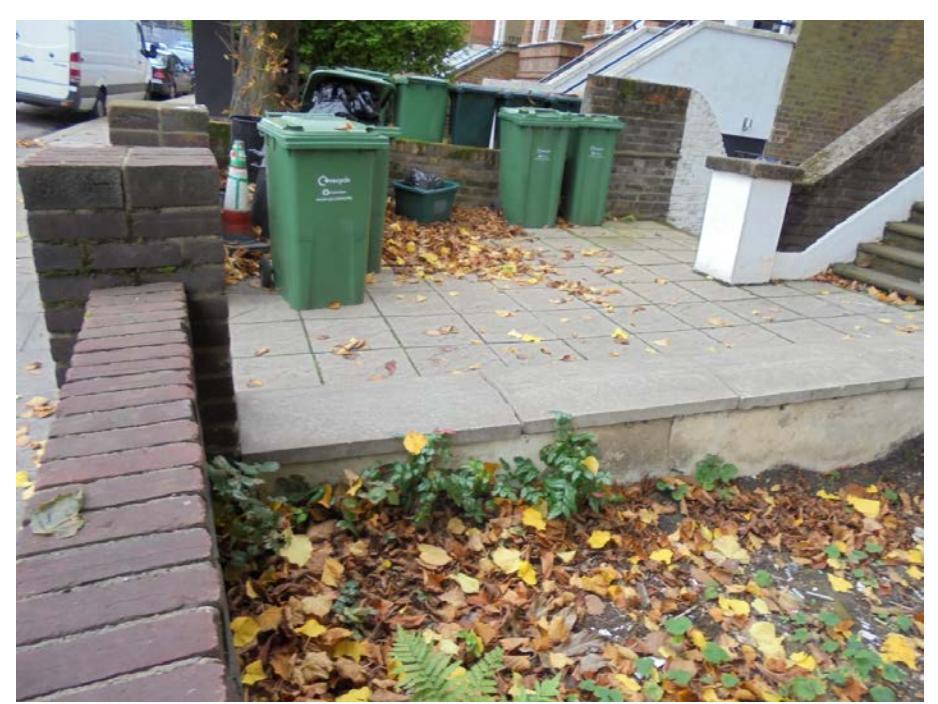
Photograph 8 - Paved area at number 45. No visible signs of root damage
