## Present Day

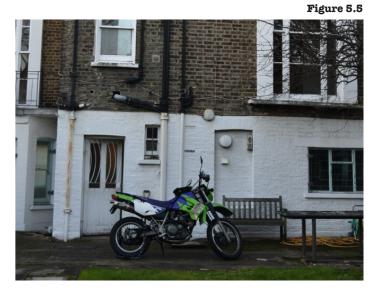
The houses has some of it's original features intact, or possibly re-constructed, but also a few non-original features breaking the continuity. There has been alterations to the rear facade, details such as extra glazing set outside of the existing windows, which are undesirable. The rear also features some unoriginal bars over a lower ground floor door. These types of bars also exist behind a door on lower ground floor on the front facade, but are not visible from the street.

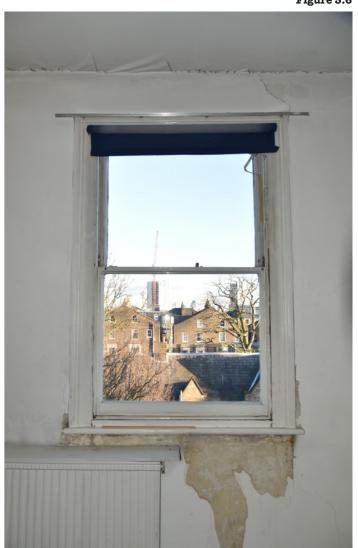
Figure 5.6

The overall internal condition of the house is poor with many damaged windows and decrepit walls, and is therefore in great need of renovation.
